ALASKA DEPARTMENT OF ENVIRONMENTAL CONSERVATION
Division of Spill Prevention and Response
Prevention and Emergency Response Program

SITUATION REPORT

INCIDENT NAME: F/V Melville Grounding

SITREP #: 2 and Final

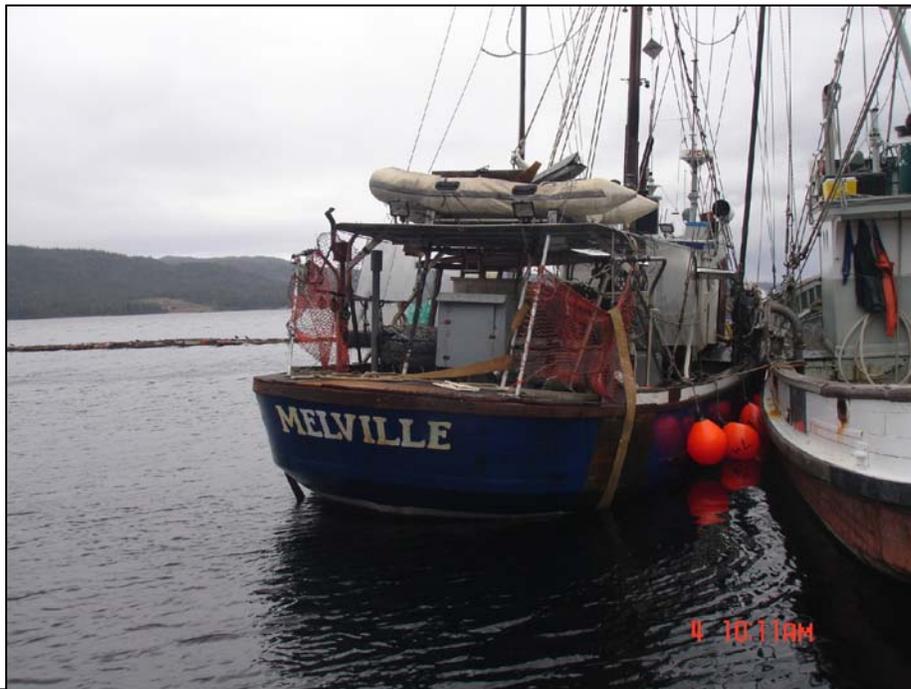
SOURCE CONTROL: The vessel has been re-floated. No sheen was visible around it. An inspection to the two fuel tank site tubes while docked in Ketchikan revealed that both tanks were near full confirming that a minimal amount of diesel oil was released during the incident.

FV Melville in Ketchikan after being re-floated. October 4, 2006. ADEC photo.

FUTURE PLANS AND RECOMMENDATIONS: The vessel will be taken out of the water on October 5 for further assessment and necessary repairs.
