**VOLUME 1**  
**REVISED FINAL CLEAN-UP REPORT**  
**ICY BAY WEST CAMP #1**

**DMC Technologies  
3528 West Hwy. 33  
Rexburg, ID 83440**

*May 24, 2004*

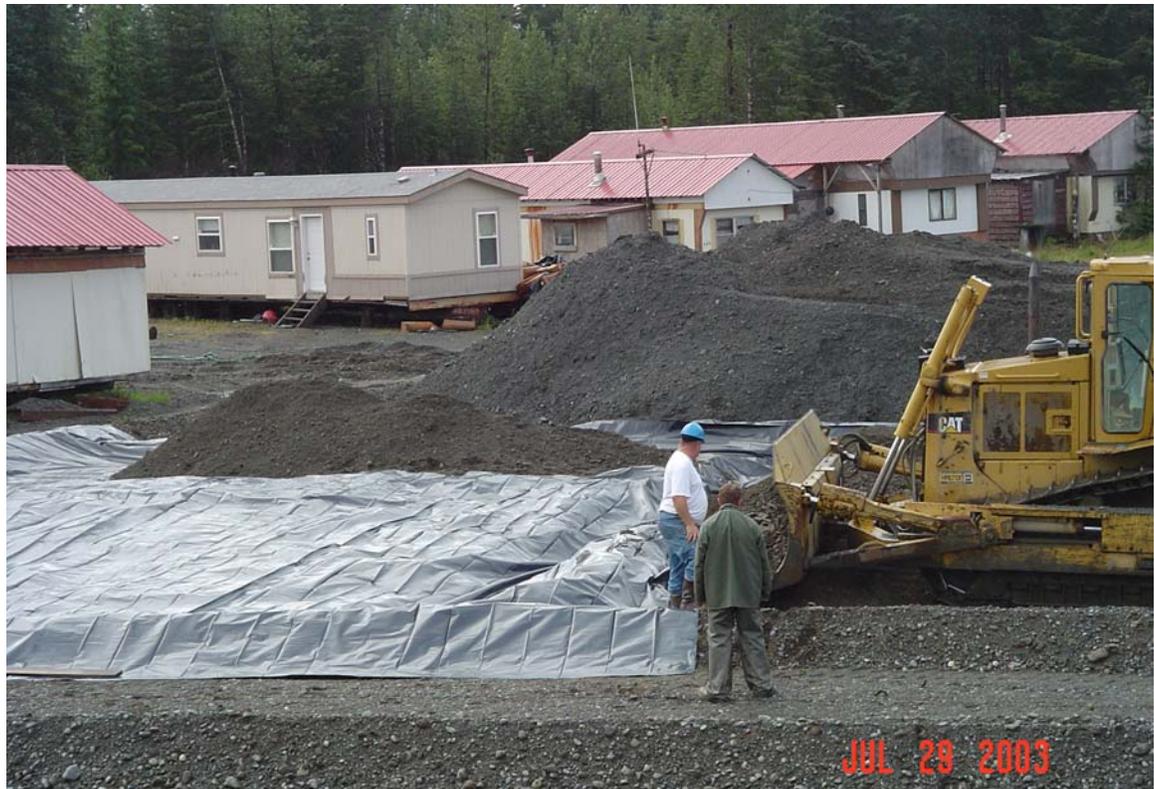
Figure 28. Separated Solvent Stockpile Excavated From Oil Shed Area

The following photo illustrates solvent contamination management activities. The segregated stockpile is shown with some contaminated soils placed in the area. Solvent contaminated soils were excavated on July 29, 2003. Confirmation samples were collected and analyzed. The west sidewall of the excavation was found to still be contaminated based on sample results. This sidewall was also littered with buried metal waste. The metal was carefully removed as additional excavations were performed. Reconfirmation samples were then collected and analyzed indicating that all contaminants had been removed. Scrap metal was loaded and delivered to the metal waste dump. A total of 408 CY of solvent contaminated soil was removed from the excavation area.

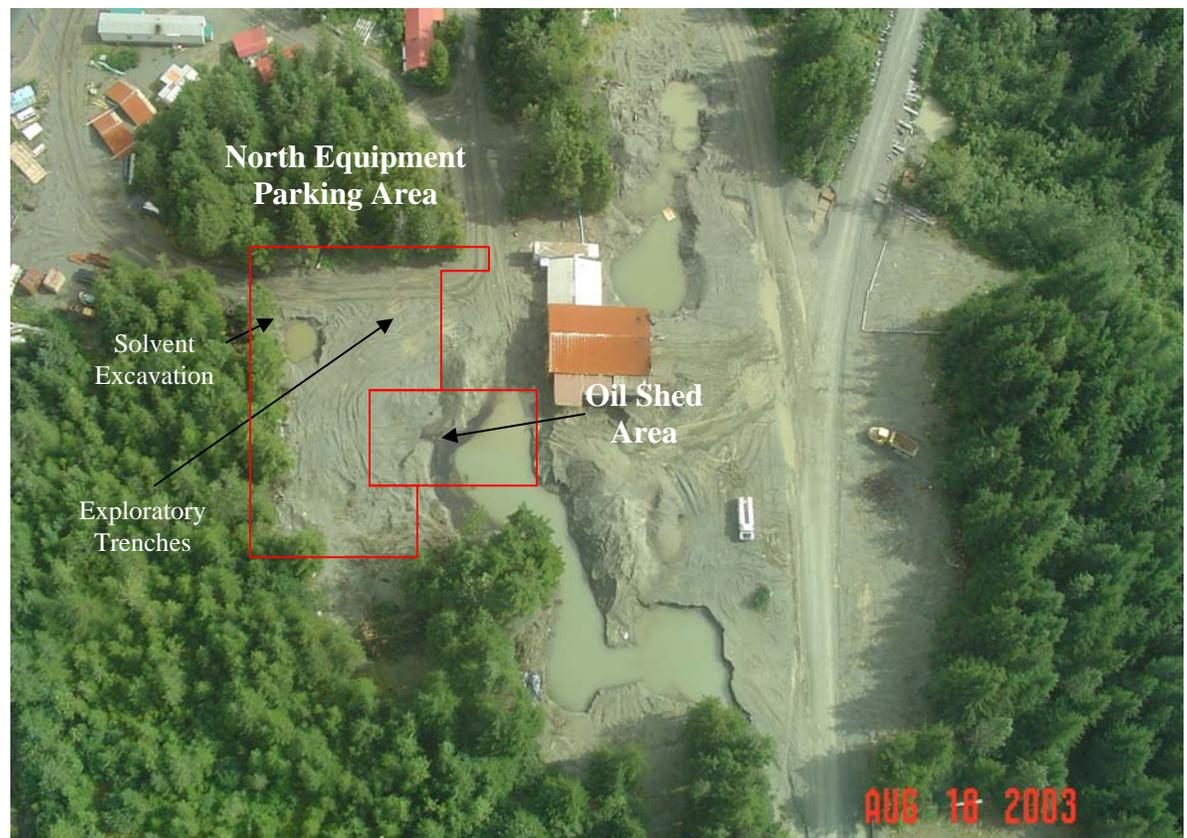
Figure 29. North Equipment Parking Area

General contamination in the parking area as evidenced by both characterization sampling results and oil stains on the ground surface was excavated and removed. Typical excavations were shallow to moderate in depth and did not proceed to the water table except at the solvent contamination site. Several empty metal drums, empty metal containers and fuel filters were collected during the excavation and managed as metal waste in accordance with camp waste regulations.

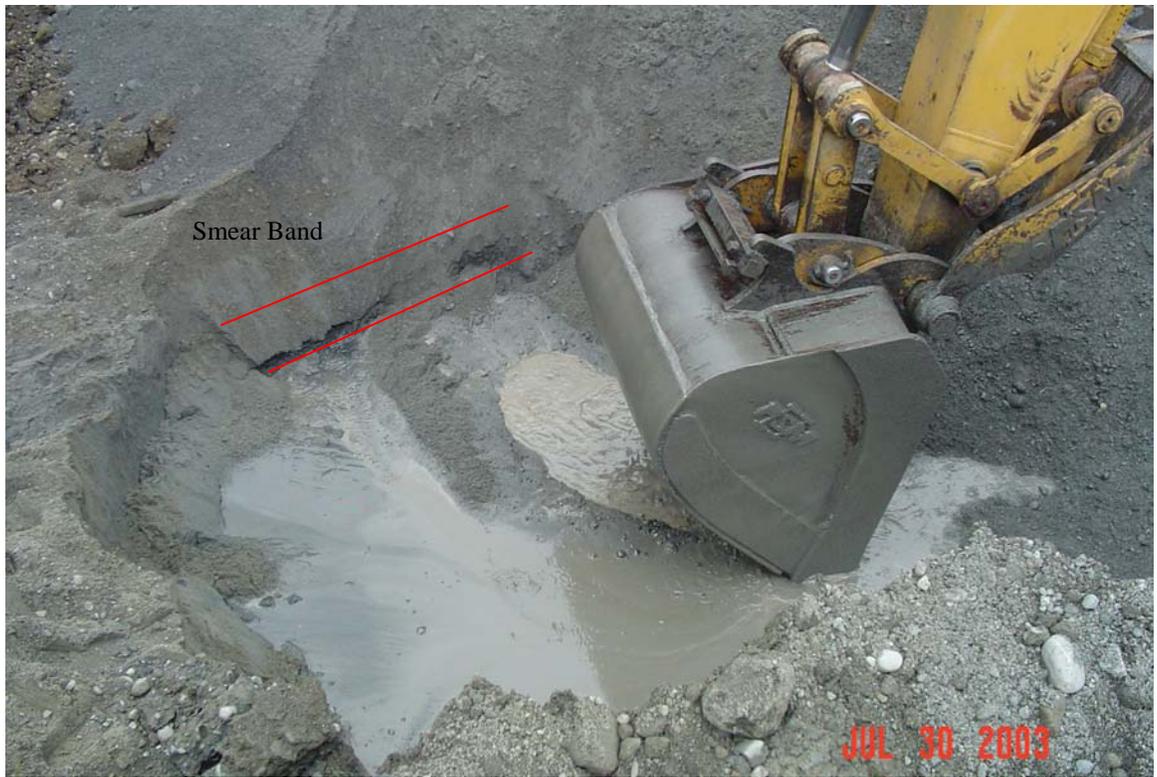
Figure 36. Smear Band at Saw Shop Excavation

As with the Oil Shed Area, excavations surrounding the water table identified a 6"-12" thick black band of sand & gravel saturated in oil. The oil was much lighter than oil under the oil shed and appeared to contain some amount of pre-1972 hydraulic oil with zinc. The smear band diminished in color and intensity under the Saw Shack and the volume of oil released to the water was also **observed** to lesser quantities than what had been previously observed. As with the Oil Shed, contaminated and discolored soil also extended above and below the smear band for several feet. However free oil was no longer visible in the interstitial spaces of the sample media. Large volumes of overburden were removed from the area to access and remove the smear band. The shape of the plume as noted by the shape of the excavation suggested a groundwater path moving from the northeast to the southwest. The following figures illustrate information noted:

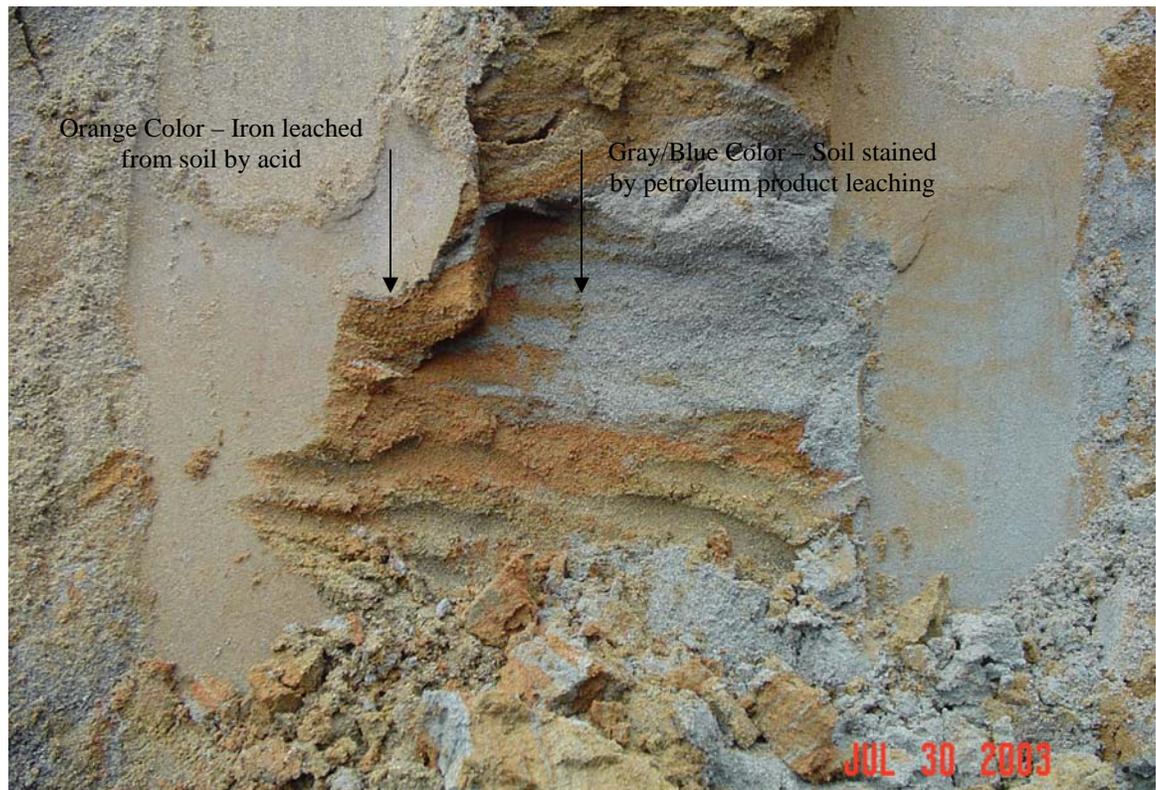
Figure 38. Acid and Petroleum Stained Soils Segregated for Testing at Saw Shop Area

The acid stained soils contained no lead and were therefore likely the result of acid spills during the filling of new batteries with no lead present. The small amount of soils collected (1-2 CY) and sequestered from the main petroleum contaminated stockpile for testing were then added back to the pile for treatment.

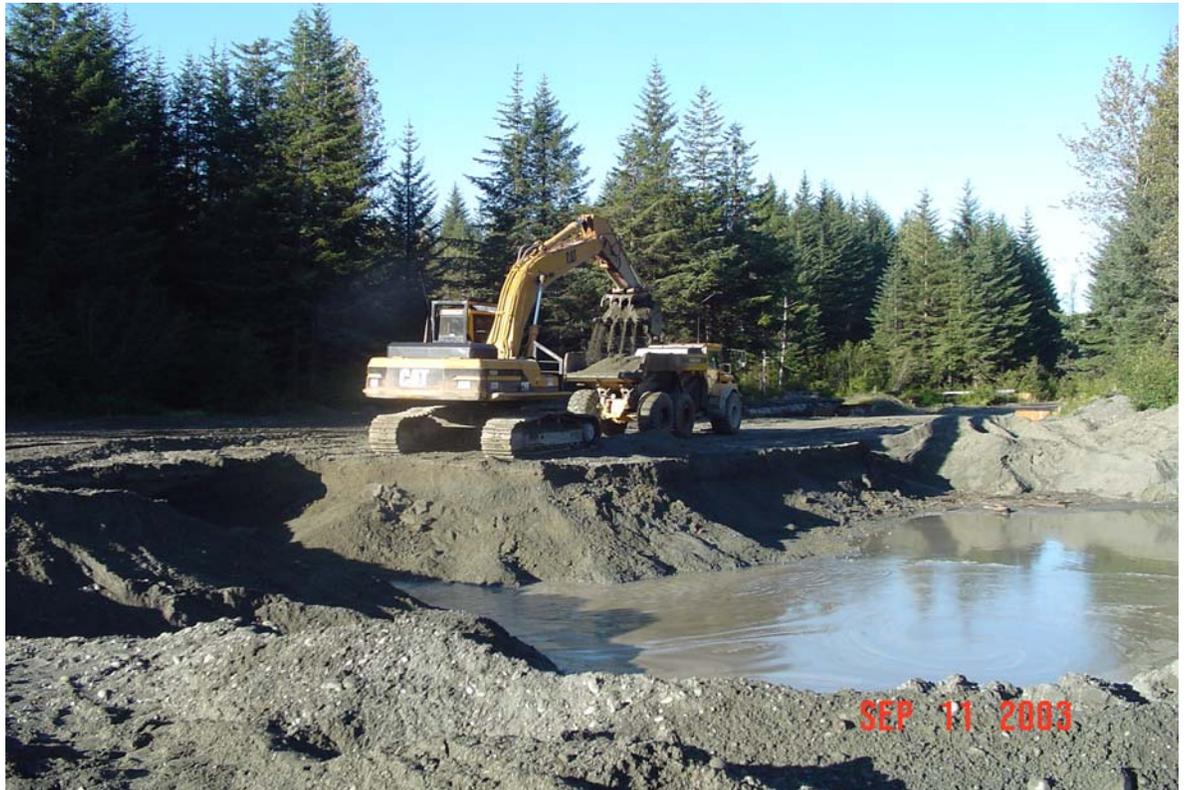
Figure 41. Camp Fuel Depot Excavation Looking West

Excavation of the camp depot was performed September 8,9,10 and 11, 2003. Excavation resulted in the removal of 3,767 CY of contaminated soil. The soil was placed in the previously approved runway stockpile for treatment. Excavation depths exceeded 12 feet. All traces of smear band at the water table were excavated and removed. Only traces of oil were noted accumulating at the water surface during excavation. Following the excavation, the water surface was observed to be clean. Prior approval was granted by ADEC to limit confirmation sampling numbers to minimum acceptable in order to preserve remediation funding. Sample results are noted following photographs of the excavation.

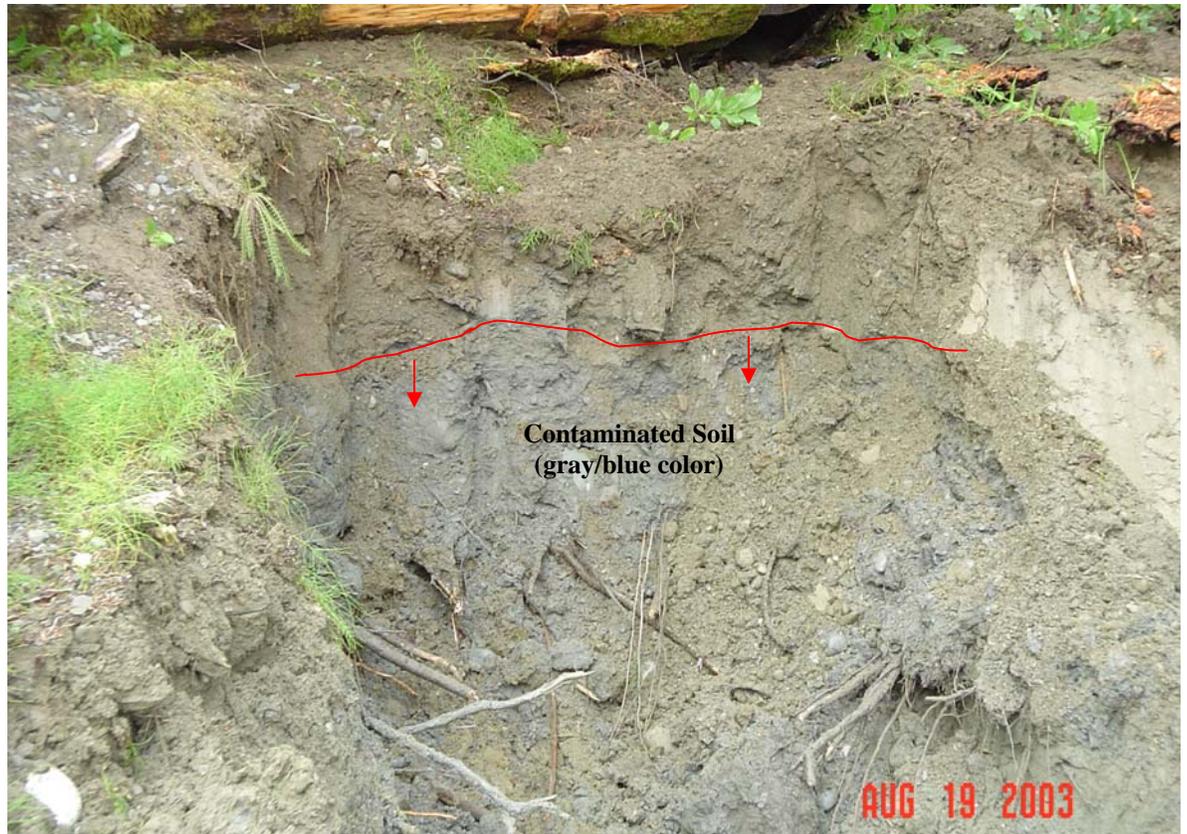
Figure 47. Boneyard Contaminated Soil

On August 21, 2003; 14 CY of soil was excavated from both ditchline areas and placed in the contaminated stockpile for treatment. 8 CY were removed from the culvert crossing the roadway that leads to Camp #2. The downgradient end of the culvert (east end) was excavated to a depth of 5 feet. 6 CY were removed from the southside ditchline area. The stockpile along the southside area and additional soils in the roadside channel were removed. A single confirmation sample was collected from each area as noted in Figure X. All visual and field measured contamination was removed.
