**VOLUME 1
FINAL CLEAN-UP REPORT
ICY BAY WEST CAMP #2**

Icy Bay

January 5, 2004

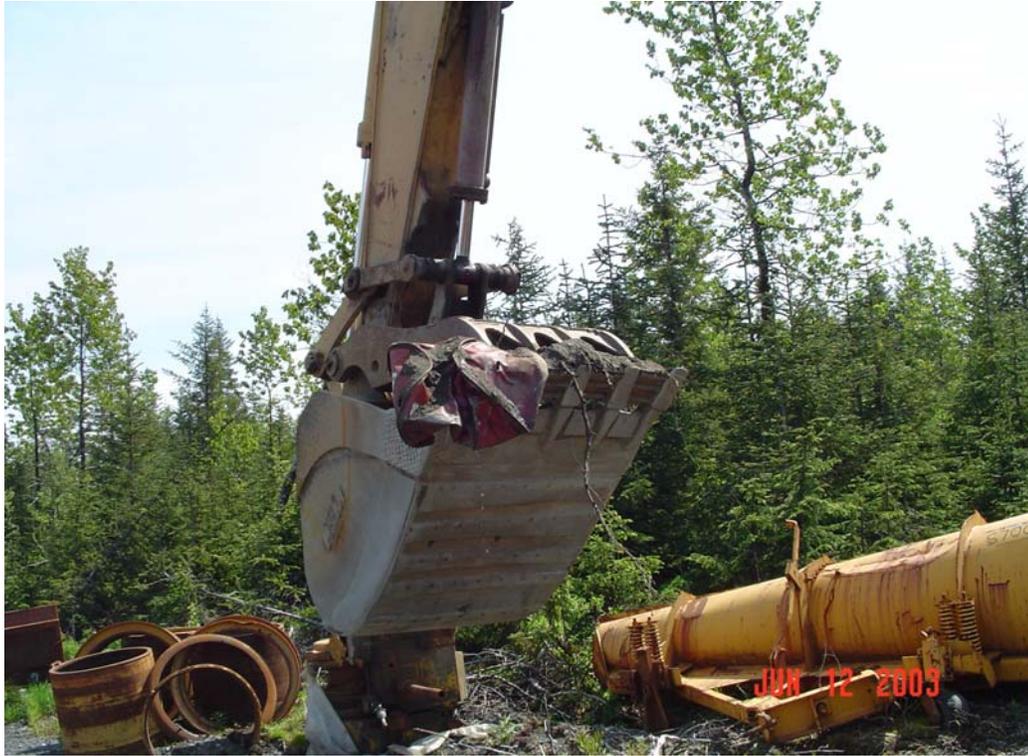
Figure 9. Excavated Drum of Hydraulic Oil

On June 12th, 2003 at 1430 hours, during routine excavation of oil-stained soils at a location approximately 100 feet south of the shop, a buried drum of hydraulic oil was uncovered approximately 24" below the ground surface in upright position. The bucket on the track hoe snagged and folded the drum as soil was being removed. Approximately 8-10 gallons of hydraulic oil spilled through the open bungle hole in the drum into the excavation area below. Free oil was removed from the water surface using absorbent pads. The pads were incinerated. The residual spilled oil adsorbed to sediment was excavated and removed as part of the routine clean-up. A release notification was made to ADEC and is attached as Appendix A to this report.

A photograph of the drum is included and follows for review. Prompt clean-up and ADEC notification were made (see Appendix A to this report).

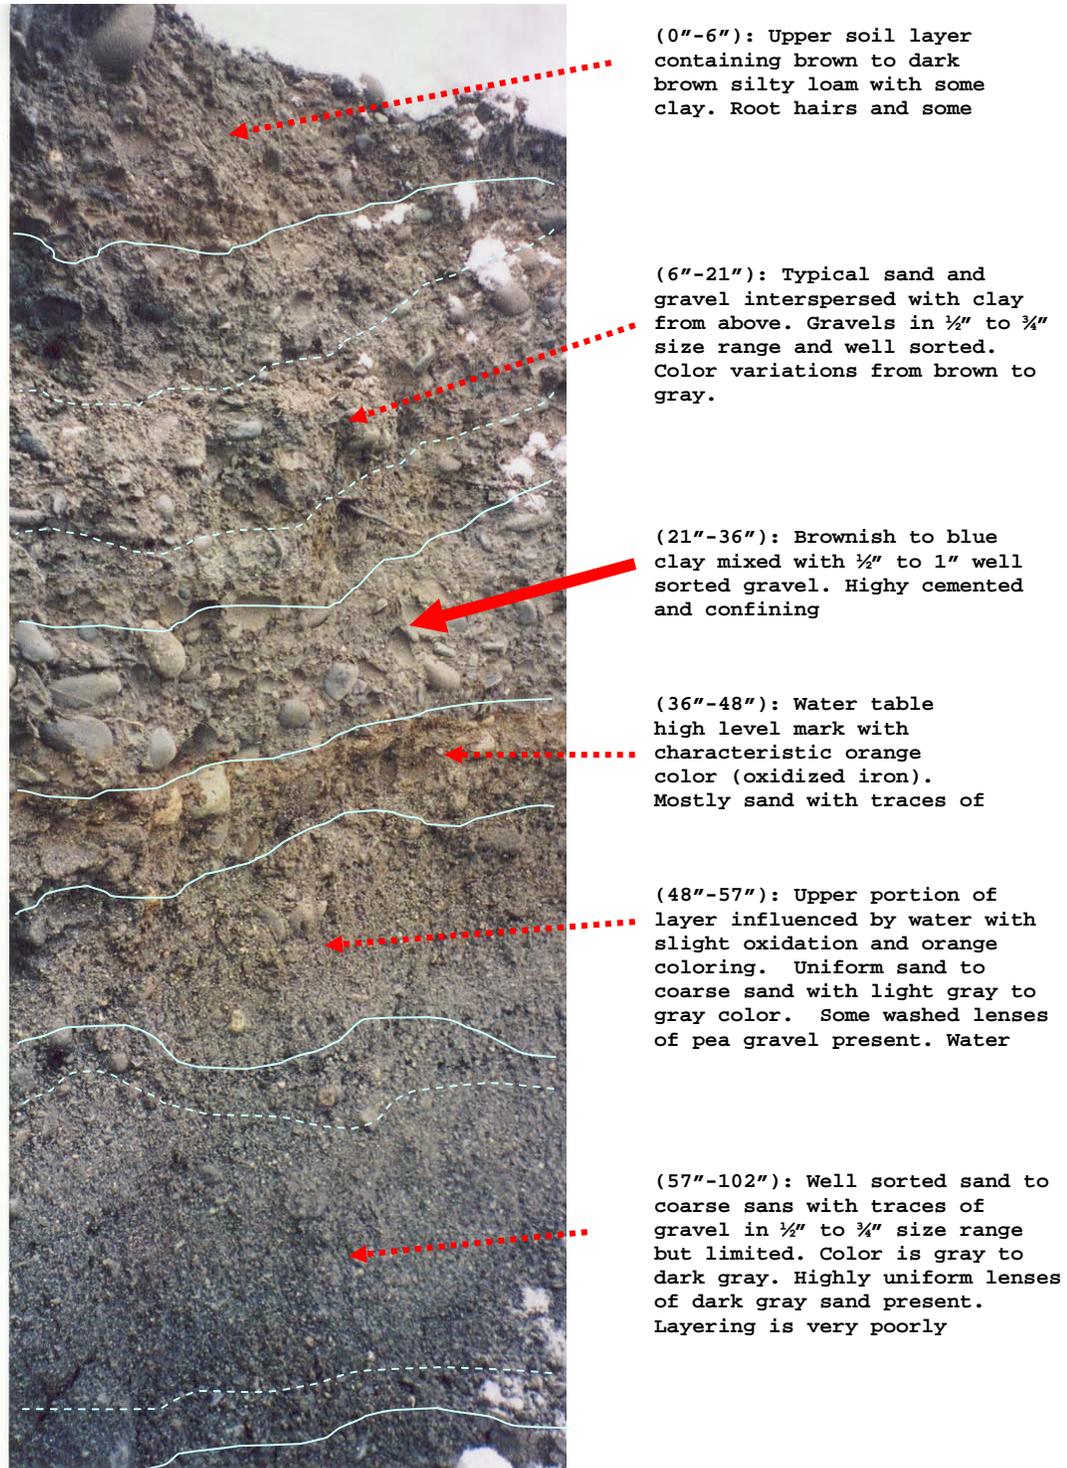
Figure 22. Typical Soil Profile Fuel Depot #2

layer was clearly distinguishable by its color. Uniform coarse sand and fine gravels were detected to depth under the water table. Identification of layering provides the ability to model transport and fate mechanisms associated with diesel spills under the depot. The typical profile is noted and described below:

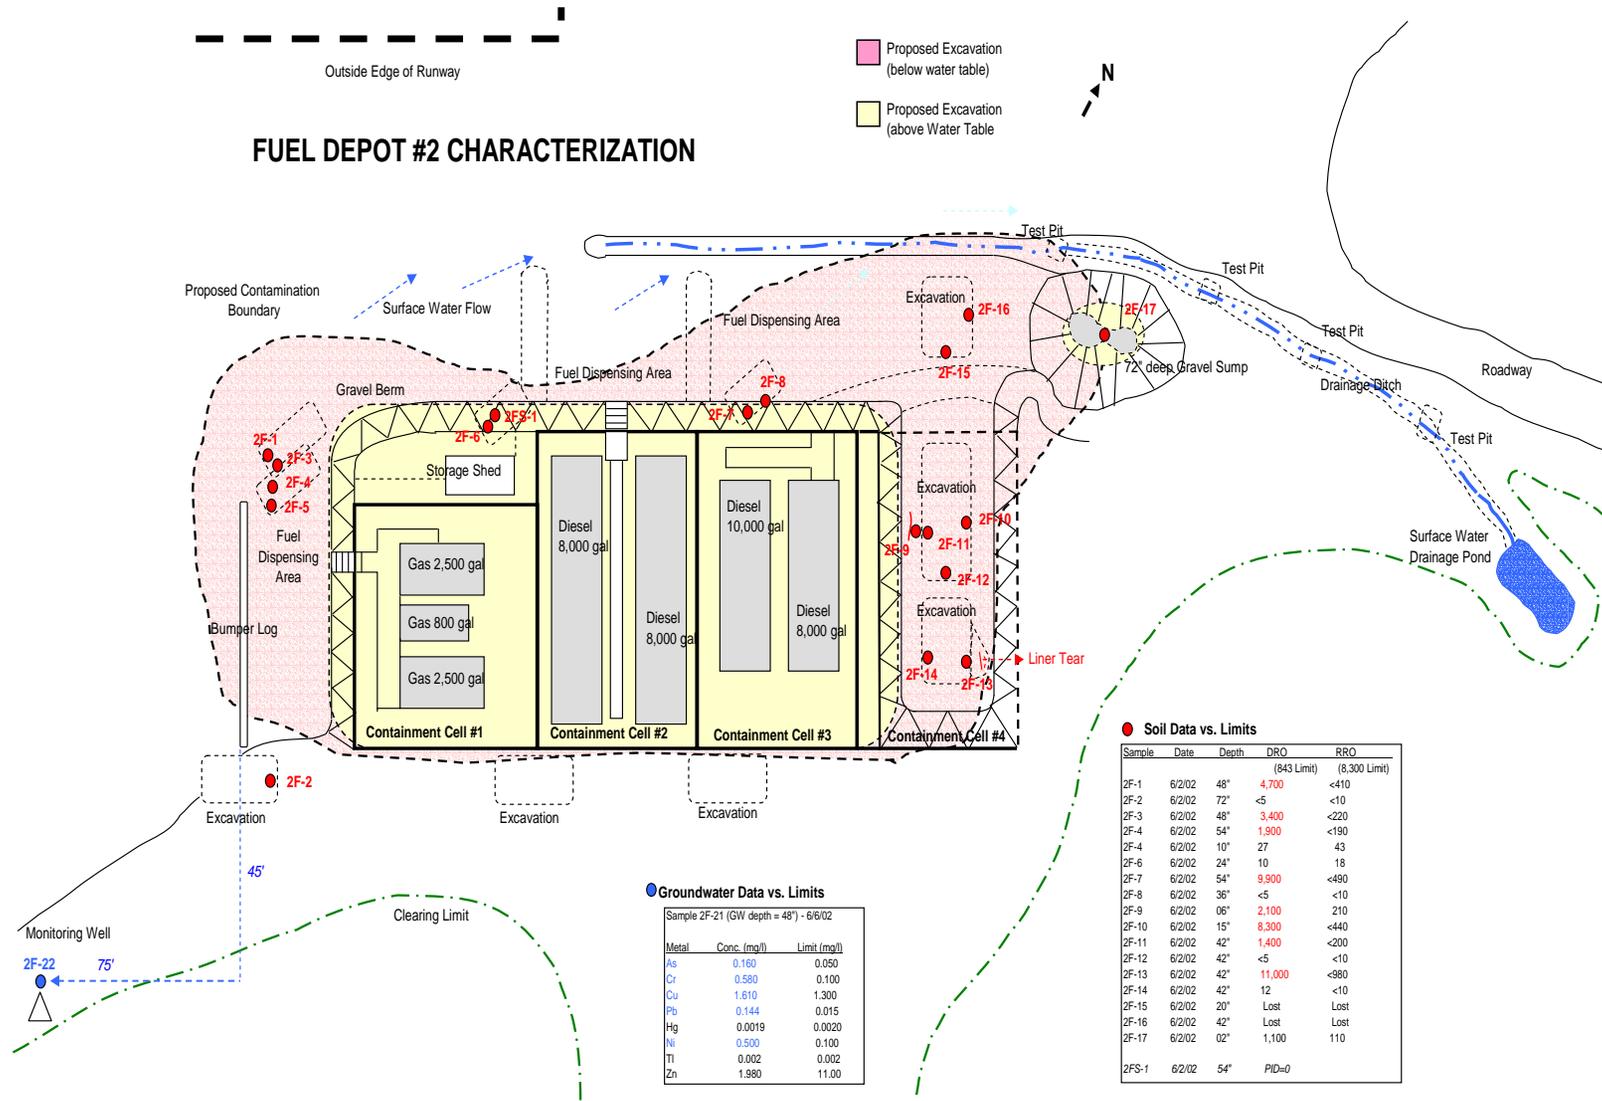
Figure 23. Fuel Depot #2 Layout - Characterization

4. No gasoline was detected under containment cell #1 which housed diesel tanks. The diesel in soils under the cell is therefore expected to have arrived by migration along the water table and most likely from depot #1.

5. Contaminated soil is present between depots #1 and #2 defeating the argument that each depot has its own plume.

6. The confining soil layer observed under depot #2 has been breached at depot #1 both by construction of the depot through installation of the roof and by the presence of buried wastes under and around depot #1.
7. Contaminated soils are close to the ground surface at depot #1 and then slope away from the depot. In essence, depot #1 sits on top of a mound of contaminated soil, further suggesting contaminant flow away from depot #1 towards depot #2.

Based on the March investigations, Diesel contaminated soils present under depot #2 likely originate under depot #1 and follow the movement of the water table both up and down and from west to east.

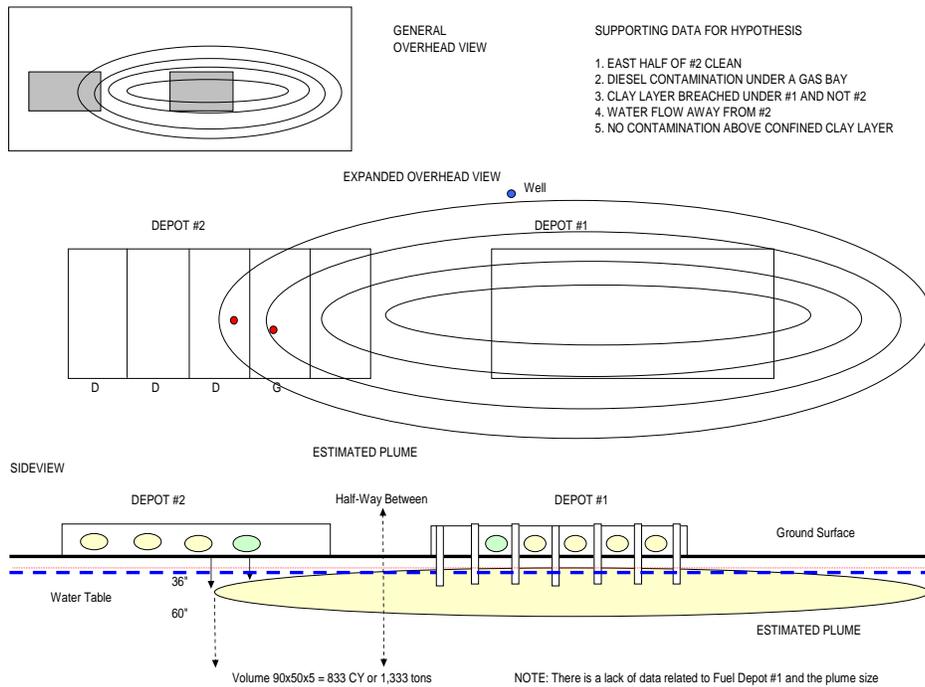
Figure 24. Revised Plume Hypothesis Depot #2

The appropriate boundary between depot #1 and depot #2 is not the halfway point between the depots. Rather, the delineation should be the most probable location where contamination from depot #2 could no longer be present. Based on data collected to date, this location is a line between depot #2 containment cells #1 and #2 as noted below:

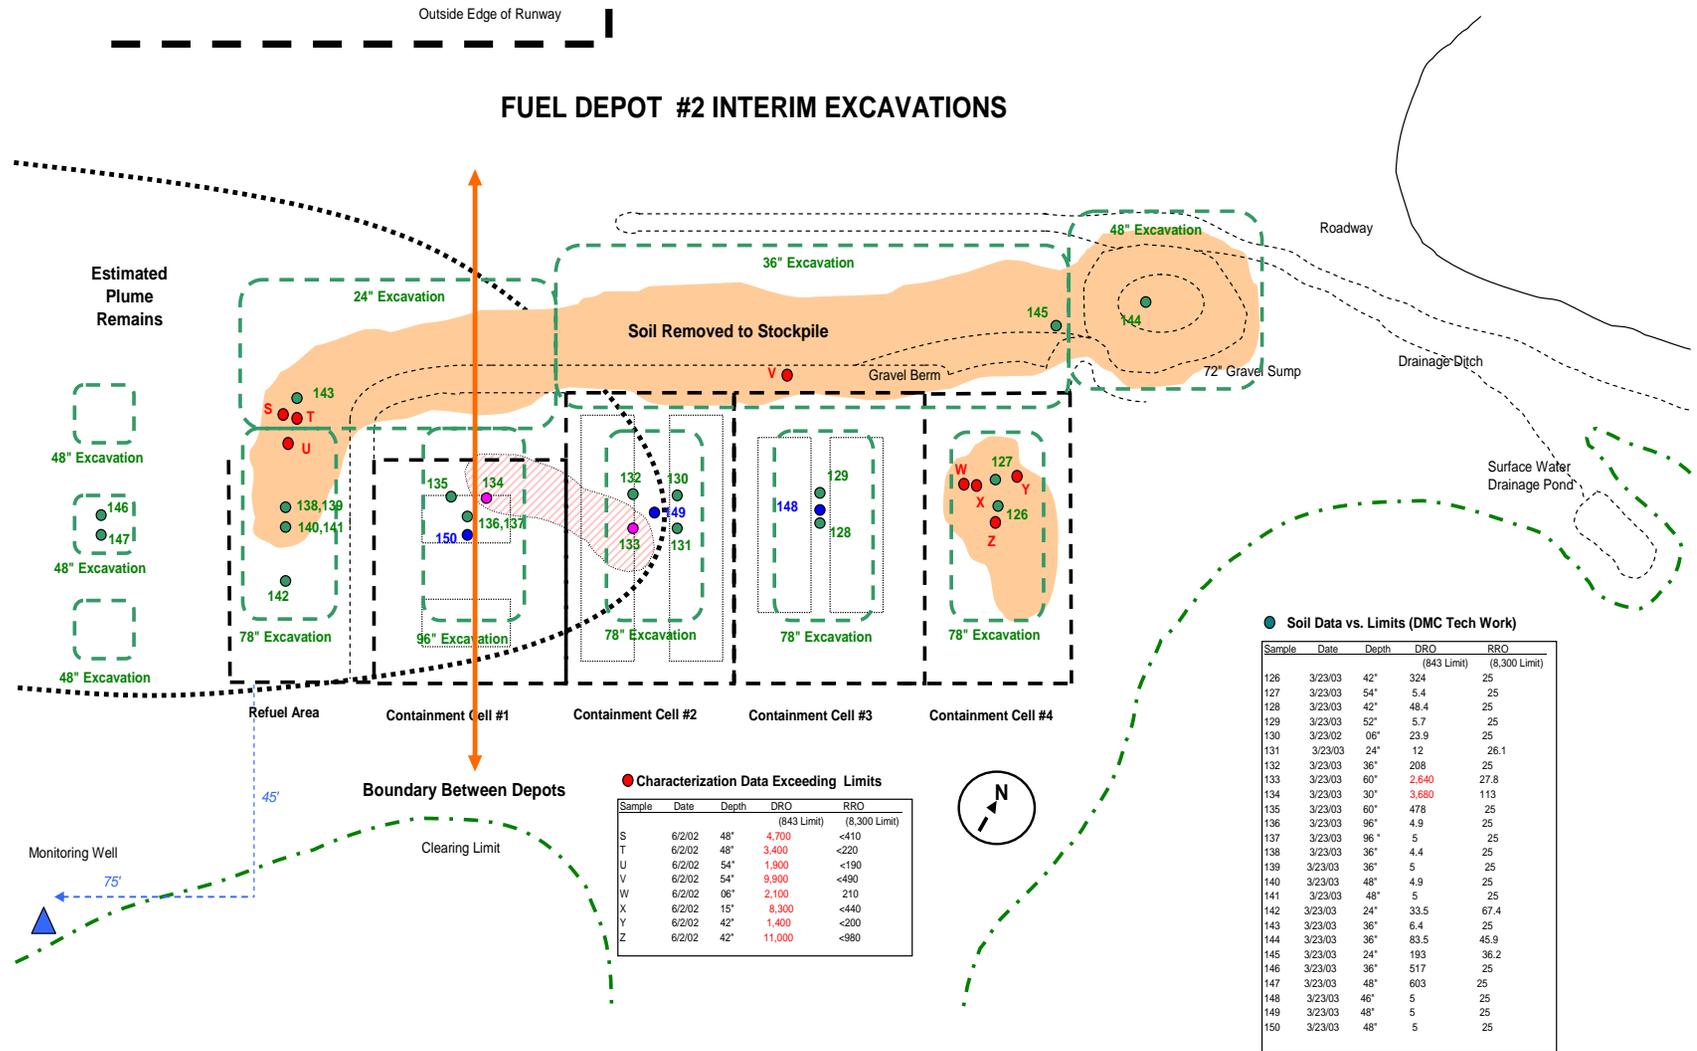
Figure 26. Fuel Depot #2 Layout - Interim Excavations

Figure 26 illustrates the state of efforts at depot #2 following interim excavations in March.

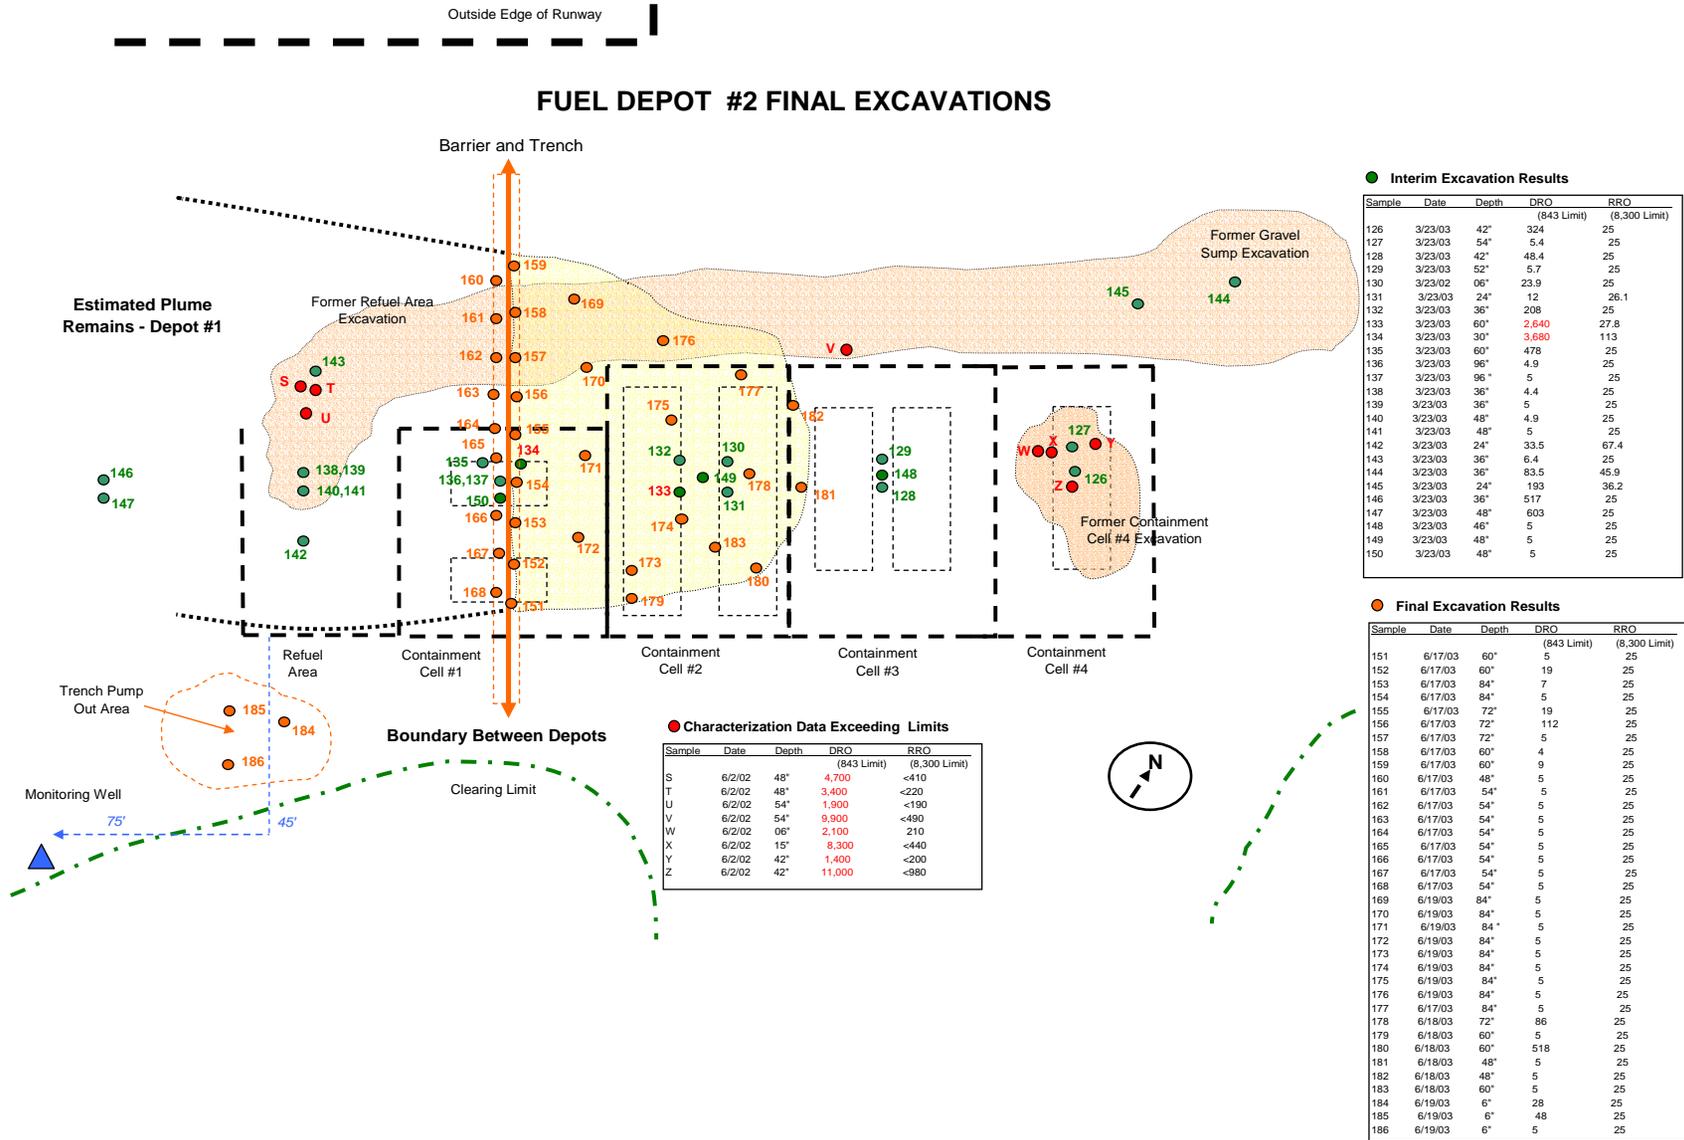
Figure 27. Fuel Depot #2 Layout – Final Excavations

Final excavations at Fuel Depot #2 were performed June 17-19, 2003. A long trench was excavated along the previously defined boundary between the depots. The trench commenced in clean soil and progressed south to north at a depth of 84 inches, which was about 2 feet under the water table level. Samples were collected from the sidewalls and bottom of the trench as it was developed in order to accurately define the edges of the contamination plume surrounding the depot. The trench was completed when the north end reached clean soils.

Former positions of depot #2 containment cells were then mapped and staked based on survey data collected in March. The estimated plume boundary was then staked starting at the trench and extending eastward through the refuel bay and containment cells #1 and #2. The plume boundary ended where excavations were completed in March. Excavations commenced inside the mapped area. Field measurements were carefully collected to ensure that all contamination was removed. Excavations removed 472 CY of contaminated soil and resulted in the collection of an additional 36 confirmation samples all indicating that clean-up was finally effective. After receipt of confirmation, the site was backfilled and graded.

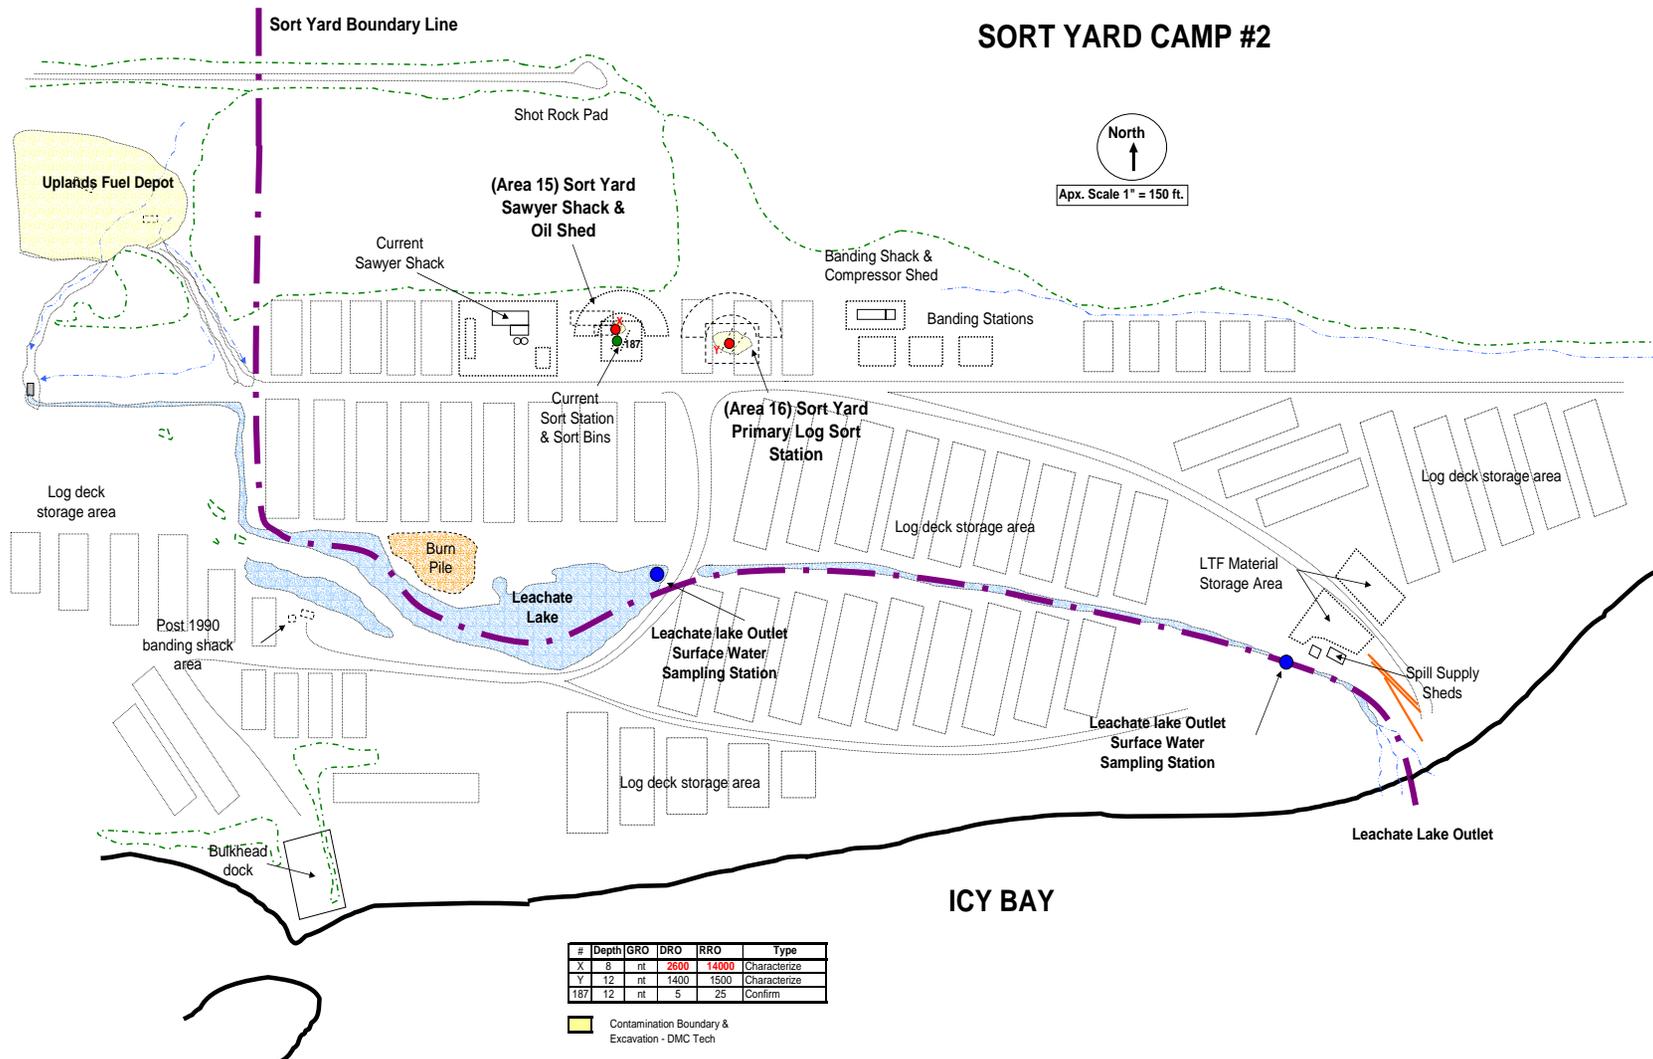
Figure 28. Sort Yard Remediation

The former log sort station and 3 log bundle banding stations were inspected in June, 2002; oil was observed across the front of the stations south log sort bin where the load loader picks up logs. Similar contamination was observed in front of the east log sort bin. Removal of the stacker equipment from the bin allowed free access to inspection. Oil stained debris and soils were present throughout the tracked areas. In spite of these observations only one sample yielded sample results close to clean-up limits (DRO-1,400 ppm, RRO-2,600 ppm). Because of the proximity to the limits, clean-up was recommended. Contamination was estimated not to exceed 6" in depth and to include less than 4-10CY of material.

In February, 2003; the sawyer shack and oil shed were relocated eastward to make room for renewed logging. The log sort station was then also moved eastward and placed at the former sawyer shack and oil shed location. The abandoned log sort station area was graded and used for log bundle storage. In March, the location of former log sort station was identified and investigated. No contamination was observed and therefore, no samples were collected. Extensive yard work and yard maintenance have dispersed any contamination that was formerly present. Figure 28 identifies areas of interest related to the sort yard

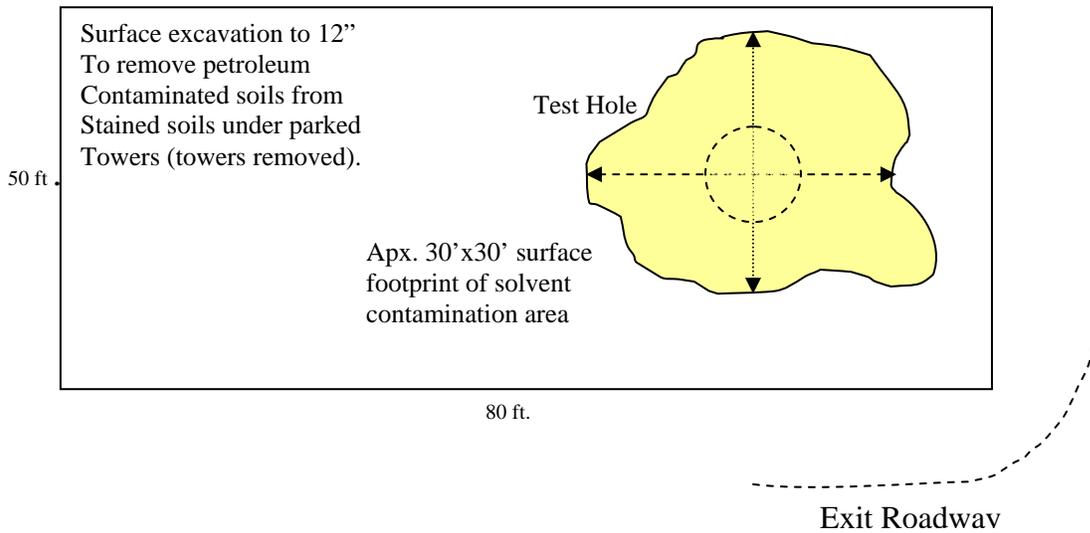
SE Corner of East Parking Area

A test hole was excavated in the center of the spill footprint to evaluate the depth of contamination with PID results as follows. A grab sample was collected at 60".

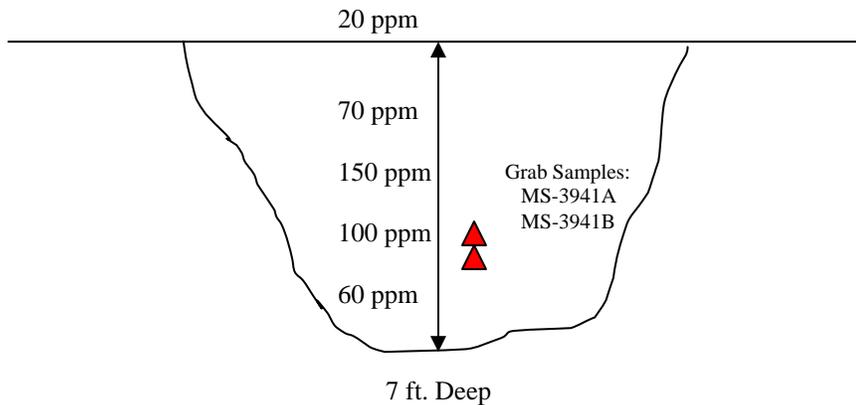
The volume of material is estimated at 233 CY or 373 tons.
