ALASKA DEPARTMENT OF ENVIRONMENTAL CONSERVATION
Division of Spill Prevention and Response
Prevention and Emergency Response Program

SITUATION REPORT

INCIDENT NAME: F/V Johnita Fire

SITREP #: 1 and final

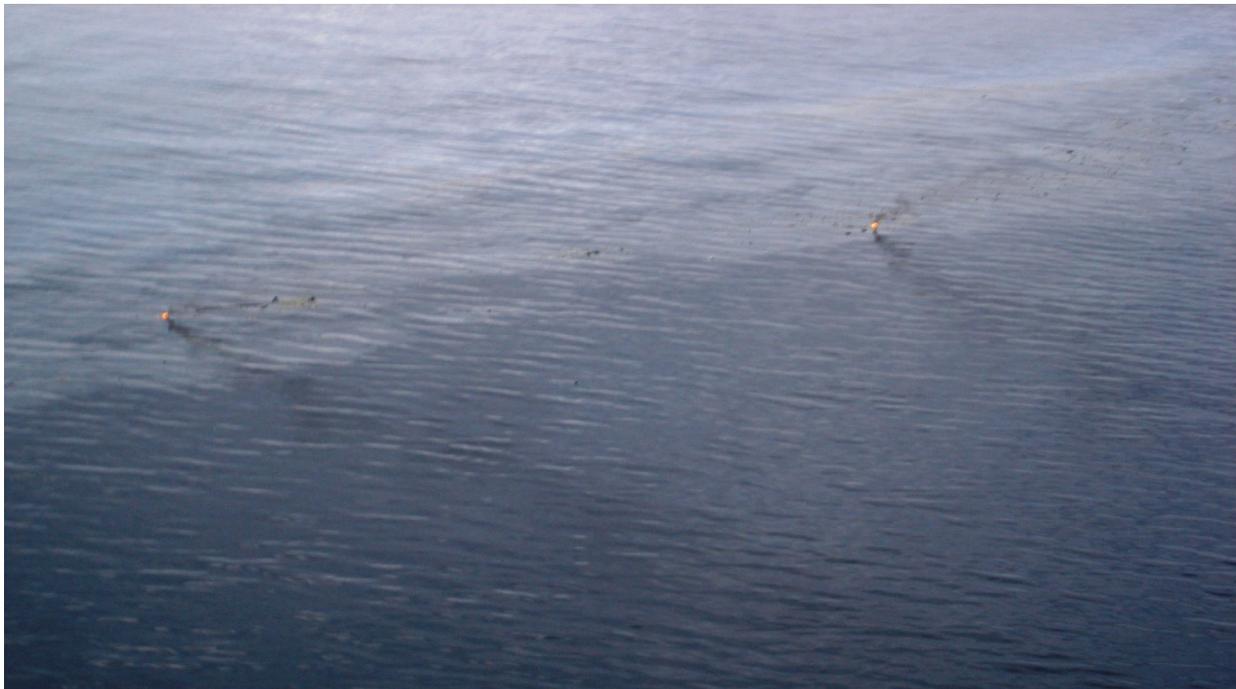
F/V JOHNITA (D937409) Sinking

TYPE/AMOUNT OF PRODUCT SPILLED: The vessel operator reported that the F/V Johnita had about 255-355 gallons of diesel on board, and approx 5-8 gallons of gasoline in cans for his 9.9 horse power Mercury outboard motor. The diesel fuel was observed burning as F/V Johnita sank. The vessel released an unknown amount fuel as it sank.

CAUSE OF SPILL: The vessel operator reported that the fire was due to an electrical fire. The F/V Johnita sank as a result of the fire leaving a sheen upon the water surface.

Diesel on fire where F/V JOHNITA sank.
