Photographs

DMTS Fugitive Dust
Risk Assessment

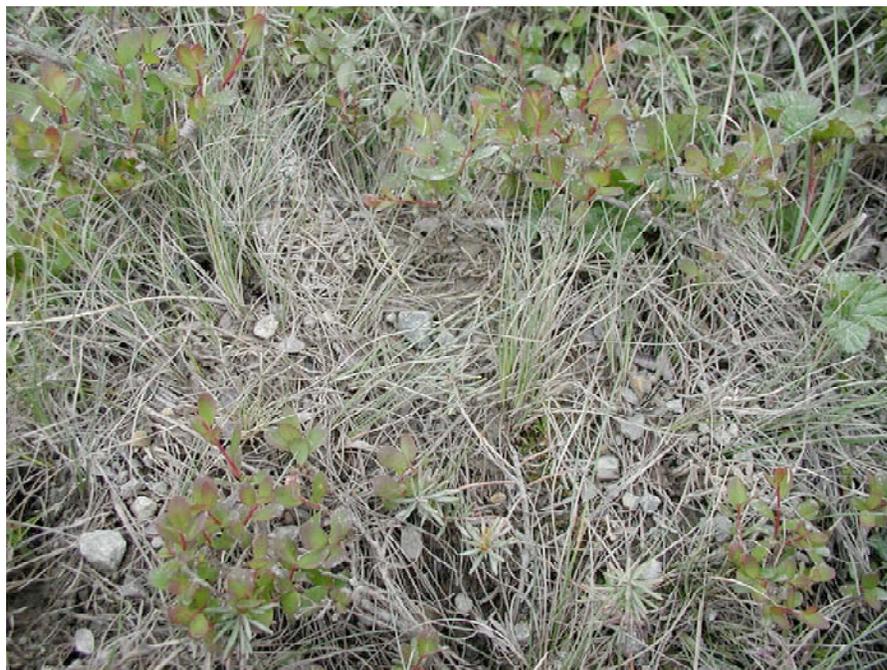
Photograph 24.
Dust deposition and road gravel at station TT5-0010

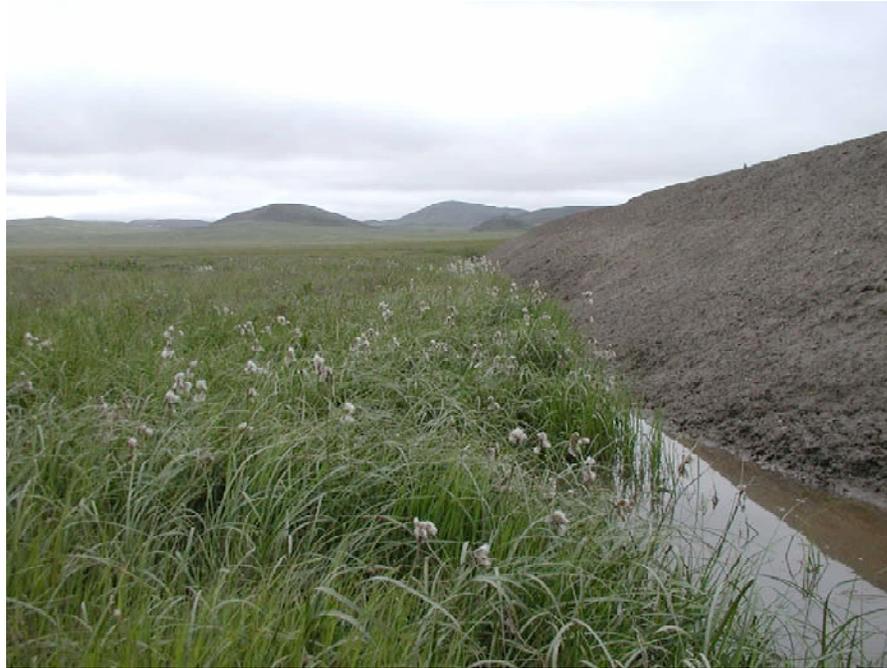
Photograph 25.
Impounded water along the DMTS road shoulder at station
TT2-0010

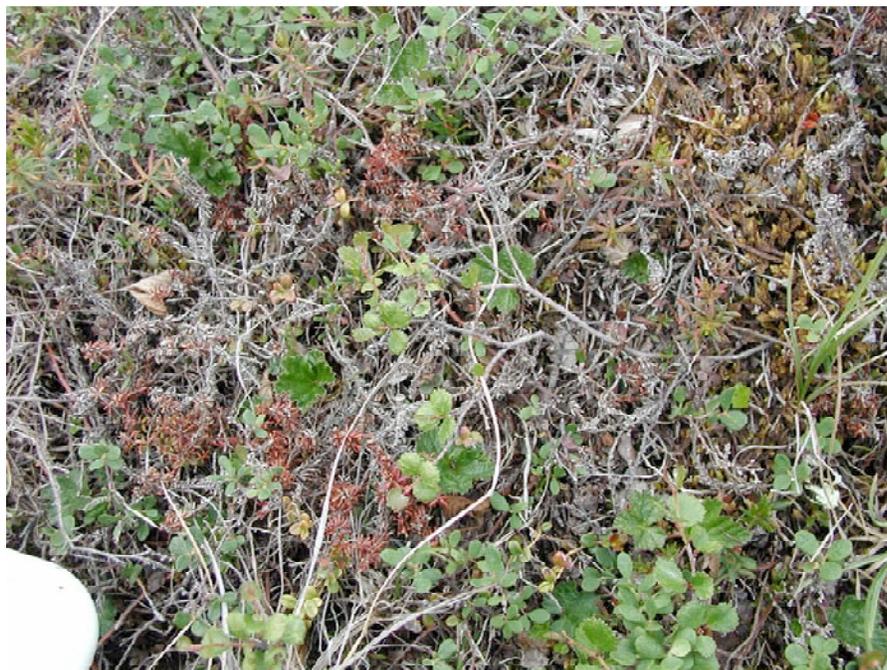
Photograph 26.
Stressed blueberry (*Vaccinium uliginosum*), Labrador tea (*Ledum palustre*), and crowberry (*Empitrum nigrum*) at station TT3-0100

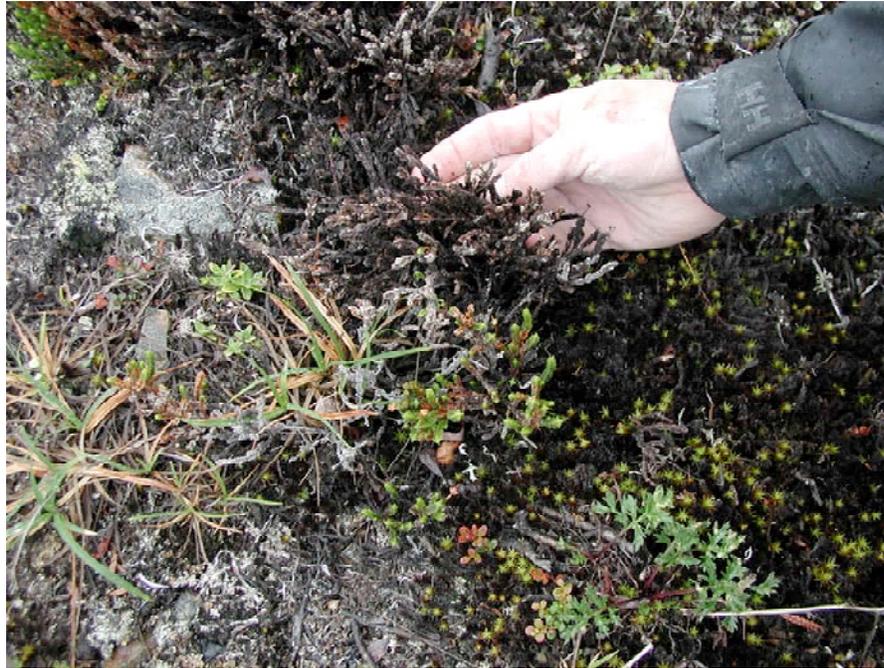
Photograph 27.
Blackened heather (*Cassiope tetragona*) in a snow accumulation
area at station TT7-0010

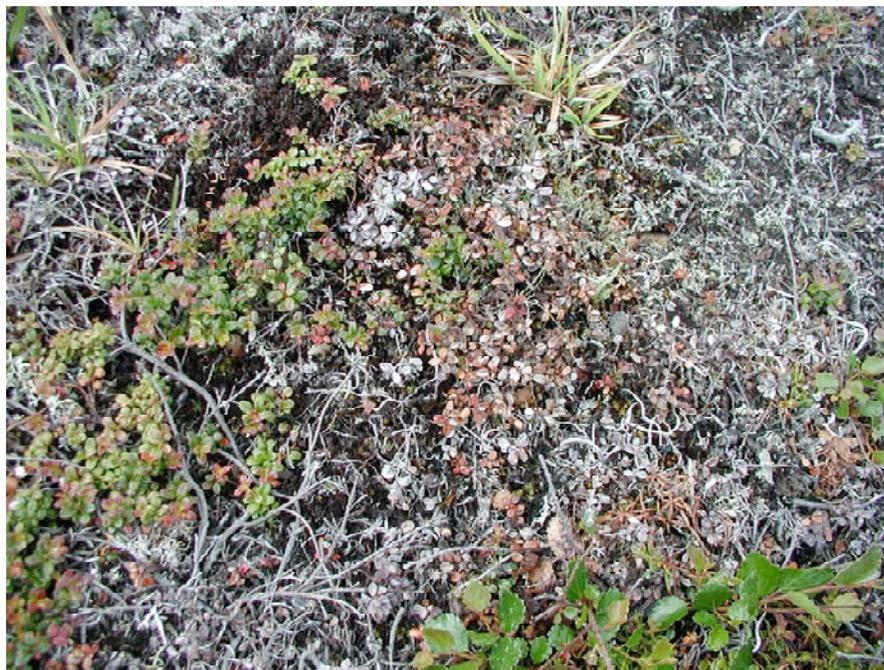
Photograph 28.
Bleached lingonberry (*Vaccinium vitis-idaea*) in a snow
accumulation area at station TT7-0010

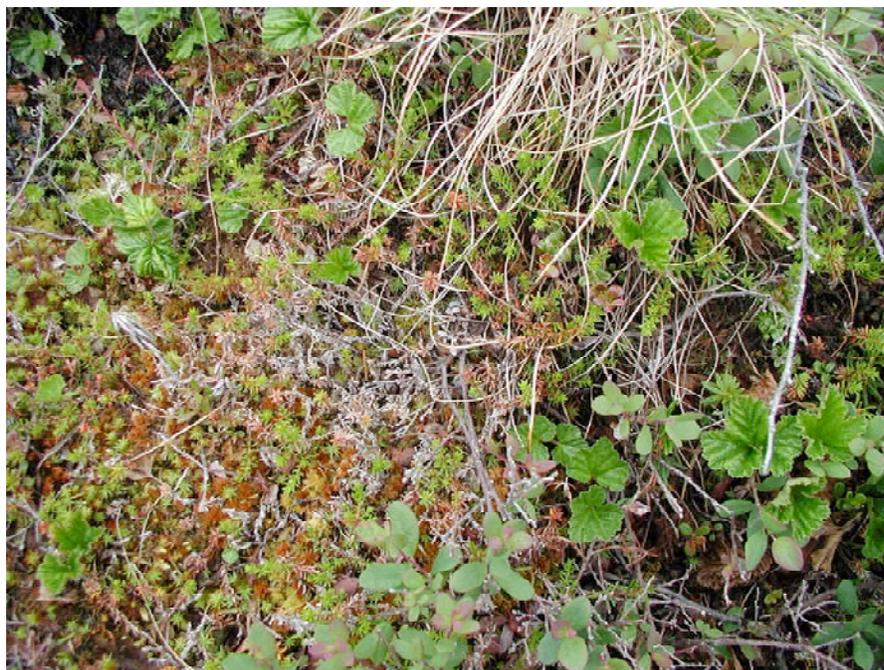
Photograph 29.
Brown crowberry and bleached lingonberry at reference station
TS-REF-5

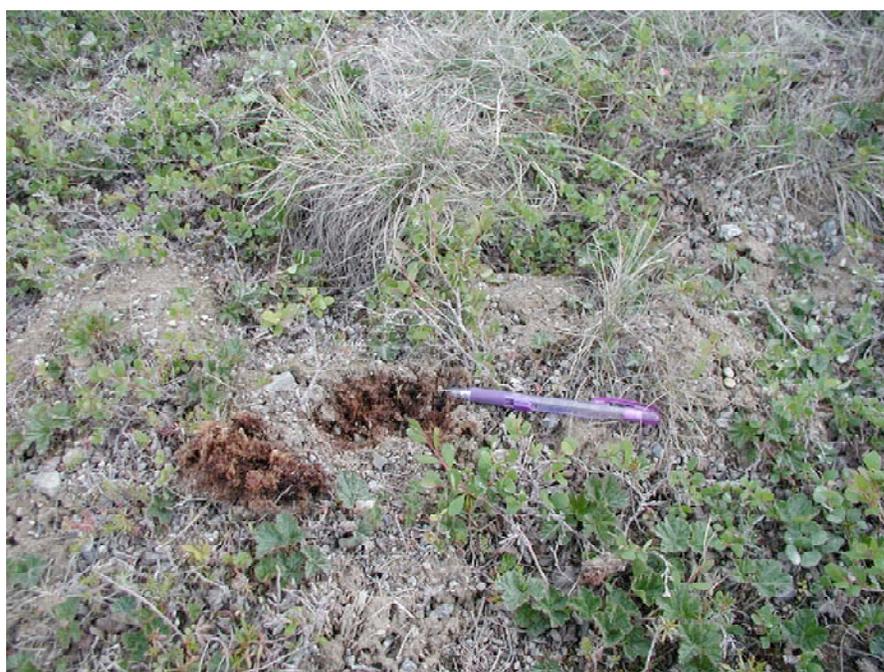
Photograph 30.
Bare ground showing dead mosses under dust at station
TT3-0010

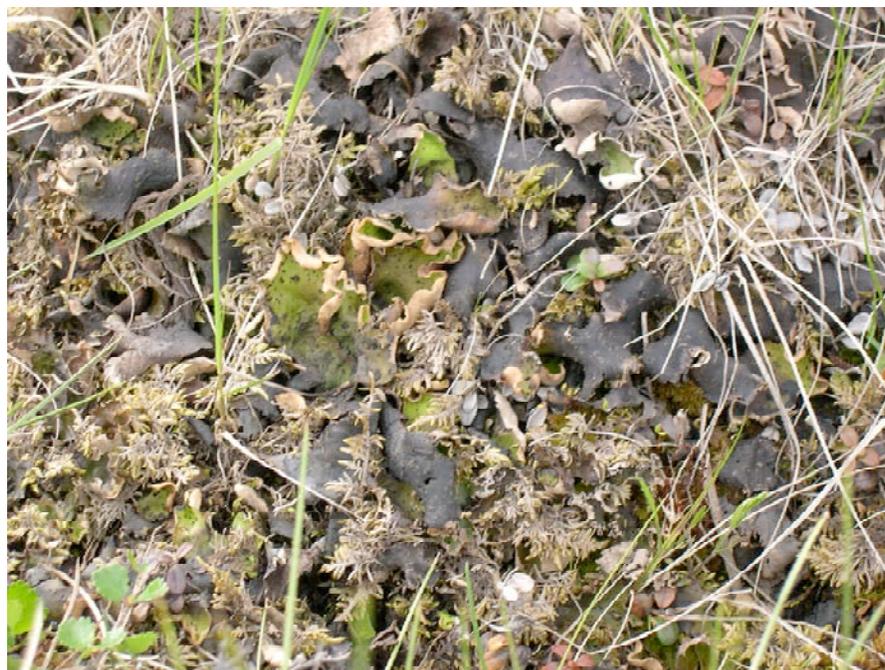
Photograph 31.
Blackened *Peltigera* lichen at station TT2-0010

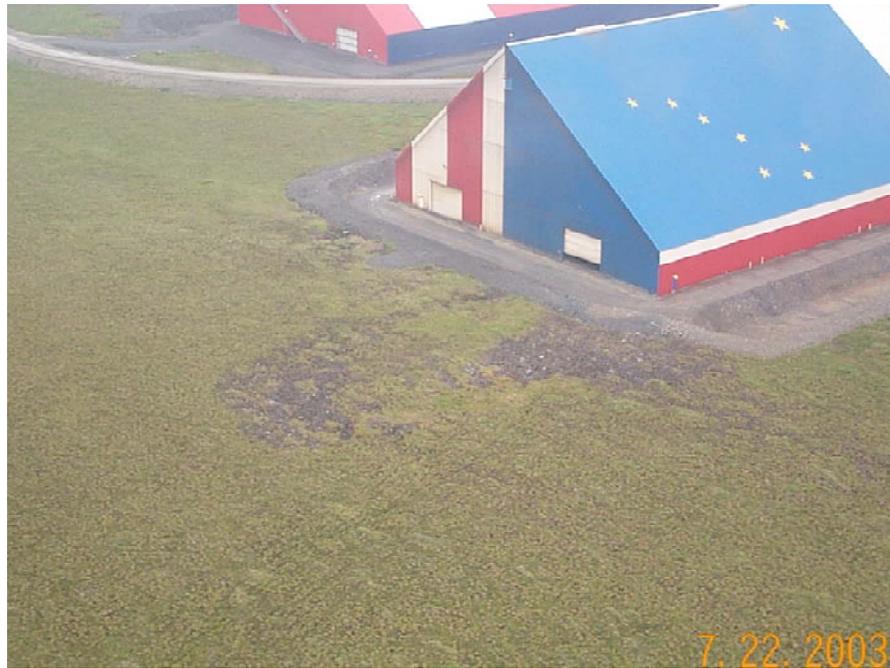
Photograph 49.
Aerial view of stressed vegetation to the northwest of CSB1.

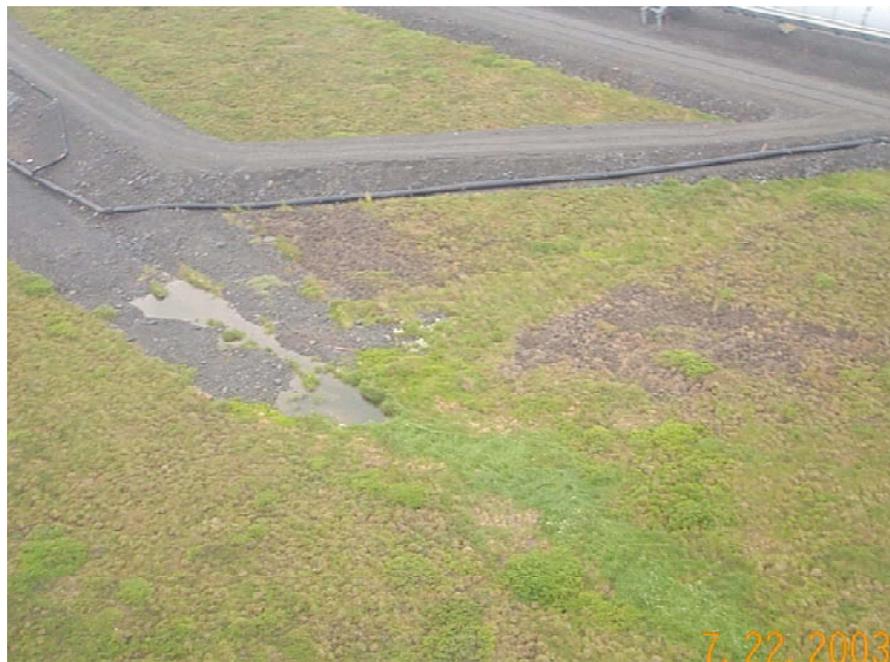
Photograph 50.
Aerial view of stressed vegetation near the ion exchange
treatment overflow ditch

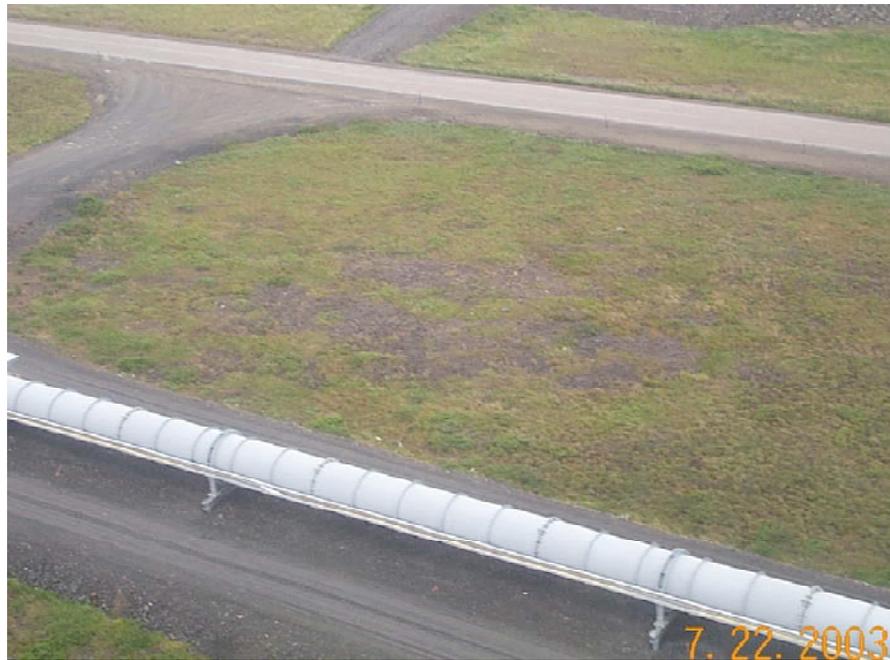
Photograph 51.
Aerial view of stressed vegetation between the southwest
corner of CSB1 and the DMTS road

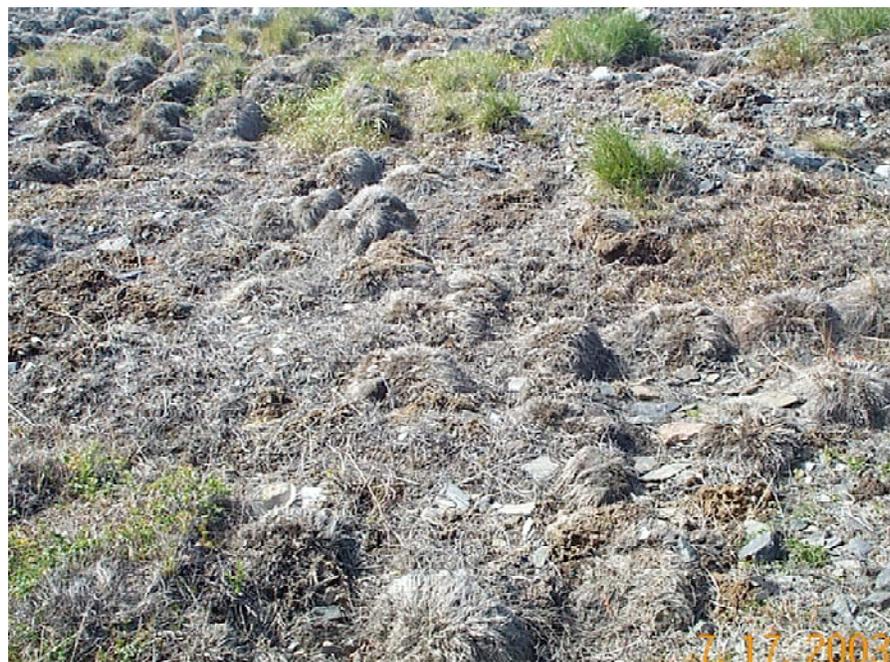
Photograph 52.
Stressed vegetation area northwest of CSB1

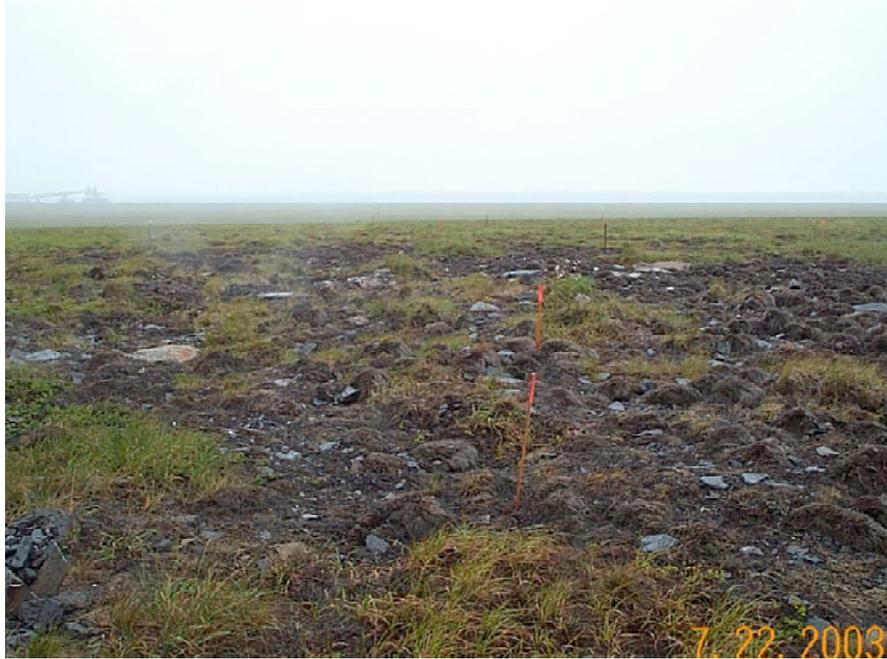
Photograph 53.
Stressed vegetation area northwest of CSB1

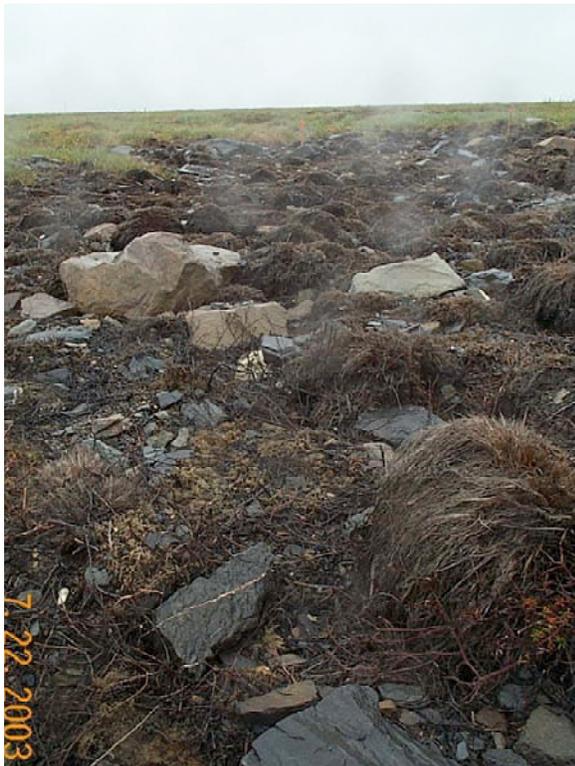
Photograph 54.
Exposed rocks and
dead vegetation
northwest of CSB1

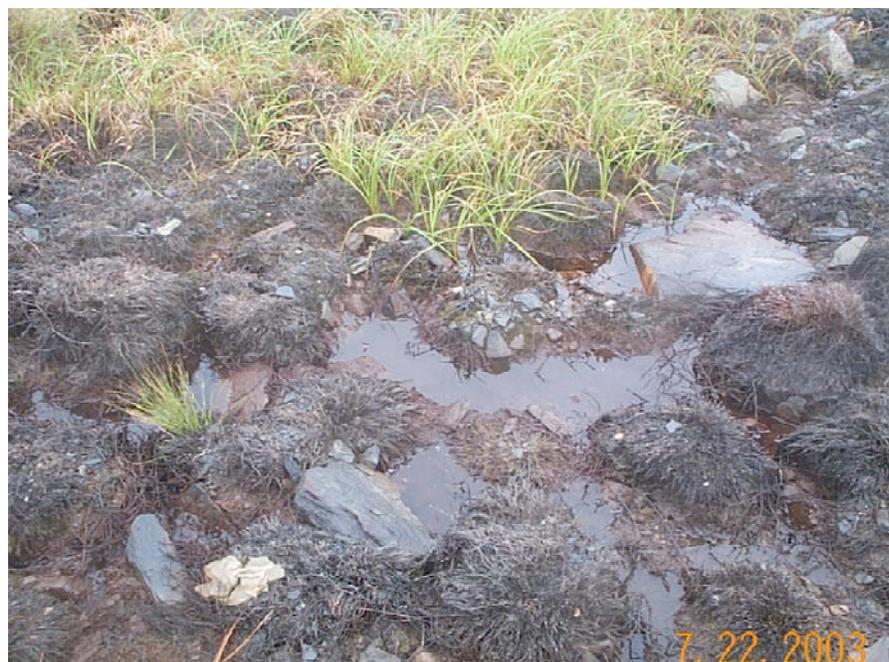
Photograph 55.
Standing water and sedges at the edge of the stressed
vegetation area northwest of CSB1

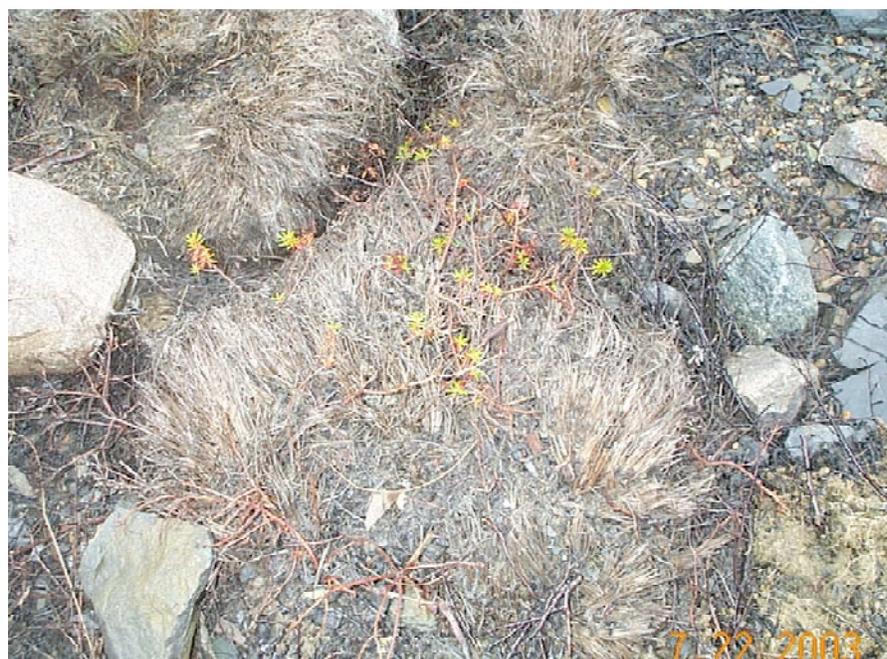
Photograph 56.
Close-up of sedge tussock in stressed vegetation area
northwest of CSB1

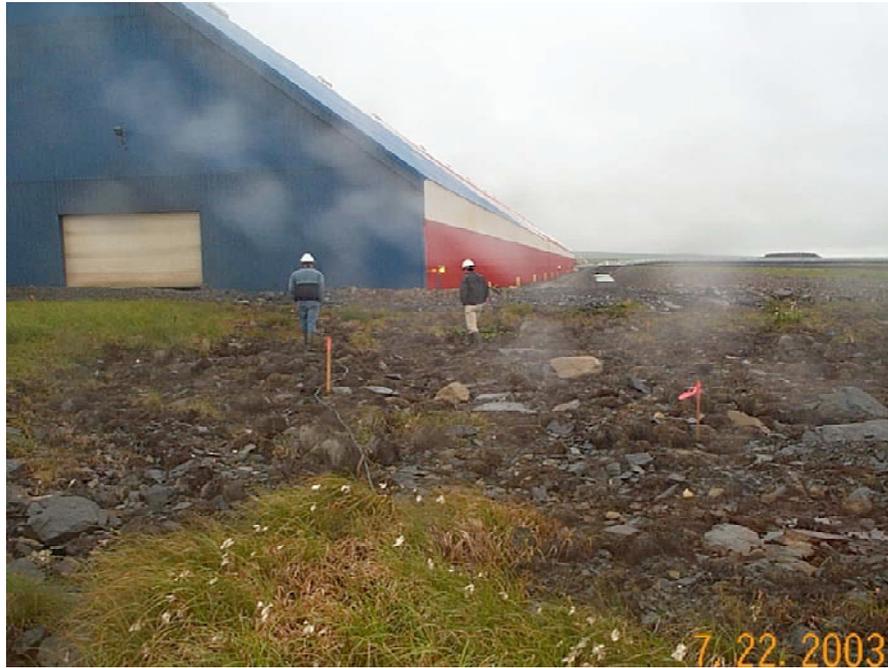
Photograph 57.
Exposed soil and rock, dead tundra vegetation, and live
cottongrass northwest of CSB1
