Alaska's 2013 Air Monitoring Network Plan

Chapter 2 Anchorage

2 ANCHORAGE MONITORING SITE DESCRIPTIONS

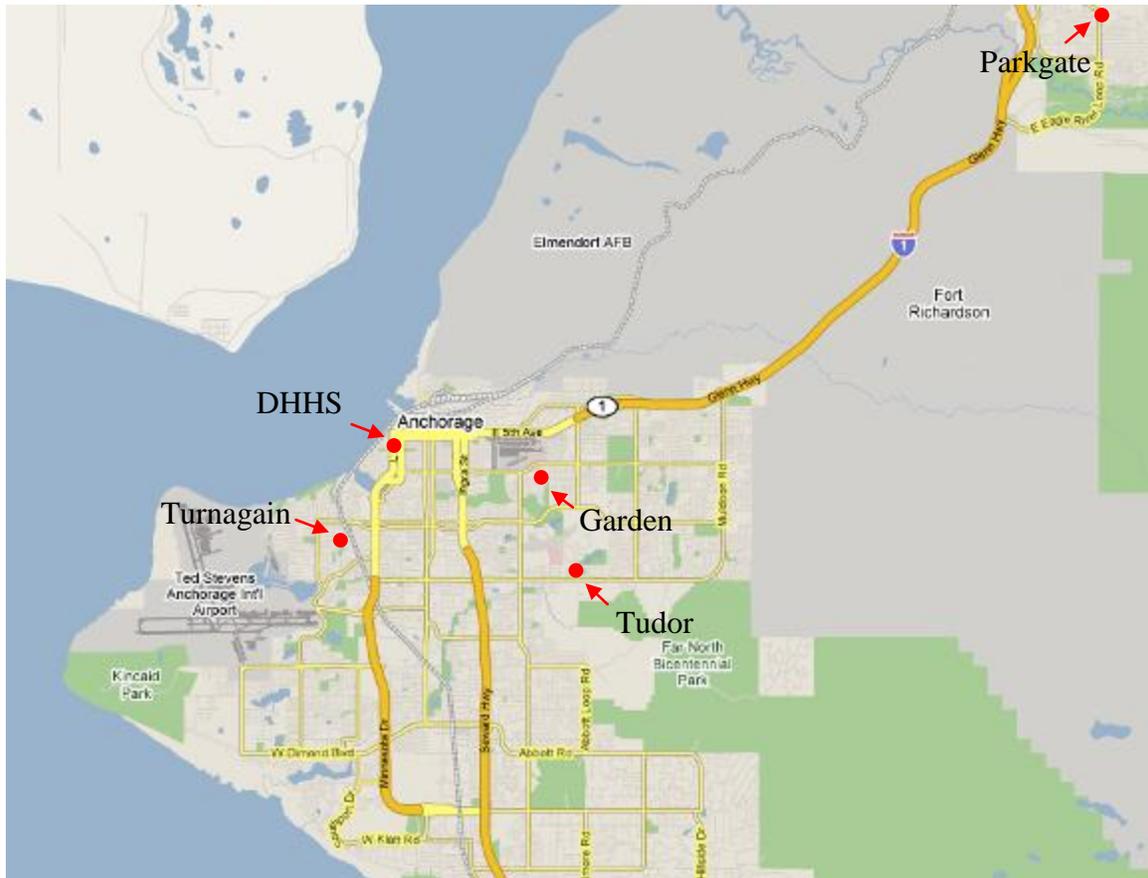
Figure 2.1:1: Map of Anchorage area. Red dots indicate monitoring sites.

Monitoring Site (SLAMS) and as Special Purpose Monitors (SPM). The MOA SLAMS and SPM monitor designations are described in Table 2-1. Figure 2.1.1 shows the entire Anchorage monitoring network. Appendix B lists siting criteria.

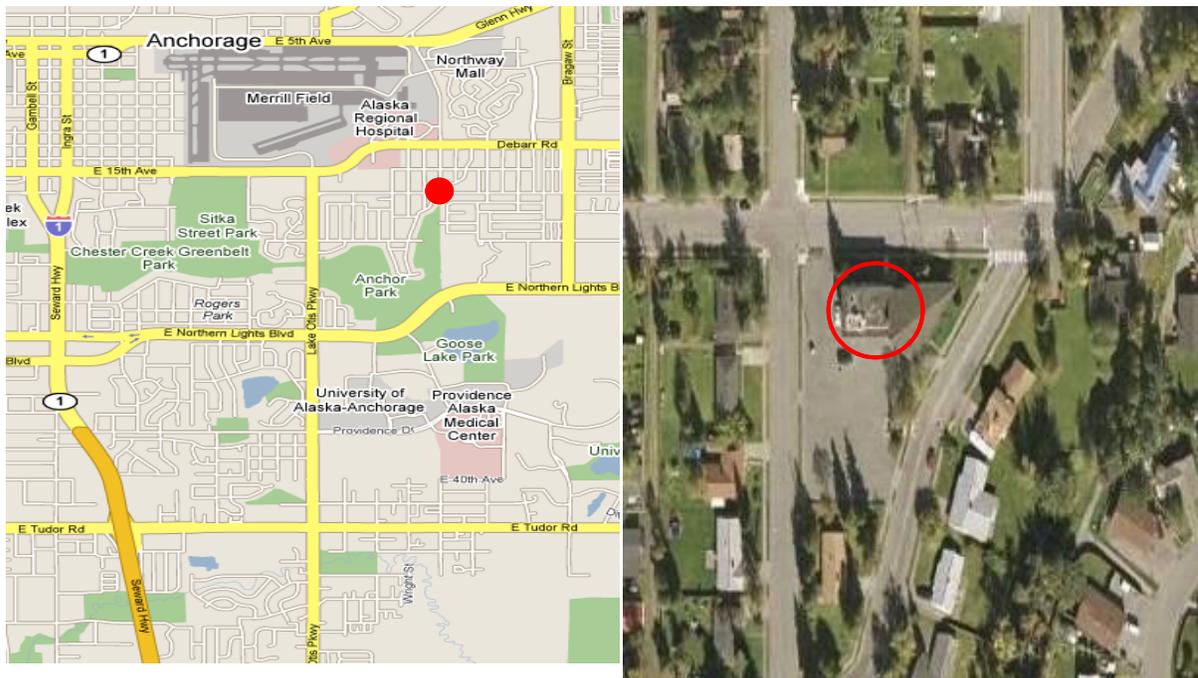
Figure 2.2:1: Street map and satellite image of the Garden monitoring site. The red circles indicate the site's location.

The Garden monitoring site is located at the Trinity Christian Reformed Church between 16th Avenue, Garden Street, and Sunrise Drive at latitude 61°12' 21.1" north (61.205861), longitude 149°49' 28.6" west (-149.824602), and 39 meters (128 feet) above sea level. Figure 2.2:1 shows a street map of the central Anchorage area and a satellite image of the area. The site is located in a suburban, residential area. Garden is a neighborhood, population-oriented CO and PM site.

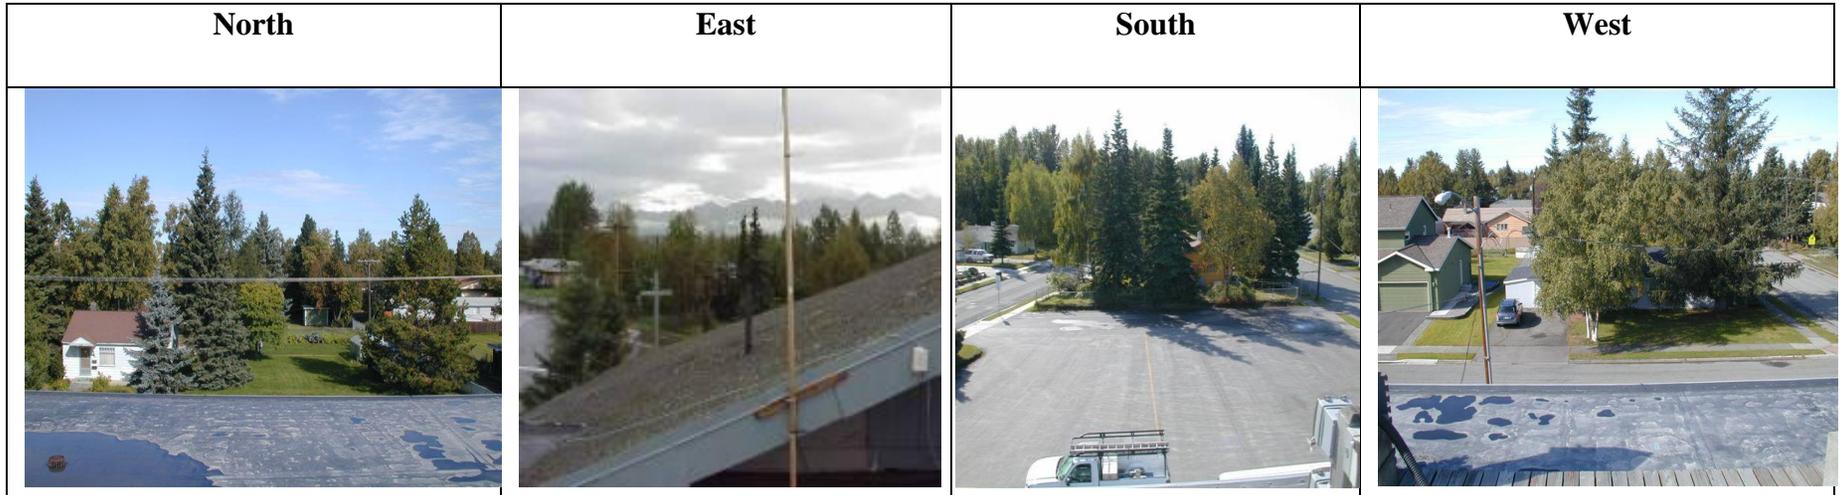
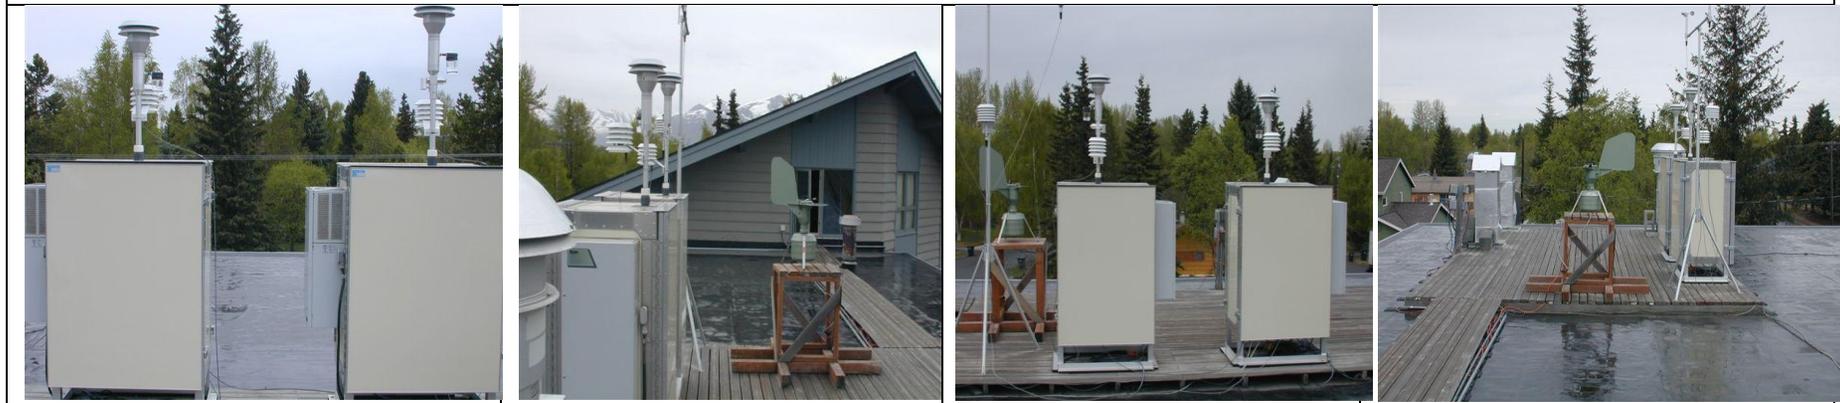
Figure 2.2:2: Pictures of the Garden Site

Views in four directions from the Garden Site

Views in four directions towards the Garden Site

The particulate matter samplers are located on the roof at the south end of the Trinity Christian Reformed Church. Access to the site is by use of a window from a split level section of the church. This split level area is several meters from the monitoring site. The roof height is six meters (19 feet), and there are no trees in the vicinity that significantly exceed the height of the samplers. The airflow to these samplers is unobstructed. The samplers are approximately 14 meters (32 feet) south of the nearest traffic lane of 16th Avenue.

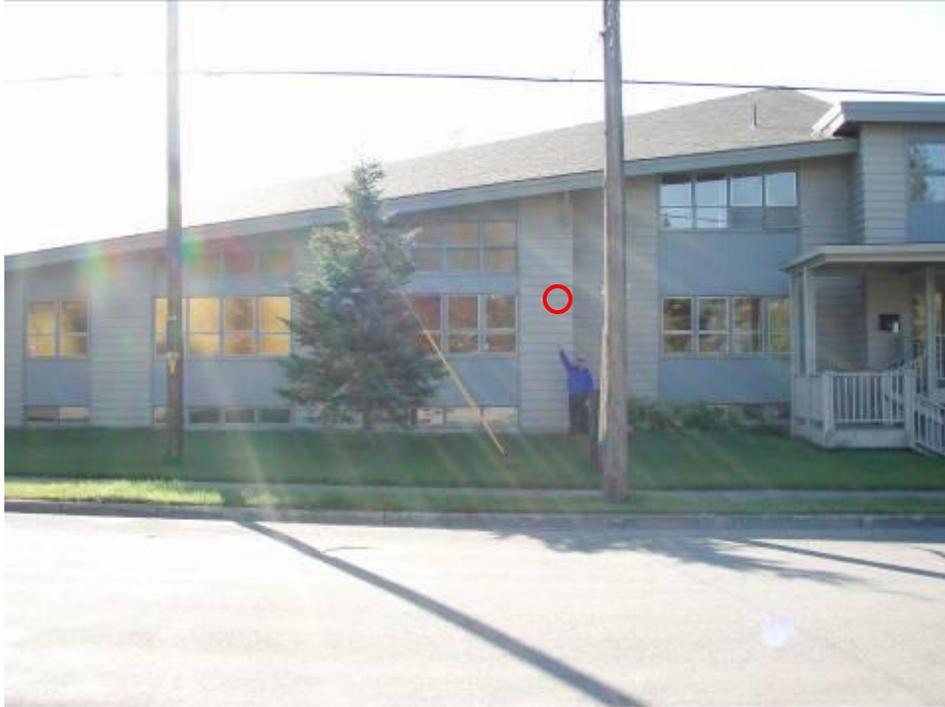
Figure 2.2:3: View of CO probe at Garden Site. The red circle indicates where the probe is located.

The CO inlet probe is fixed to the north wall of the church 3 meters (9.5 feet) above the ground approximately 10 meters (32 feet) from the nearest traffic lane of 16th Avenue. Between the inlet and 16th Avenue is one tall spruce tree. The church itself obstructs air flow from the south. The probe inlet for the ozone analyzer is located 1 meter above the roof and is unobstructed.

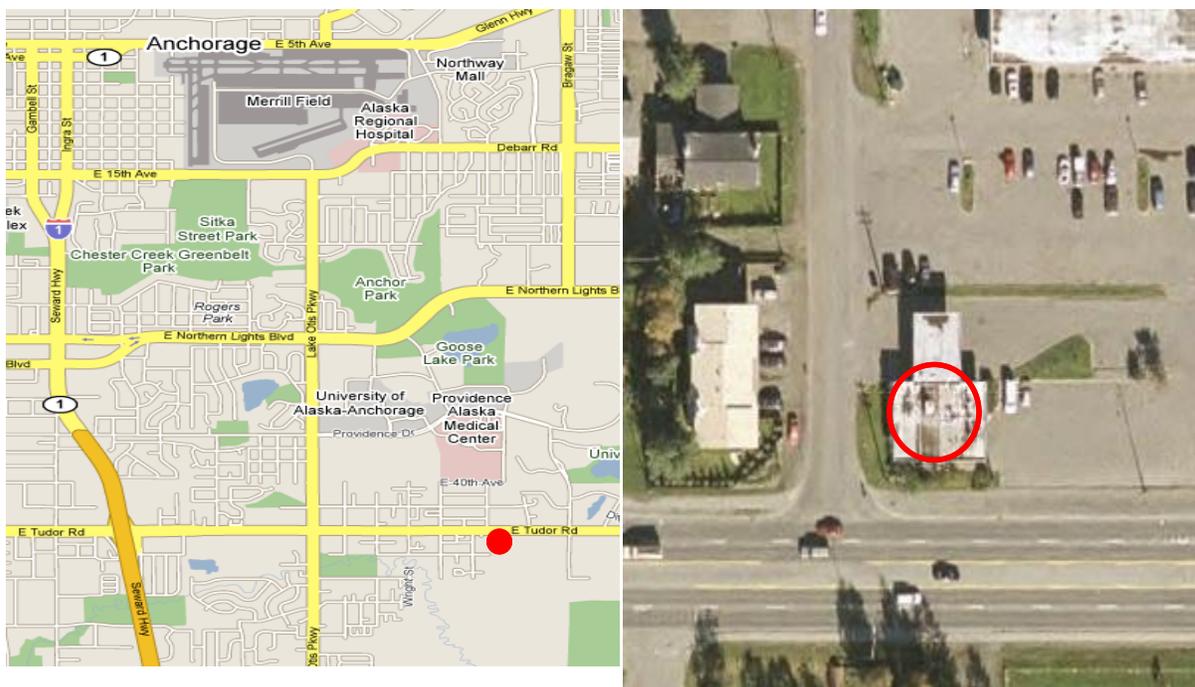
Figure 2.3:1: Street map and satellite image of the Tudor monitoring site. The red circle indicates the sites location.

The Tudor monitoring site is located at 3335 East Tudor at latitude 61°10' 51.9" north (61.181083), longitude 149°49' 2.6" west (-149.817389), and 50 meters (164 feet) above sea level. Figure 2.3:1 shows a street map of the central Anchorage area and a satellite picture of the area immediately surrounding the Tudor site. The site is located in an urban, commercial location. Tudor is a microscale, source-oriented PM₁₀ site.

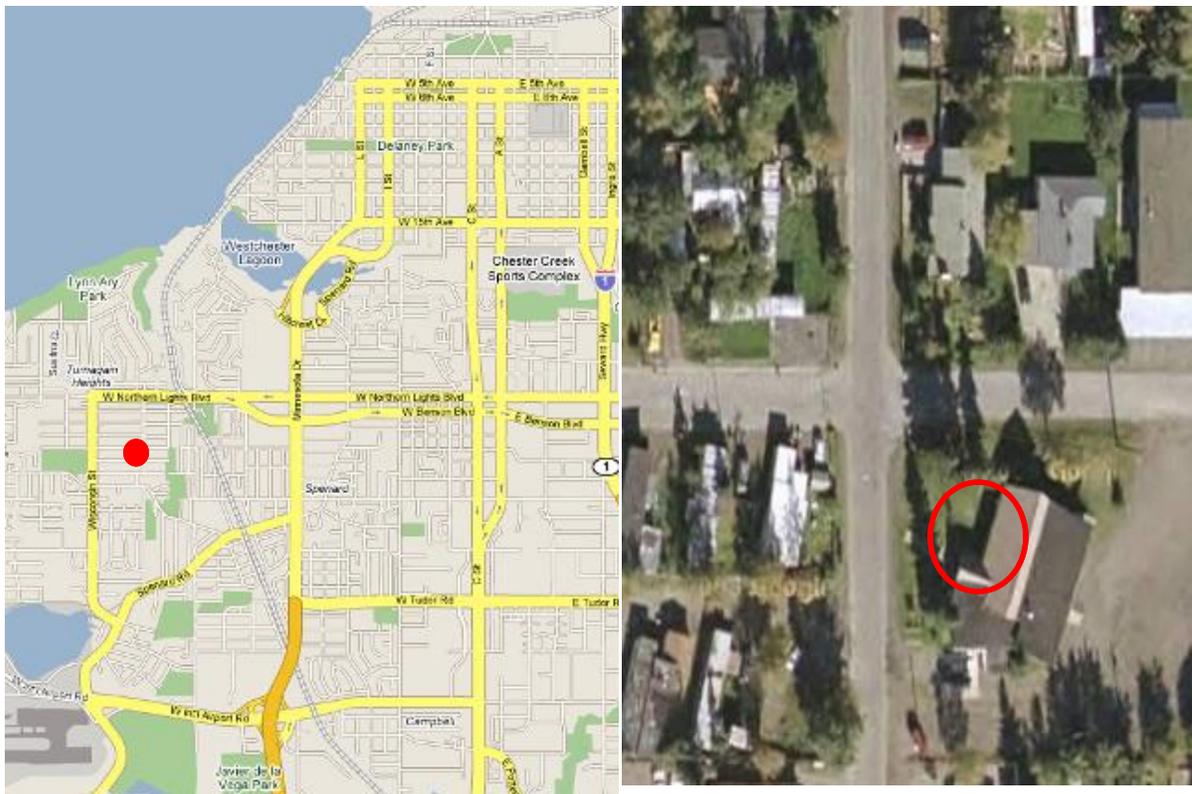
Figure 2.4:1: Street map and satellite image of the Turnagain monitoring site. The red circles indicate the sites location.

The Turnagain CO monitoring site is located at the corner of Turnagain Street and 32nd Avenue at latitude 61°11' 29.4"north (61.191514), longitude 149° 56' 5.7" west (-149.934930), and an elevation of 21 meters (69 feet) above sea level. Figure 2.4:1 is street map of the western part of Anchorage and a satellite picture of the Turnagain site and surrounding area. The site is located in a suburban location. Turnagain is a neighborhood scale, population-oriented site.

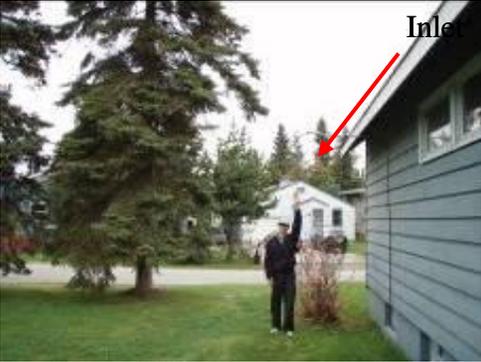
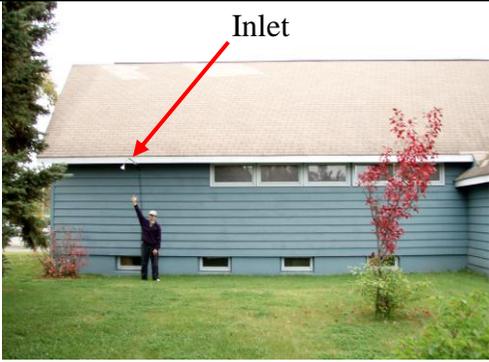
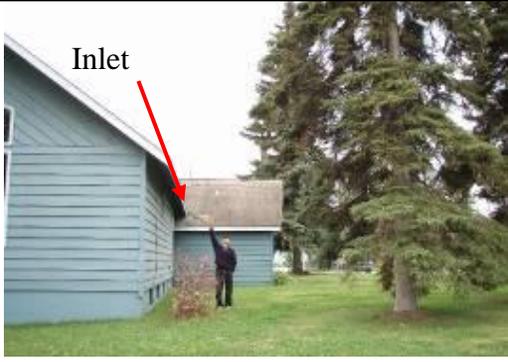
Figure 2.4:2: Pictures of the Turnagain Site

A photograph showing a view from the north towards the Turnagain Site. A person stands on a grassy area in the foreground. In the background, a blue house is visible, with a red arrow pointing to a feature on the roof labeled "Inlet".

A photograph showing a view from the east towards the Turnagain Site. A person stands on a grassy area in the foreground. A blue house is visible, with a red arrow pointing to a feature on the roof labeled "Inlet".

A photograph showing a view from the south towards the Turnagain Site. A person stands on a grassy area in the foreground. A blue house is visible, with a red arrow pointing to a feature on the roof labeled "Inlet".
<p>Views in three directions towards the Turnagain Site</p>		
East	West	South

The monitor is installed in the Unitarian church. The inlet probe is approximately 3.0 meters (9.5 feet) above the ground. The inlet probe is approximately 18.5 meters (58 feet) from the nearest traffic lane of Turnagain Street. Between the inlet and Turnagain Street are several tall white spruce trees. The church itself obstructs air flow from the south and east.

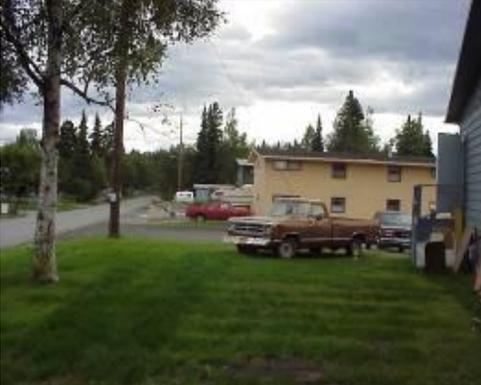
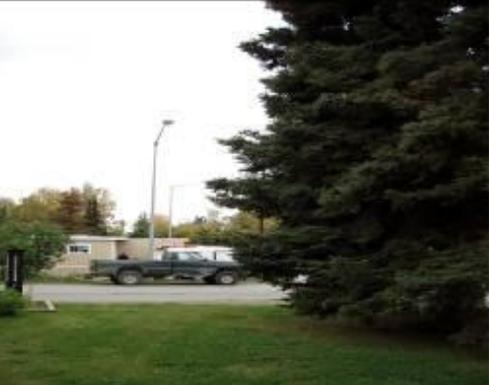
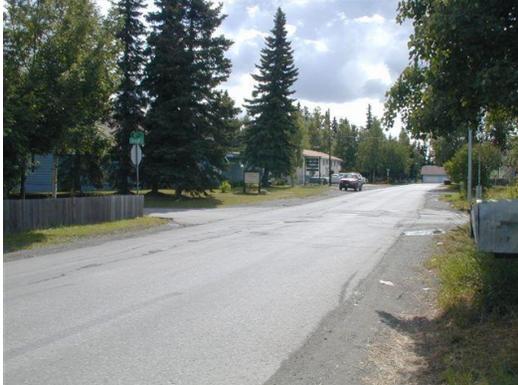
<p>Views in three directions from the Turnagain Site</p>

A photograph showing a view from the east from the Turnagain Site. A grassy area is in the foreground, and a yellow house is visible in the background.

A photograph showing a view from the west from the Turnagain Site. A grassy area is in the foreground, and a street with a car is visible in the background.

A photograph showing a view from the south from the Turnagain Site. A paved road is in the foreground, and a street lined with trees and houses is visible in the background.

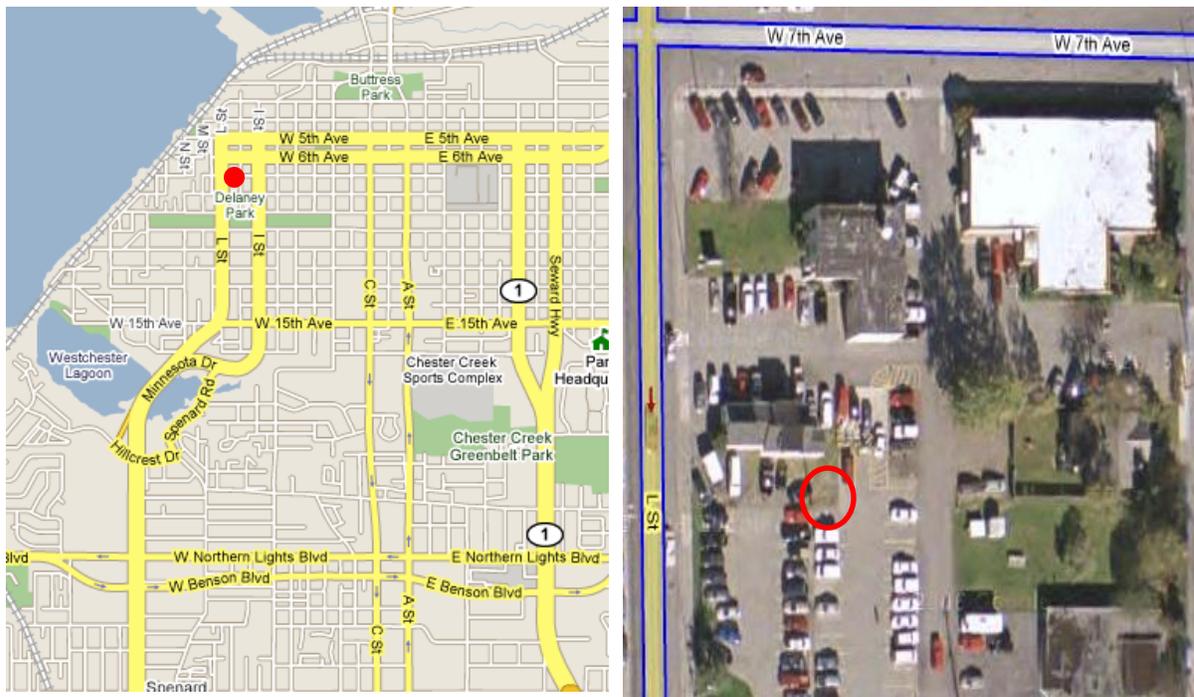
Figure 2.5:1: Street map and satellite image of the DHHS monitoring site. The red circles indicate the sites location.

The Department of Health and Human Services (DHHS) monitoring site is located in the employee parking lot for DHHS at latitude 61° 12' 54.1" north (61.215027), longitude 149° 54' 11.2" west (-149.903111), and an elevation of 35 meters (115 feet) above sea level. Figure 2.5:1 shows a street map of the western part of Anchorage and a satellite picture of the DHHS site and surrounding area. The site is located downtown. The Municipality of Anchorage considers the DHHS site to be middle scale, representing a dimensional area up to 0.5 km.

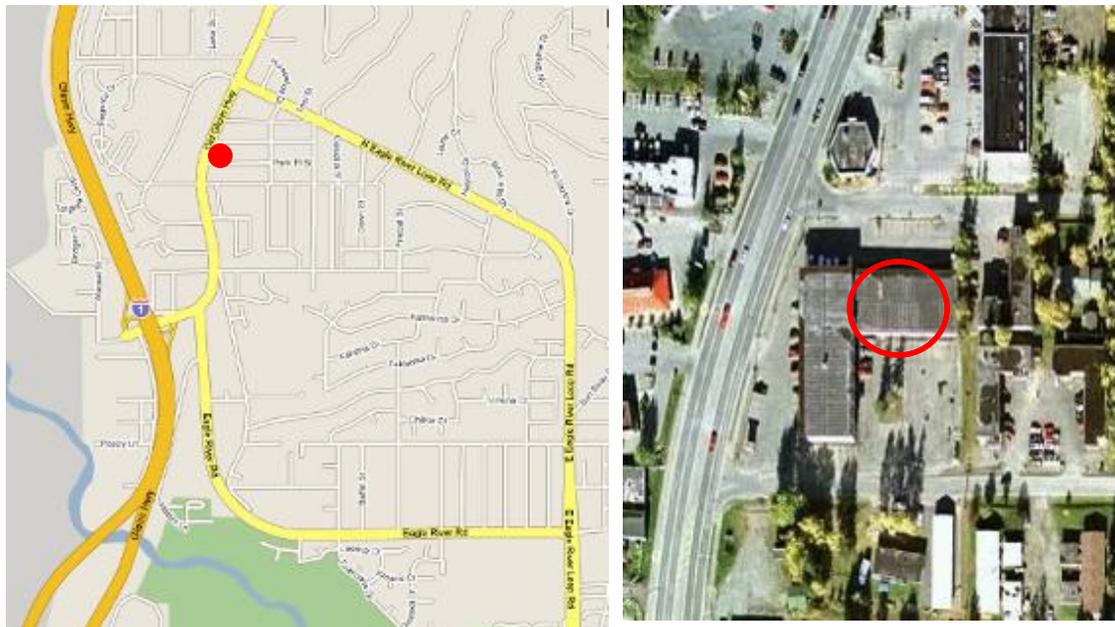
Figure 2.6:1: Street map and satellite image of the Eagle River monitoring site. The red circle indicates the sites location.

The Parkgate PM₁₀ monitoring site is located at the Parkgate Business Center building in Eagle River (a bedroom community of Anchorage that lies within the Municipality) at latitude 61° 19' 36.1" north (61.326700), longitude 149° 34' 10.9" west (-149.569707), and an elevation of 100 meters (328 feet) above sea level. Figure 2.6:1 is a street map of the western Eagle River area and a satellite picture of the Parkgate site and surrounding area. The site is located in a suburban/commercial use area. The site is classified as neighborhood scale, population-oriented monitoring site.
