Final Report

Preliminary Assessment Former Galena Forward Operating Location, Alaska

Prepared for
**Air Force Center for Engineering
and the Environment**

September 2011

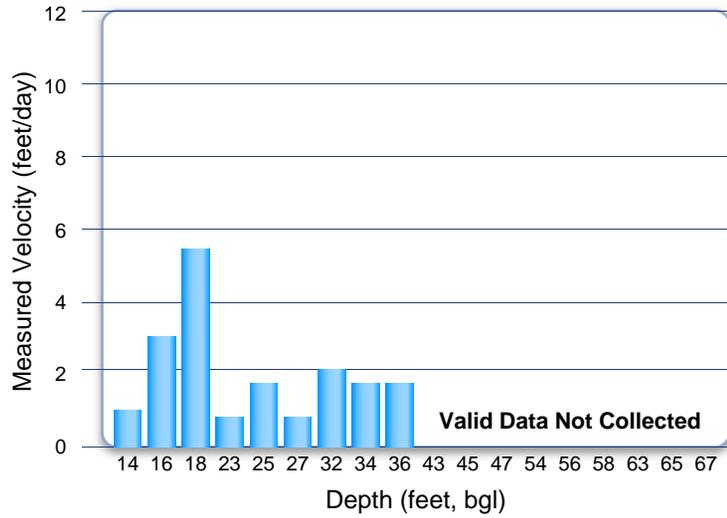
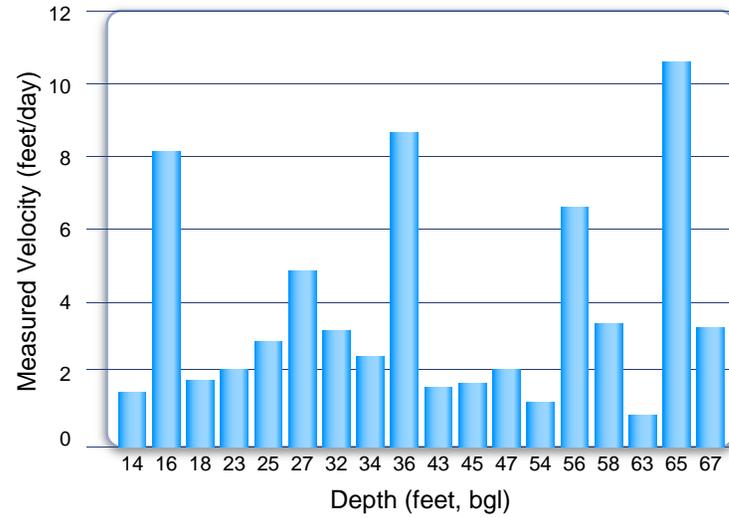
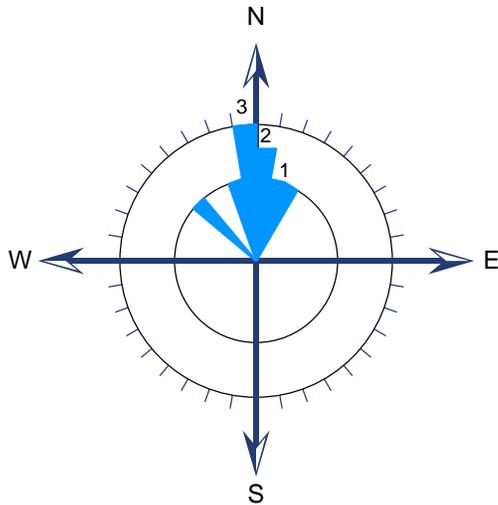
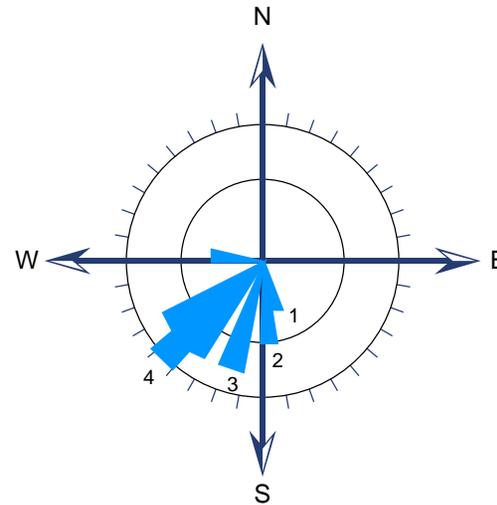
FIGURE 3-7
Flowmeter Velocity Plot and Direction Rose for
Ambient-May and Ambient-August Flowmeter Tests
 Preliminary Assessment Report
 Former Galena Forward Operating Location, Alaska

Ambient May Flowmeter Velocities

Ambient August Flowmeter Velocities

Changes in groundwater flow direction and velocity as a result of changes in river stage were also measured directly using a down-hole flowmeter in a group of wells installed for pump test observations near Monitoring Well 05-MW-06. The results of these flow meter tests are presented in detail in the *Final Aquifer Test Report, Galena Airport, Alaska* (USAF, October 1994). A Geoflow flowmeter was used to collect groundwater flow velocity data during ambient conditions in May and August 1993.
