Appendix A

History of Sulfolane Releases to the Environment at the Flint Hills Refinery, North Pole, Alaska

Geomega Inc.

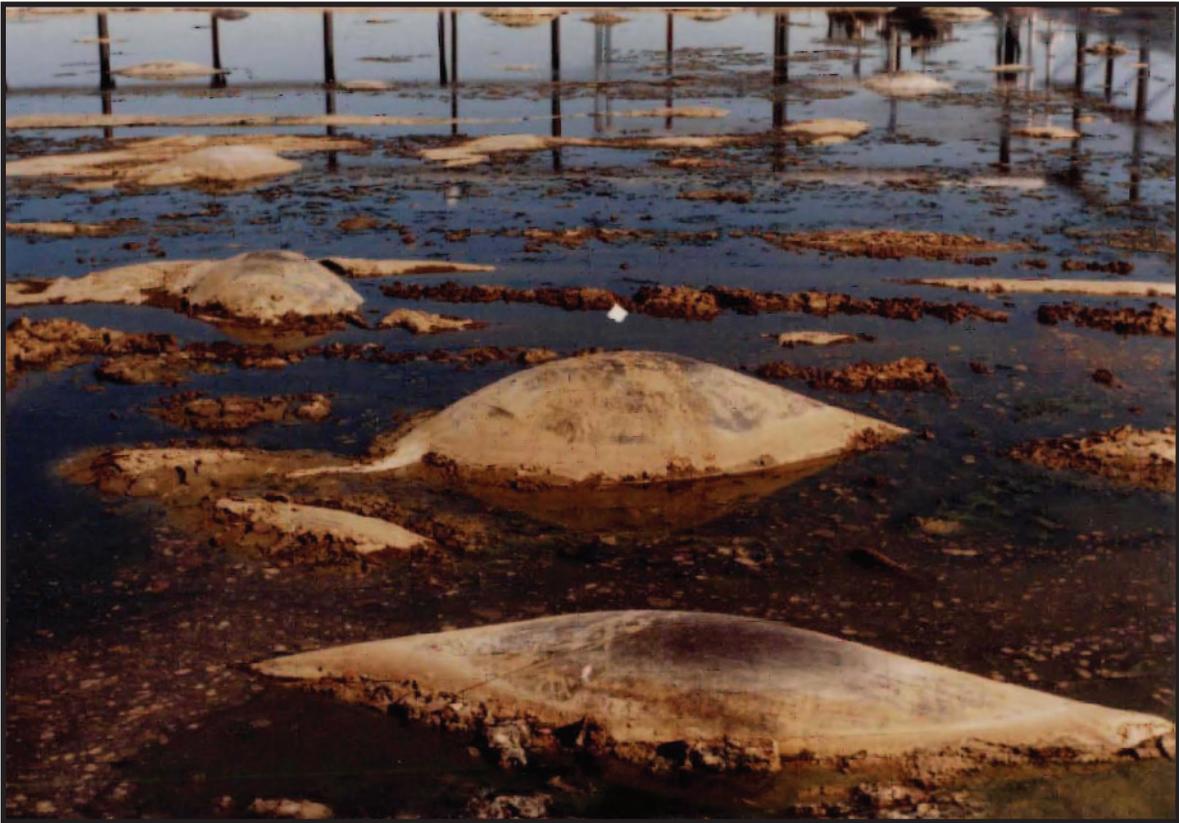
Figure
4-11

Photographs of the Lagoon B liner, illustrating (a) tears in the liner and (b) bubbles, also known as "whales" taken during the 1990-1991 Lagoon B inspection.

Initial repairs since construction was completed on Lagoon B in the summer of 1986 included draining and repairing >45 holes (MAPCO 1989). During the initial closure process of Lagoon B in July 1990, an S&W employee identified several tears and rips >1 ft (S&W 1990) (Figure 4-11a). On June 1991, additional tears in the liner of Lagoon B were identified (S&W 1991). Williams prepared a Lagoon B Closure Report that was submitted to EPA, which report contained the S&W field notes, but omitted the photographs that depicted the tears in the liner (compare MAPCO 1991c with S&W 1990, 1991). After the liner was removed in 1991 the soil was tested for hydrocarbons. Benzene was detected above regulatory levels, indicating that the liner had leaked (S&W 2000).

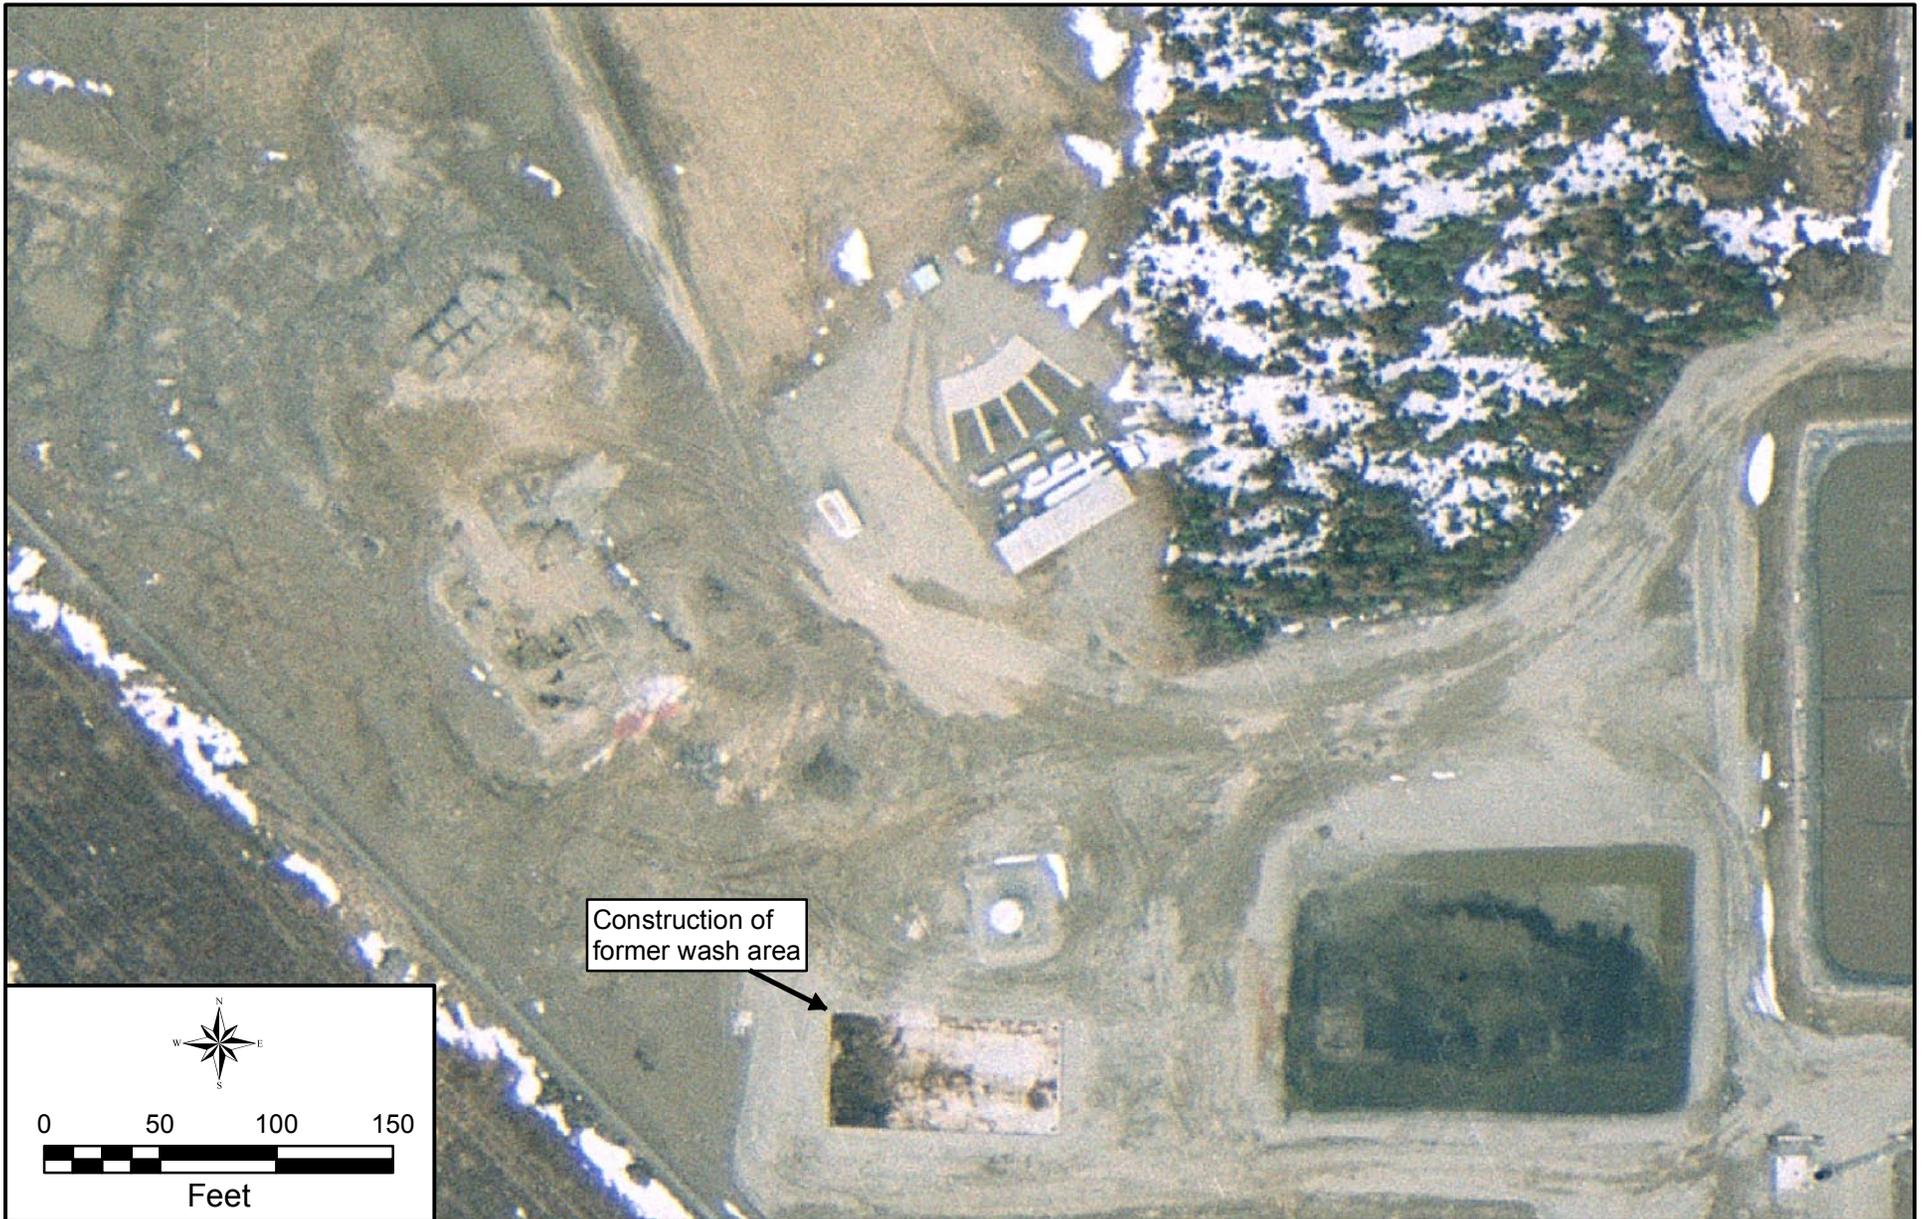
Figure
4-14

Construction of
former wash area

April 28, 1990, aerial photograph of former wash area construction.

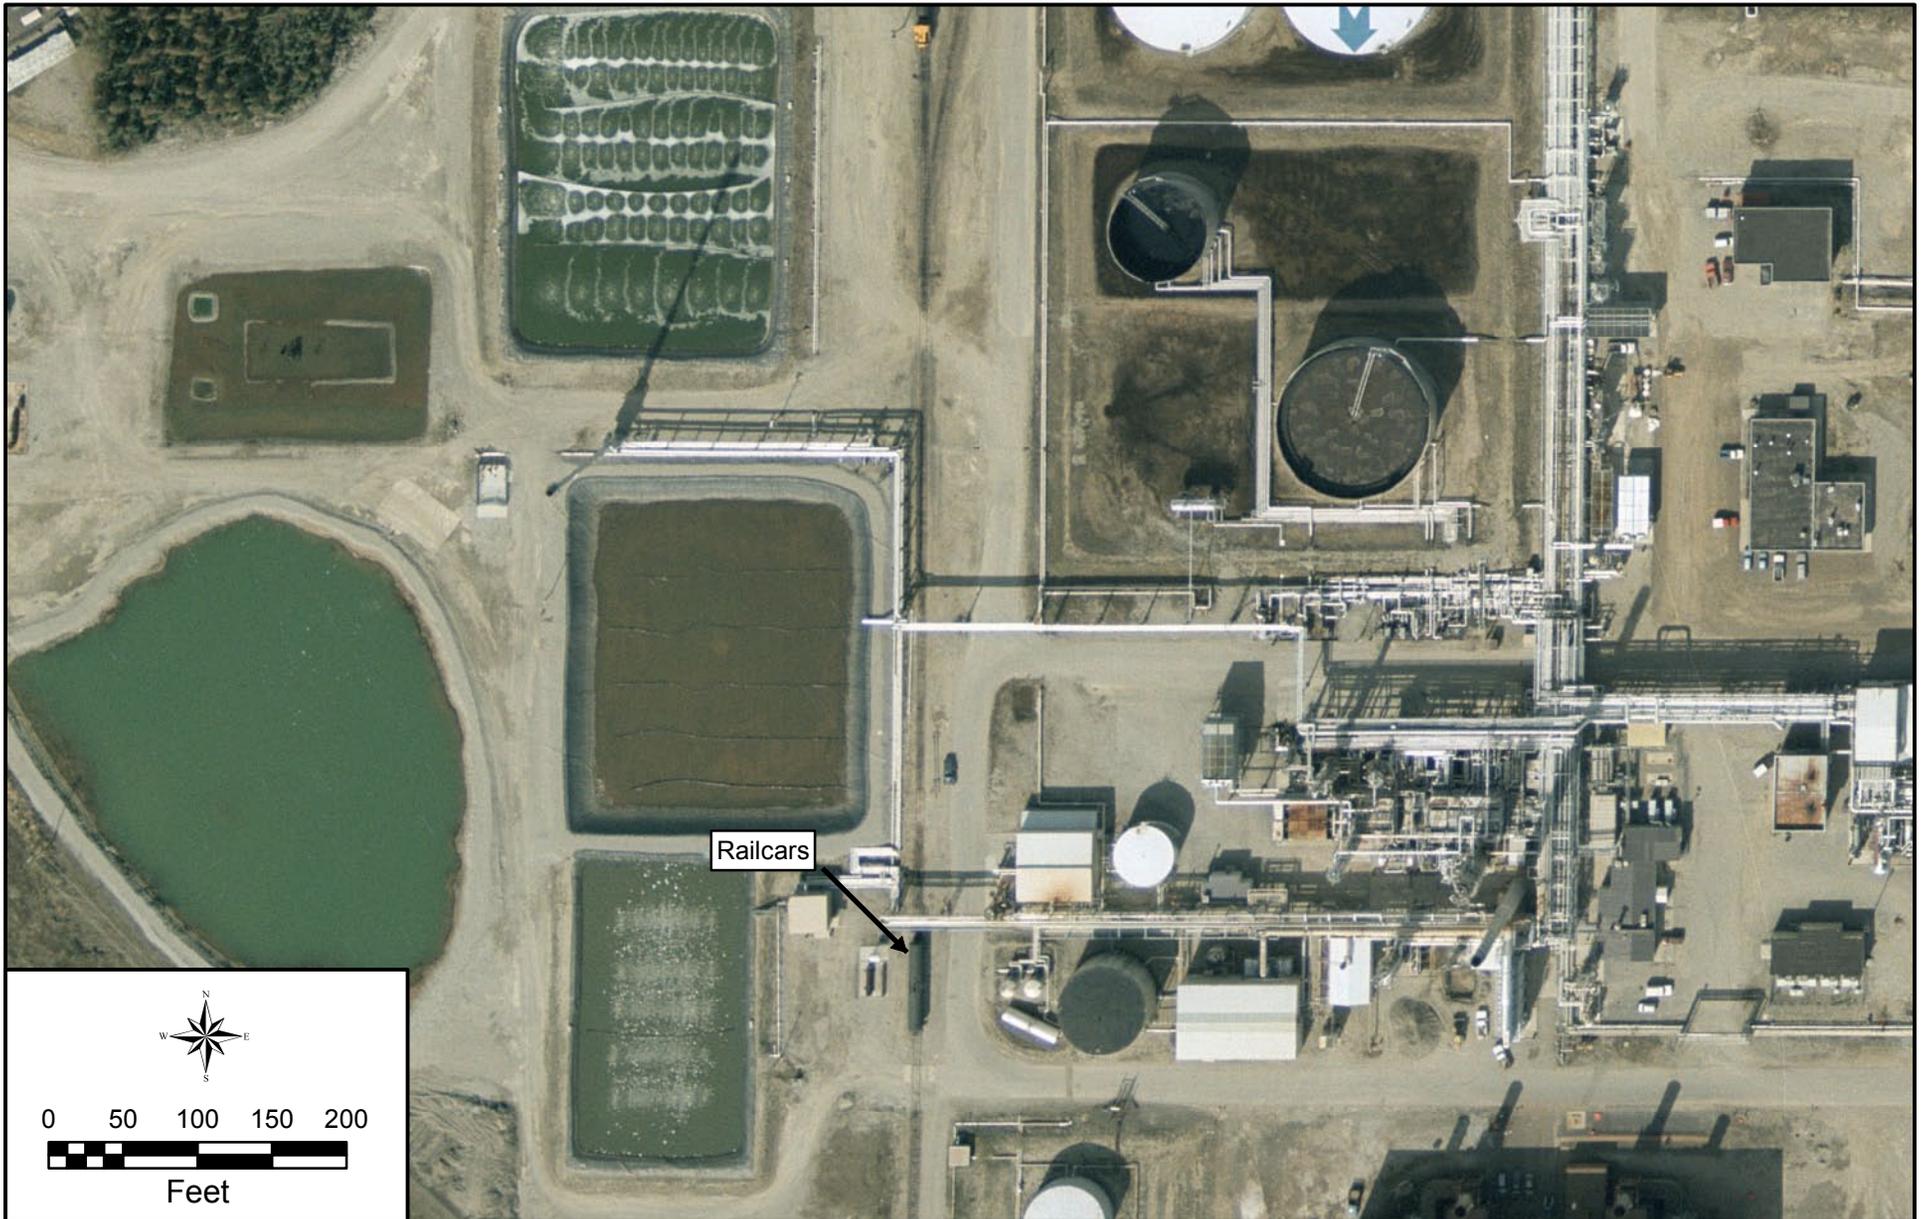
Figure 4-16

May 13, 1993, aerial photograph illustrating railcars near Tank 194.

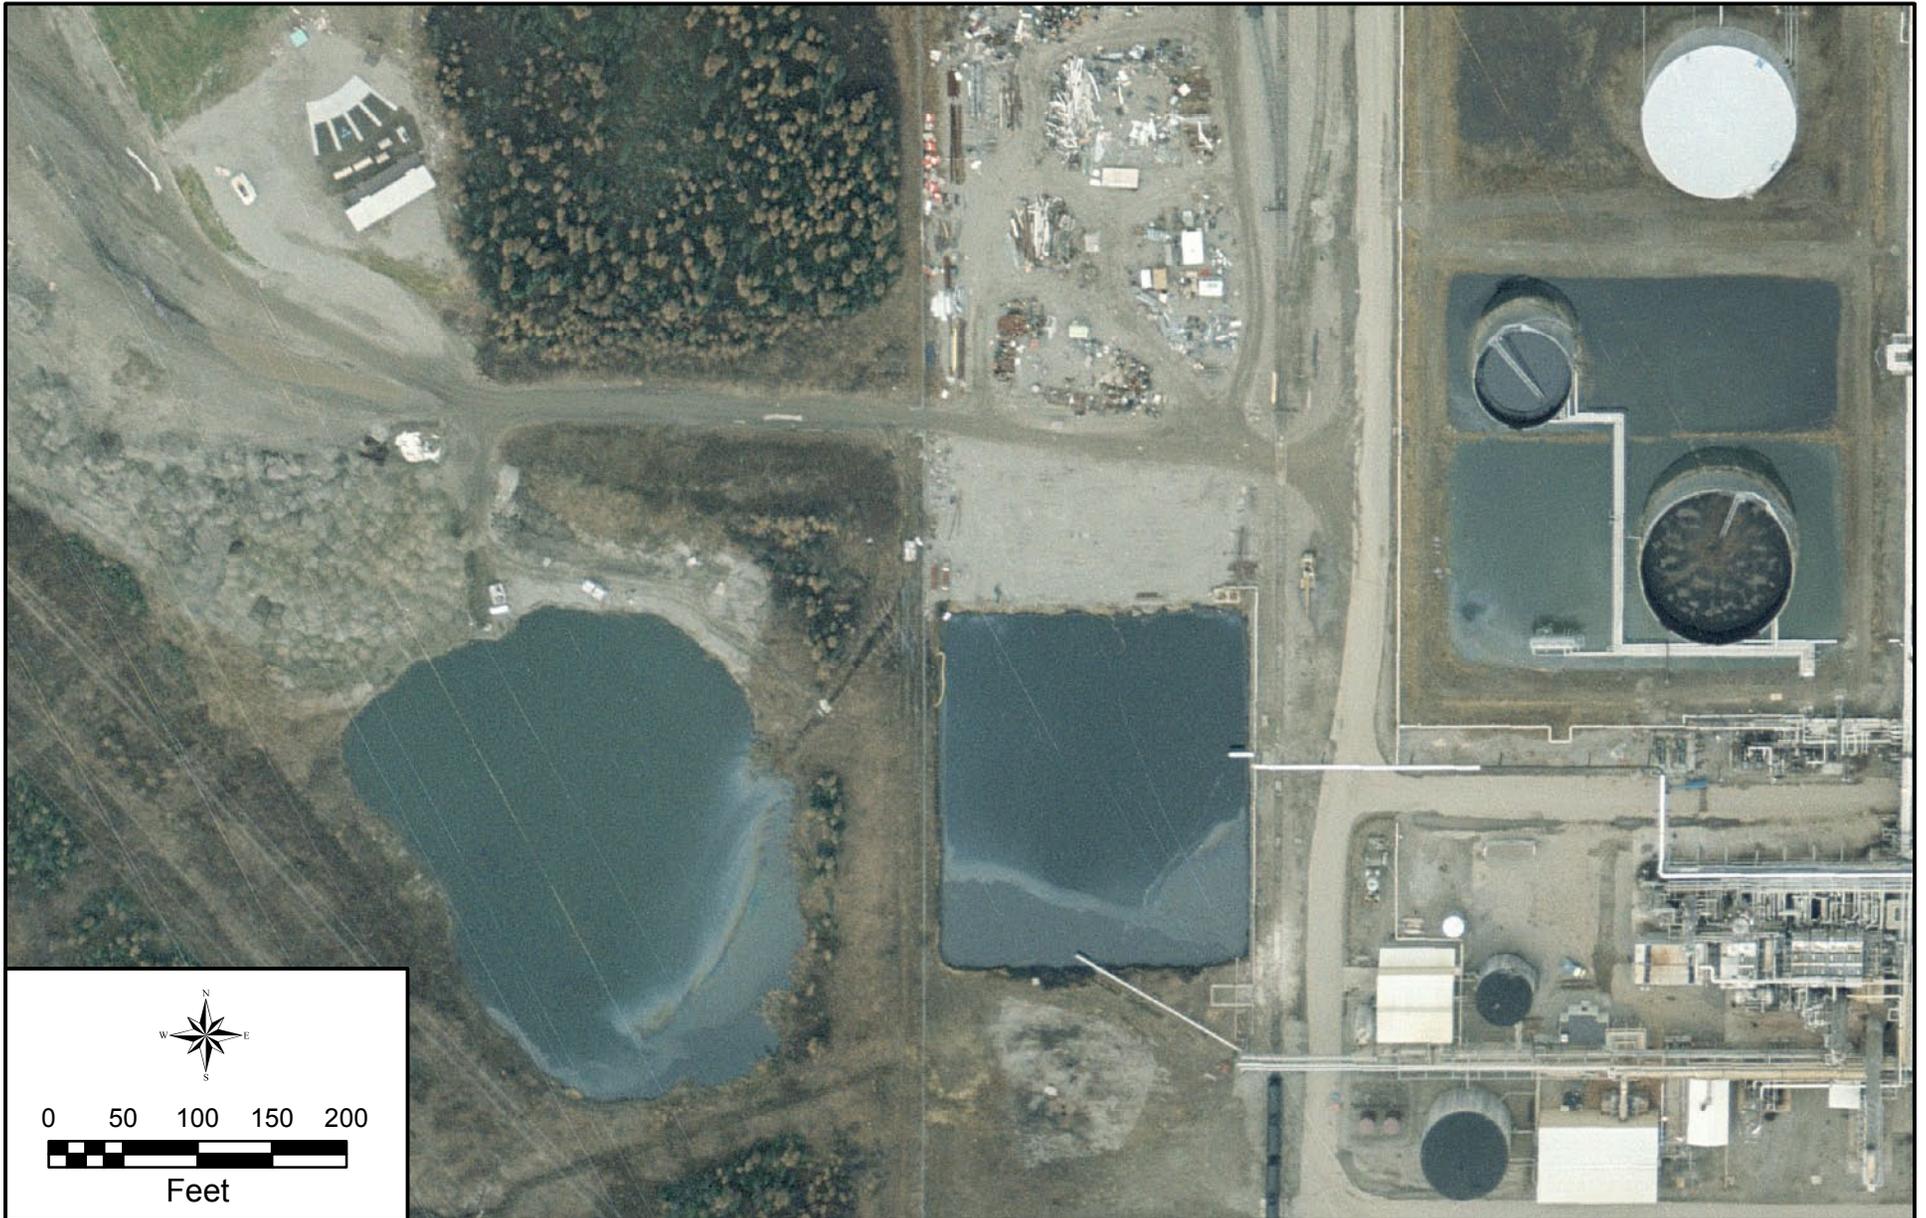
Figure
4-20

October 6, 1985, aerial photograph of the North Pole Refinery showing sheen in Lagoon B, and adjacent south gravel pit, and the overflow ditch.

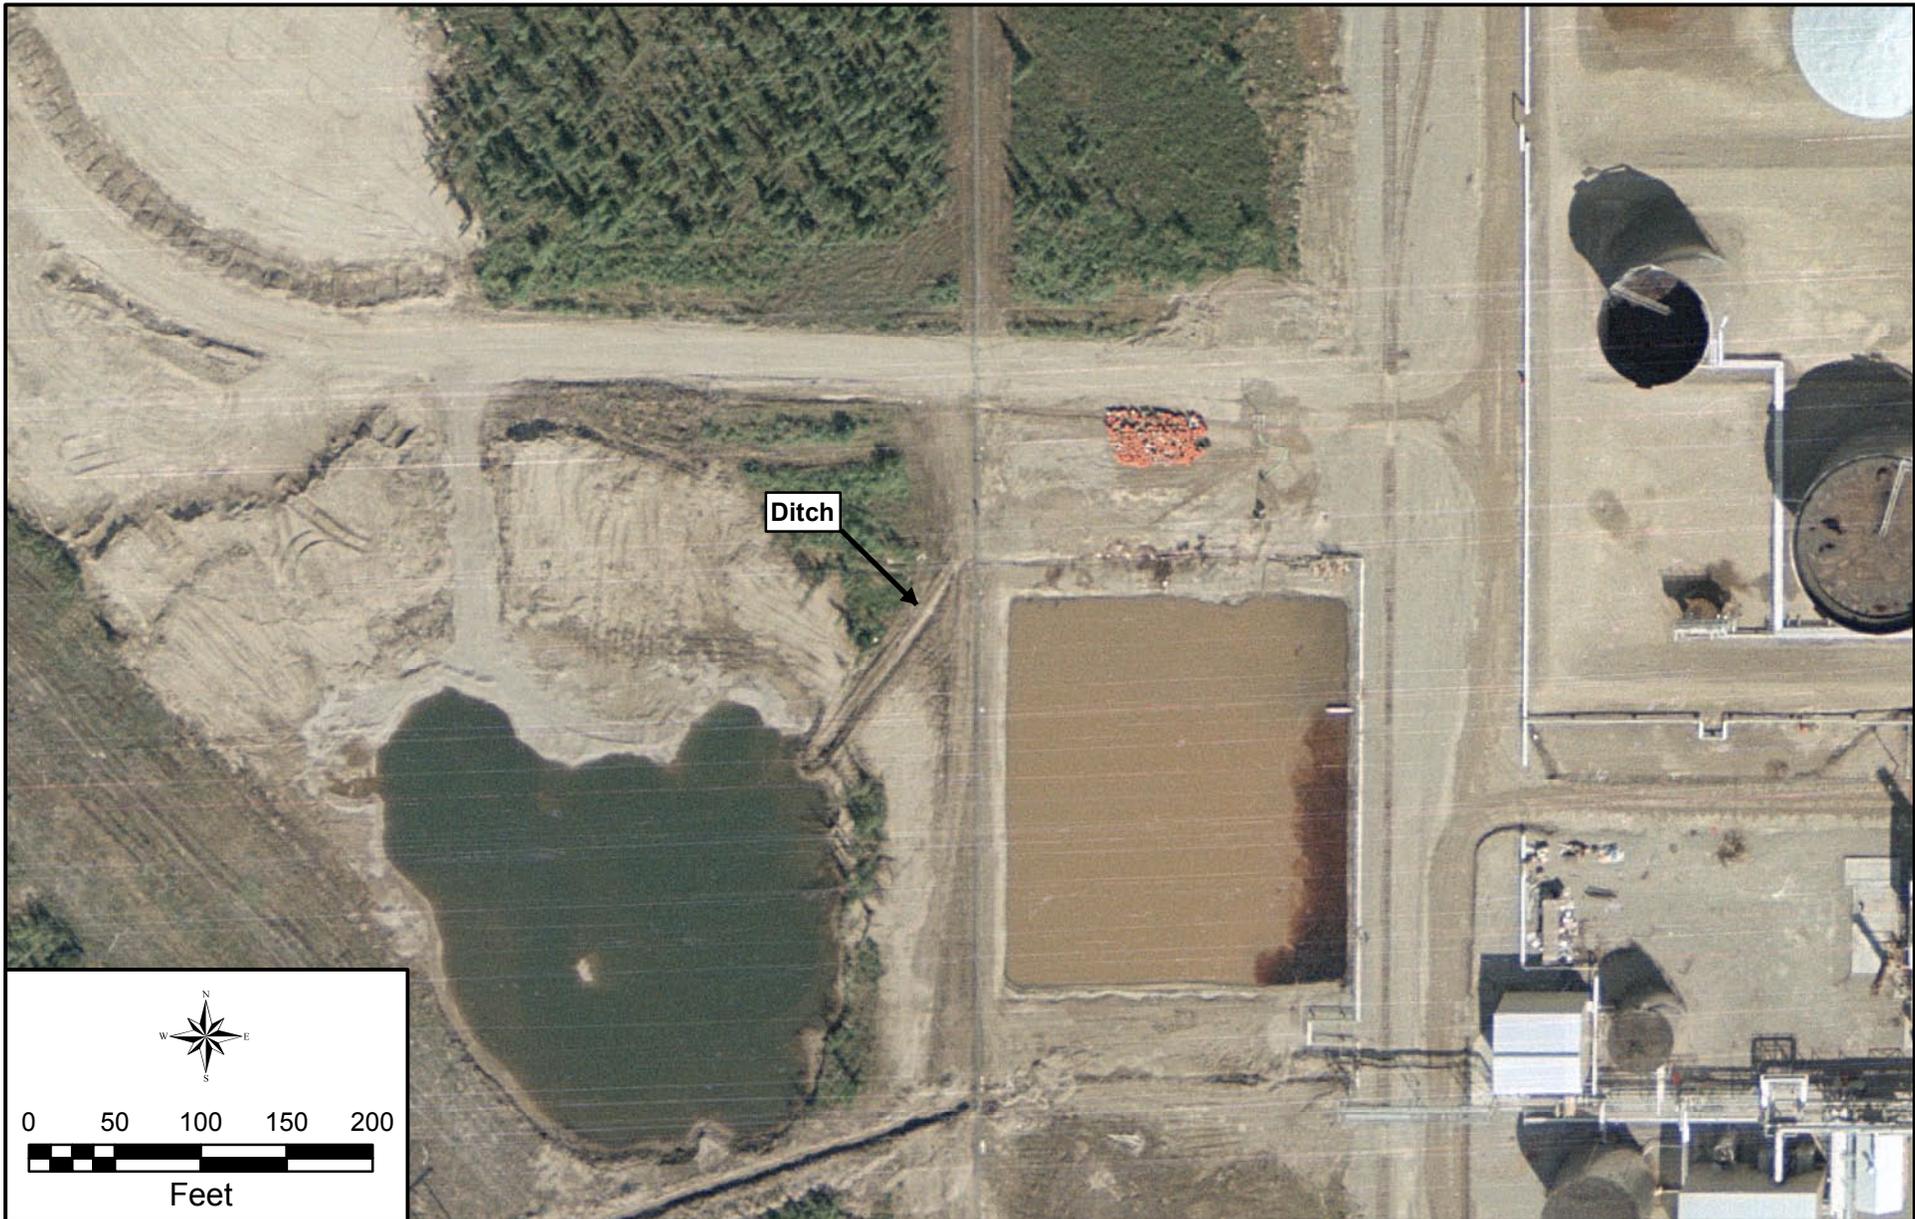
Figure
4-21

June 4, 1978, aerial photograph of the North Pole Refinery showing Lagoon B, the South Gravel Pit, and the overflow ditch.
