FY 2006
FINAL REPORT

PROJECT #: ACWA-06-11

**Watershed Protection and Recovery for
Pederson Hill Creek, Juneau, AK**

July 2006

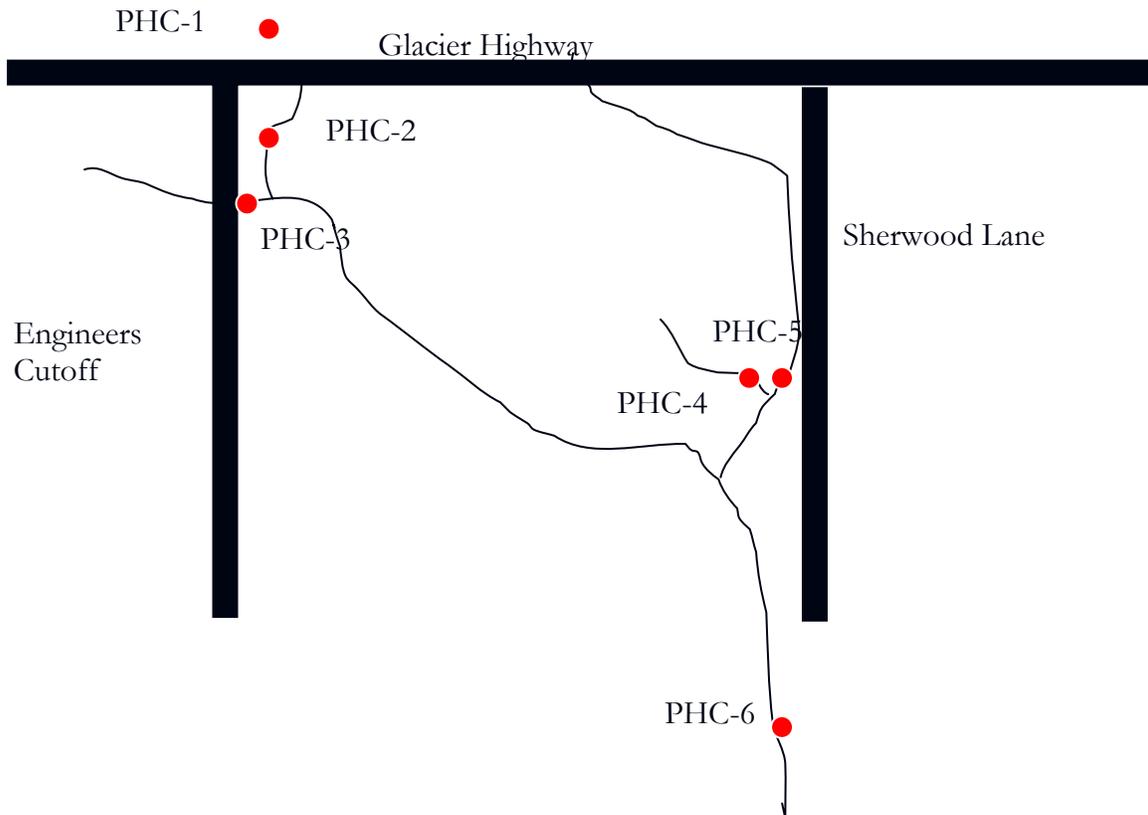
Figure 3. Sketch of location of sampling sites along Pederson Hill Creek. The area shown above is equivalent to the orange inset in Figure 2.

Six sites were selected along Pederson Hill Creek for seasonal fecal coliform and water quality parameter sampling, (following consultation with Lori Sowa of the ADEC) (Figure 3). Funding constraints allowed for only 3 rounds of measurements at the 6 sites (and the 3rd round allowed for sampling only 4 of the 6 sites). We sampled the creek at a higher spatial resolution (6 sites) on fewer dates instead of at one or two sites on a more frequent basis, in order to help determine the source locations of high fecal coliform concentrations. One site was located upstream of the area of development to serve as a background site. Other sites were selected to reflect flows primarily from residential areas. We chose a point in back of the troopers building (with historically high levels of bacteria), and also an area of commercial/industrial use by a Fire Training Center. All testing was conducted on what is known as the east fork of the creek – in earlier times it was identified as Casa Del Sol Creek.

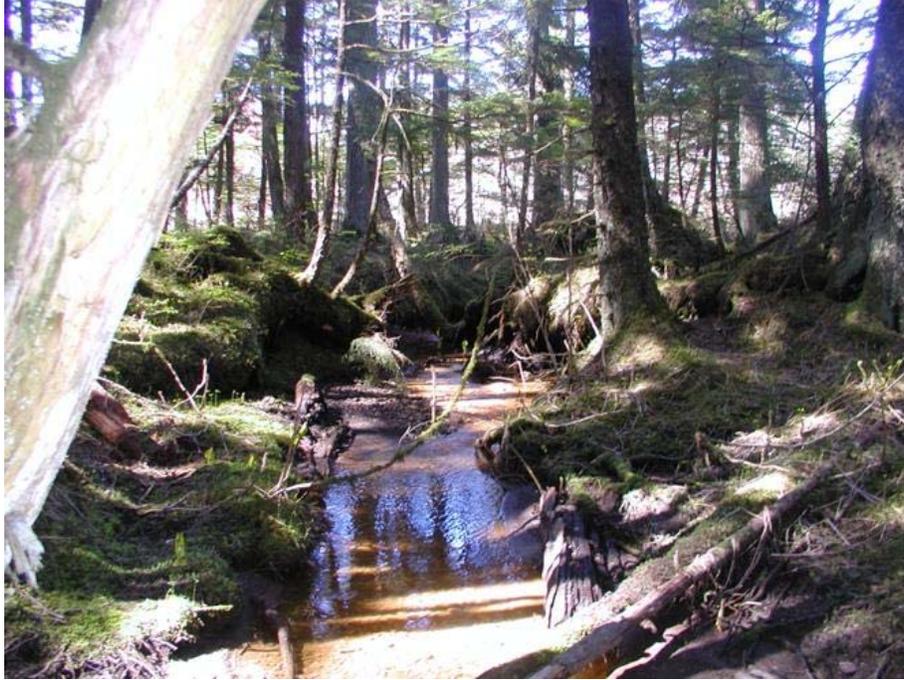
- Site PHC-3: This sampling site was selected because of historically high measurements of fecal coliform bacteria in past studies. The source is primarily a residential development across Engineers Cutoff, runs under the road through a culvert. Accessible on the maintained nature trail in this area. (Photo: Figure 4)

Figure 4. *Pederson Hill Creek at site PHC-3, near the intersection of Glacier Highway and Engineers Cutoff Road; site accessible on the nature trail footpath. May, 2006.*

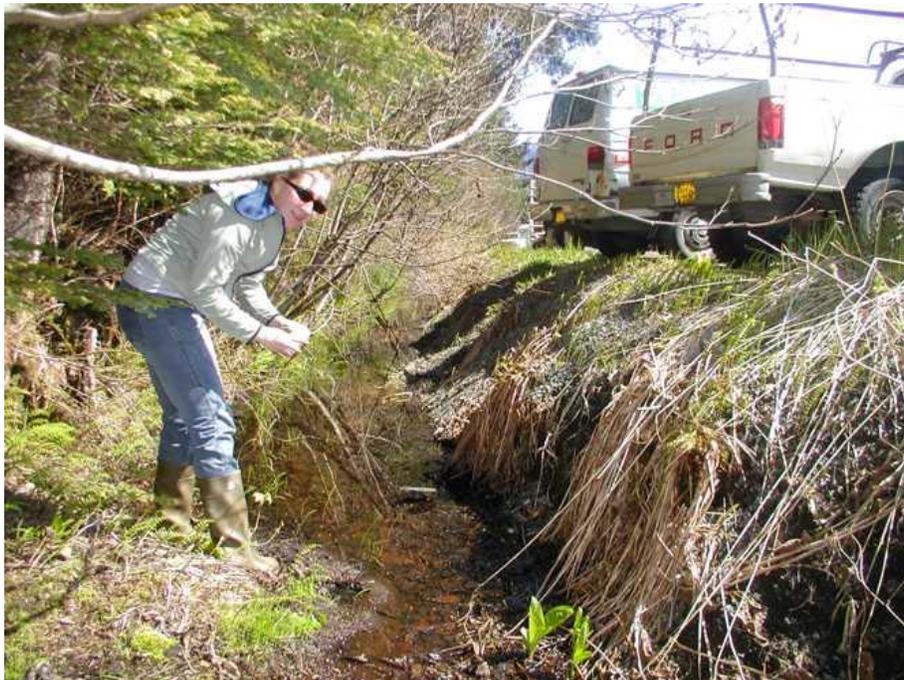
- Site PHC-5: The east side of the fork described in PHC-4 was selected again due to historically high reports of fecal coliform bacteria. It contains the runoff from the parking lot and office buildings on Sherwood Lane. (Photo: Figure 5)

Figure 5. *Pederson Hill Creek at site PHC-5, flowing along the edge of the parking lot for the office buildings on Sherwood Lane. May, 2006.*

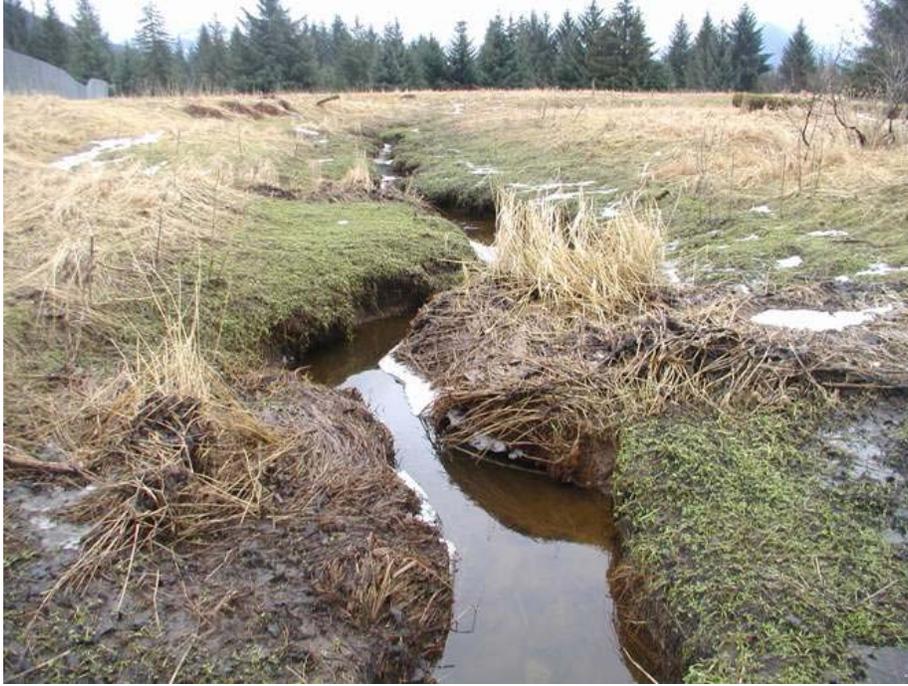
- Site PHC-6: This site is reached by driving to the end of Sherwood Lane. The road goes to gravel, and has a small turn around. A short walk through tall grass leads to a footbridge, the sampling site. This is the lowest point in the stream used for collection, and has higher flow levels than the upper sites. (Figure 6)

Figure 6. *Pederson Hill Creek- Downstream view from the footbridge at PHC-6. February, 2006.*
