South Fork Little Campbell Creek from Little Campbell Creek to Lake Otis Parkway

Cottonwood Creek from Wasilla Lake to Old Matanuska Road

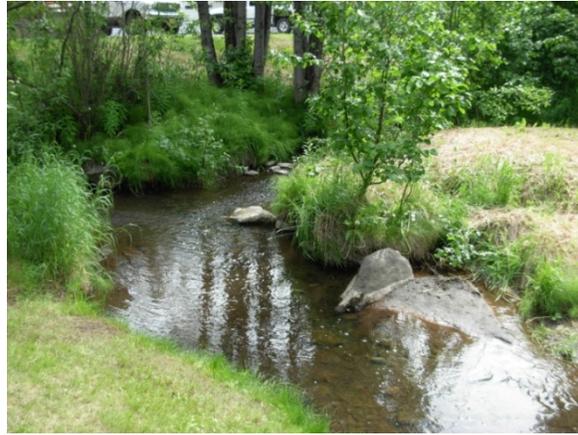
The land use at the confluence of the North and South forks of Little Campbell Creek is approximately 80% residential and 20% commercial. The riparian vegetation is mowed to the streambank directly at the confluence (Photograph C1) and ~ 4 m upstream along the North fork. Intact riparian vegetation upstream along the North fork was mowed to the stream edge (Photograph C2). Downstream of the confluence and upstream along the South Fork, the riparian vegetation is intact from about 0-3 m on either side of the stream channel. No apparent microbial sources were detected.

Photograph C1. The confluence of the North and South Forks of Little Campbell Creek (N 61.15319, W 149.86589).

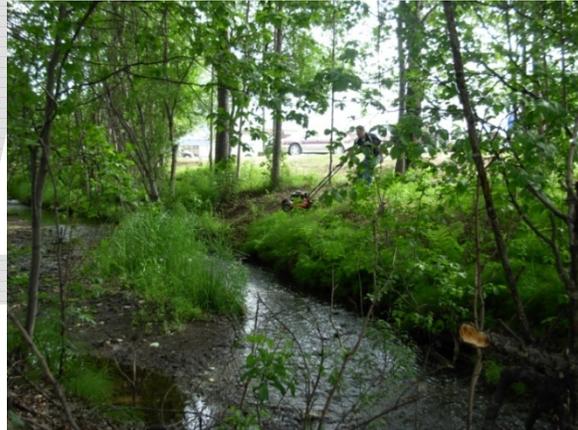
Photograph C2. Mowing of riparian vegetation along the North Fork Little Campbell Creek.

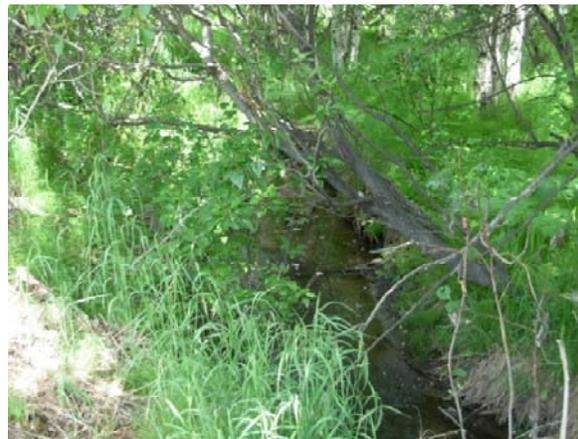
Land use is 100% commercial. Riparian vegetation is intact from 0-4 m along both stream banks (Photograph C3). Dog waste observed ~2m from stream edge

Photograph C3. South Fork of Little Campbell Creek at Spring St. off 80th.

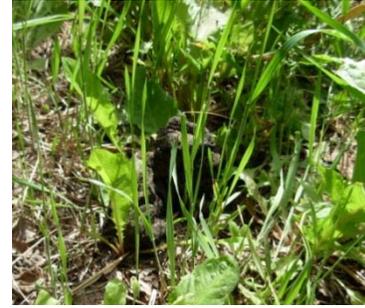
Photograph C4. Dog waste along the South Fork of Little Campbell Creek at Spring St. (N 61.15083, W 149.86200).

(Photograph C4). Trails were present at the end of the street down to the stream. Microbial source inputs are likely from dogs.

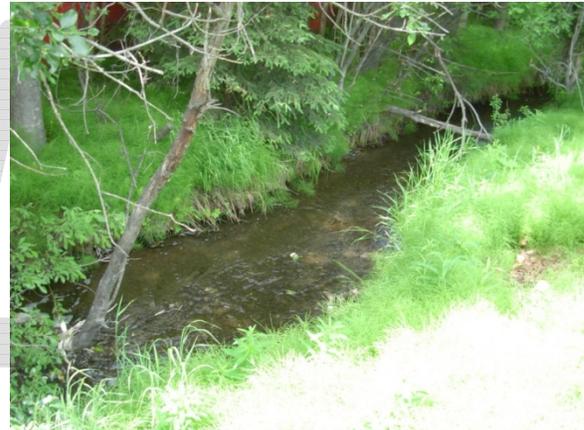
Land use is 100% industrial with poor riparian vegetation cover on the right descending bank (RDB) upstream of fire department driveway with asphalt from parking lot encroaching on the creek (Photograph C5) and good riparian vegetation of the left descending bank (LDB) from 0-2 m along stream with good tree cover upstream of the fire department driveway. Garbage dumpsters are present within 2 m of stream and during high storm flow events microbial input is possible as there is evidence of run-off entering the stream at the culvert adjacent to the fire department driveway (Photographs C6 and C7). Riparian vegetation increases downstream of the fire department driveway with ~ 2 m of riparian vegetation along both streambanks between the driveway and E. 80th Ave. Evidence of bird waste is on rocks along stream edge (Photograph C8). Moose droppings found ~ 1.5 m from stream in multiple locations (Photograph C9). Microbial source inputs likely from dogs, moose, and garbage dumpsters.

Photograph C5. South Fork of Little Campbell Creek at Fire Station #12.

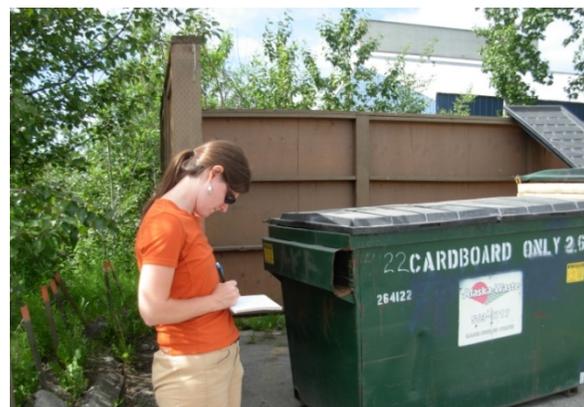
Photograph C6. Garbage dumpsters adjacent to South Fork of Little Campbell Creek at Fire Station #12.

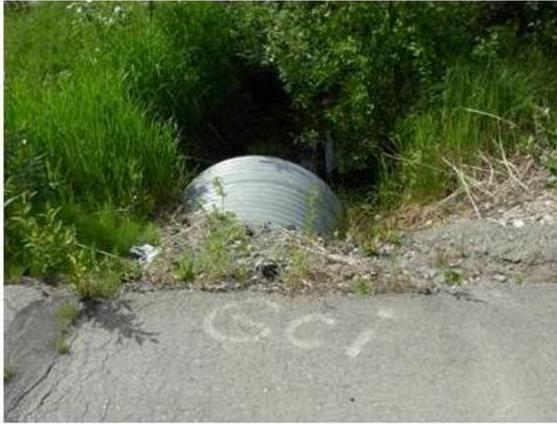
Photograph C7. Culvert adjacent to dumpsters on the South Fork Little Campbell Creek at Fire Station #12.

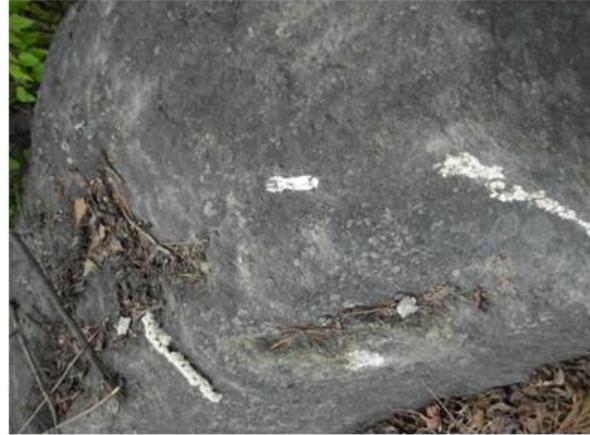
Photograph C8. Bird waste on rocks along the South Fork Little Campbell Creek at Fire Station #12.

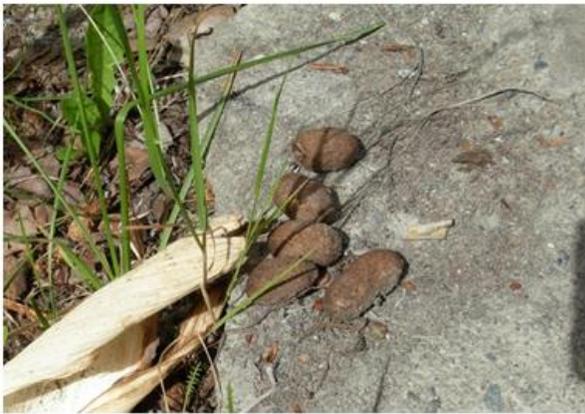
Photograph C9. Moose droppings from the South Fork Little Campbell Creek near Fire Station #12.

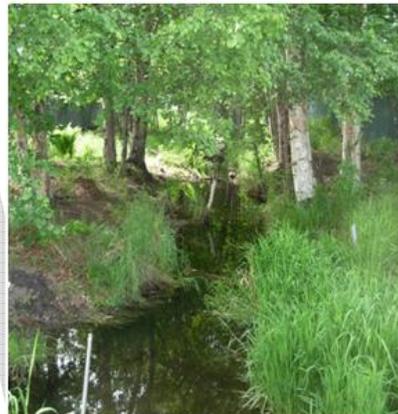
Photograph C10. Little Campbell Creek South Fork looking downstream from Sandalwood Pl.

Downstream of the Sandalwood Pl. crossing (Photograph C10), land use is 75% industrial and the other 25% is a pond.

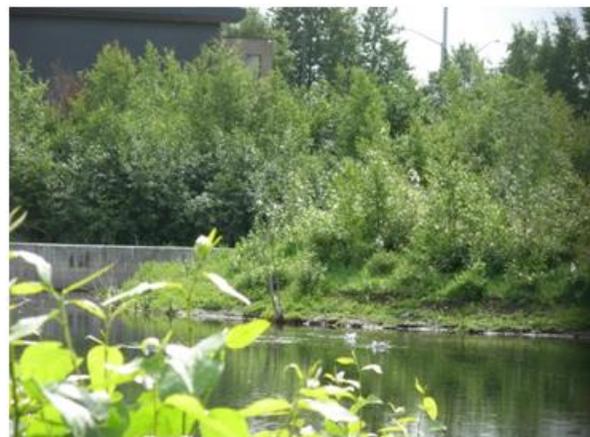
Photograph C12. The pond adjacent to the left bank of Little Campbell Creek South Fork looking upstream from Sandalwood Pl.

The culvert impounds the creek moderately at the road crossing. The riparian vegetation is comprised of large trees, but there is little riparian understory (mainly hard packed dirt). A copious amount of gull waste is present all around the creek (Photograph C11). The pond adjacent to the LDB hosts large numbers of gulls which are also using the creek (Photograph C12). Upstream of the road crossing, land use is 100% industrial (Photograph C13). The creek is also slightly impounded by the culvert. Riparian vegetation is intact 0- 4 m from creek on both banks. Vegetation likely is undisturbed because there is barb wire preventing access beyond the road crossing.

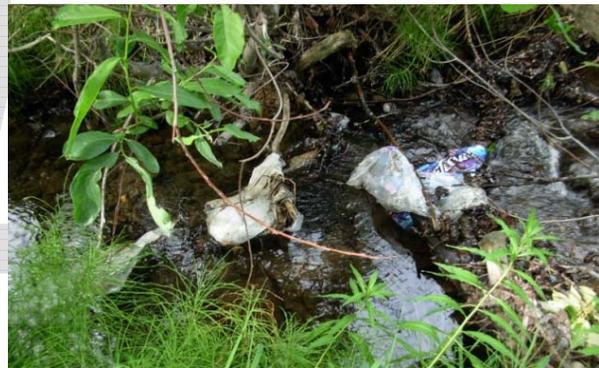
Photograph C14. Trash in the South Fork at Petersburg (N 61.14556 W 149.84560).

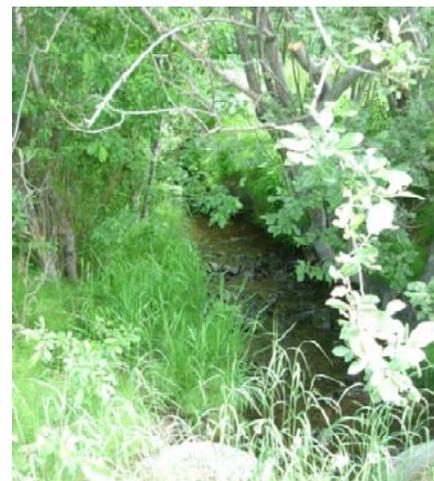
Photograph C15. Little Campbell Creek South Fork at Petersburg.

Land use is 100% industrial. Downstream of road crossing there is a good riparian buffer 0-4 m on either side. The stream may experience high run-off input during rain events washing the abundant trash in the area into the stream (Photograph C14). The creek flows under the road through double culverts. Upstream of the road crossing the riparian buffer is thickly vegetated from 0 – 4 m (Photograph C15).

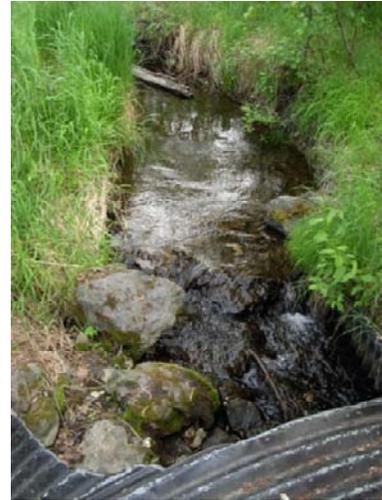
Photograph C16. South Fork at Abbott Loop Elementary School (N 61.14463, W 149.83179).

Land use is 100% residential which includes the elementary school property. The riparian zone is largely intact from 0 – 4 m on either side of the creek (Photograph C16). The elementary school abuts the creek along the LDB while the road abuts along the RDB. Moose droppings are found in multiple locations within 0 - 2 m from the streambank (Photograph C17). There is lots of trash in the stream. A dry culvert with dog tracks in the mud enters the stream from the road side. The riparian vegetation is interrupted for approximately 50 m giving way to a trail along the RDB. Dog waste was also found. Foam is present in the stream (Photograph C18). Many trails from houses lead to the stream upstream from the elementary school. The stream goes under Atkins Rd. further upstream (Photograph C19). This road crossing seems new as grass seed has been planted. Microbial source inputs are likely from dogs, moose, and birds.

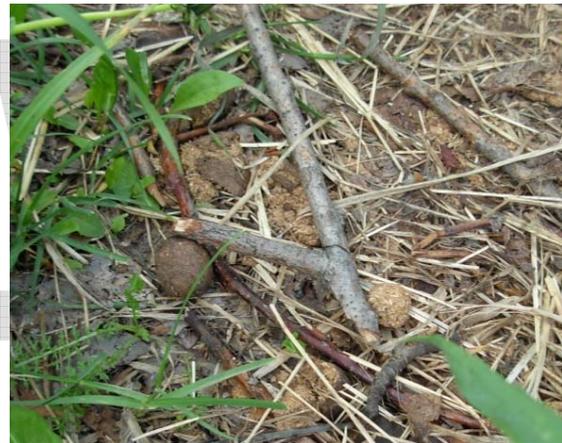
Photograph C17. Moose droppings at Little Campbell Creek South Fork at Abbott Loop Elementary.

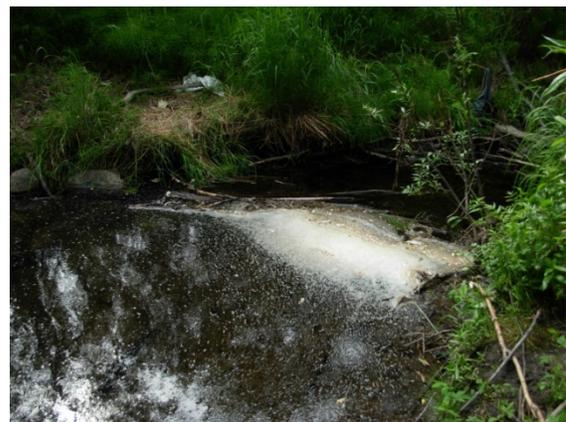
Photograph C18. Foam in the South Fork at Abbott Loop Elementary School (N 61.14376 W 149.82942).

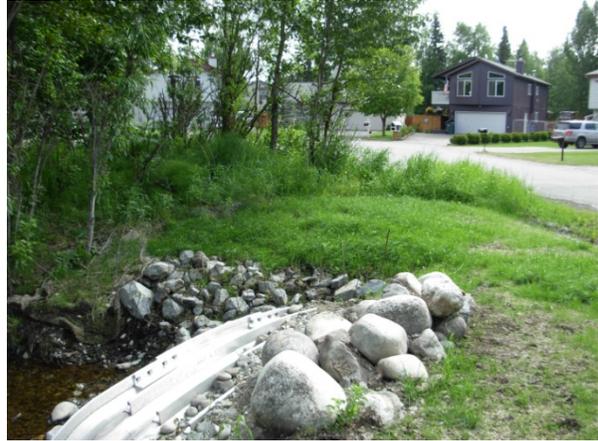
Photograph C19. Culvert on Little Campbell Creek South Fork at Atkins Rd. (N 61.14376, W 149.82942).

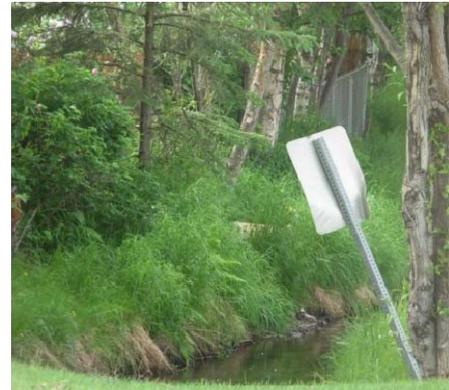
Land use is 100% residential. Riparian cover extends from the bank to over 4 m. A dog was seen in the creek, so a possible source of microbial input is canine (Photograph C20).

Photograph C20. Dog in Little Campbell Creek South Fork at Rosalind (N 61.14251, W 149.82368).

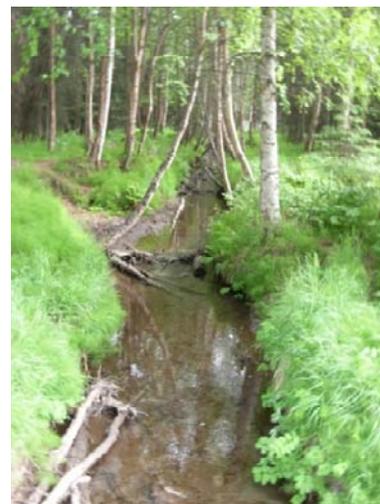
Photograph C21. Little Campbell Creek South Fork at 88th St. (N 61.14109, W 149.82150).

Land use is 100% residential. Riparian cover extends from the bank to over 5 m (Photograph C21).

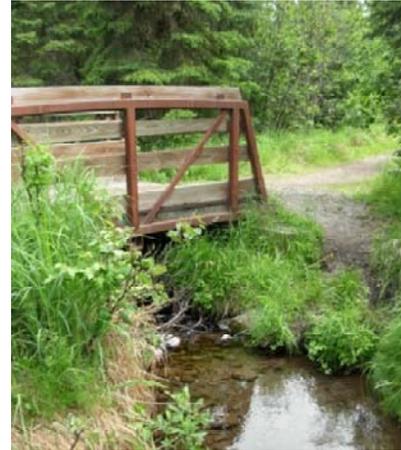
Photograph C22. Little Campbell Creek South Fork near Abbott Rd. (N61.08217, W 149.49226)

Land use is 100% undeveloped (forested). The section of the stream is in a park. A trail crosses the stream about a ¼ mile from the road via small footbridge (Photograph C22). Dog waste was observed near the trail and birds were observed in the stream (Photograph C23). The riparian cover open up near the bridge but is otherwise intact over 1 mile from stream edge.

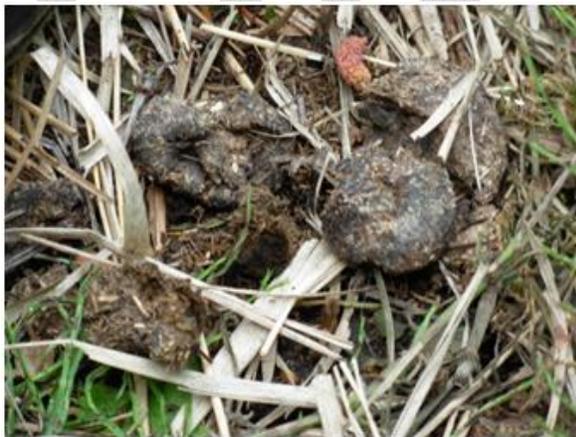
Photograph C23. Dog waste at Little Campbell Creek South Fork near Abbott Rd. (N 61.08217, W 149.49226).

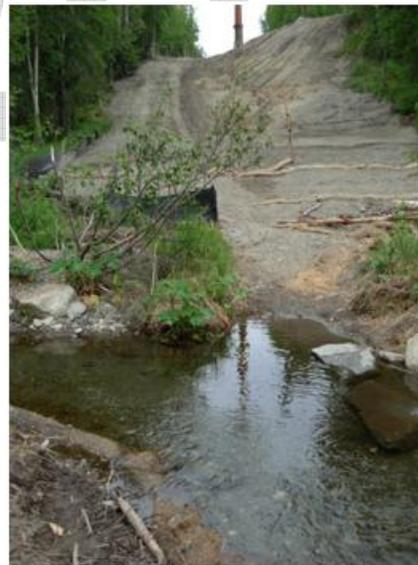
Photograph C24. Little Campbell Creek South Fork between Elmore Rd. and Elmore Rd. (N 61.13119, W 149.80435).

Land use is 85% undeveloped and 15% power line right of way. Riparian cover is lacking along the right of way of the power lines with evidence of recent alteration as restoration materials are new (Photograph C23). Beyond the right of way, riparian cover extends from the bank to over 1 mile (Photograph C24). Dog tracks were observed in the mud in the right of way crossing of the stream (Photograph C25). Horse activity is present in the area, however neither tracks nor waste were found directly near the stream. Possible sources of microbial input are equine and canine.

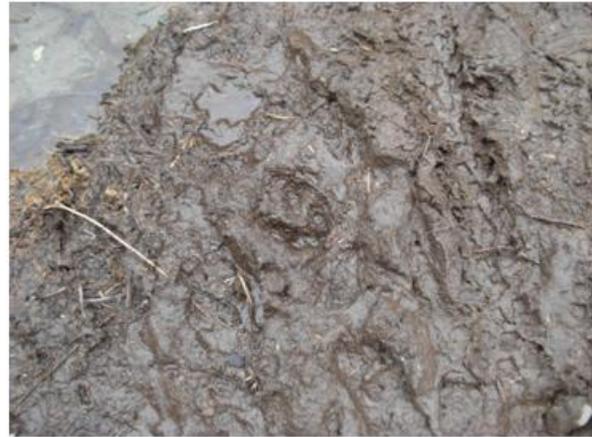
Photograph C26. Tracks in the mud on the banks of South Fork Little Campbell Creek between Elmore Rd. and Elmore Rd. (N 61.13119, W 149.80435).

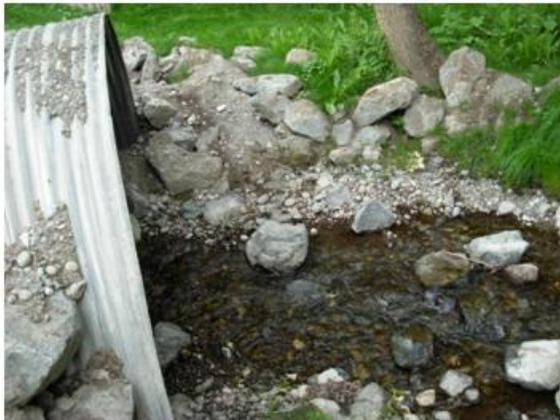
Photograph C27. Little Campbell Creek South Fork at Pacer Pl. between 102 and 104 Ave.

Land use is 100% residential. Stream flows under road through very large, newly installed culvert (Photograph C27). Upstream of culvert tree cover is good. Downstream, the understory of the riparian cover is impacted from residential use. Bird waste was observed on rocks near stream. Possible microbial source inputs are avian and canine.

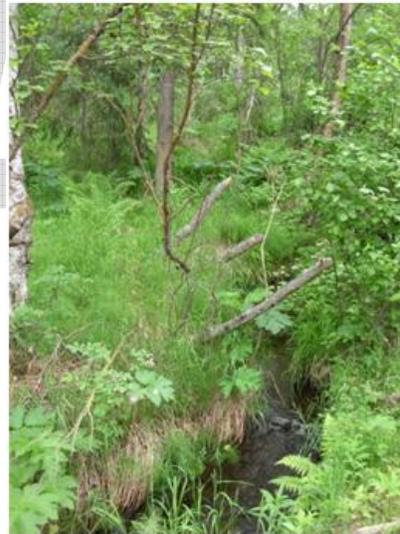
Photograph C28. Little Campbell Creek South Fork at 104th Ave. (N 61.12674, W 149.79466).

Land use is 100% residential and the creek flows through well forested private property with good riparian cover (Photograph 28). Upstream is an impoundment flowing into the creek (Photograph C29), a garbage dump, and a horse stable (Photograph C30). Garbage dump area is gravel that likely drains into the impoundment during rain events. A horse stable is directly adjacent to garbage dump and impoundment and also upstream of the stream. The stream further upstream was unable to be accessed due to a locked gate. Possible microbial contamination includes garbage, zoo animals, and equine sources.

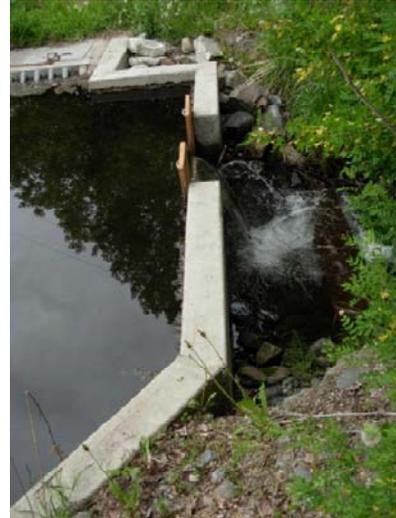
Photograph 29. Impoundment flowing into South Fork Little Campbell Creek at 104th Ave. (N 61.12643, W 149.79506).

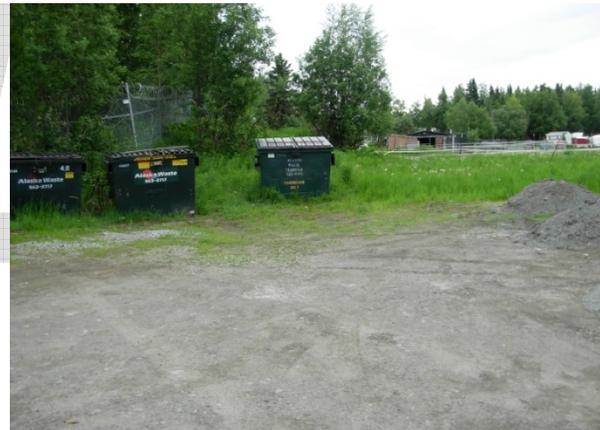
Photograph C30. Garbage site adjacent to South Fork Little Campbell Creek at 104th Ave. (N 61.12643, W 149.79506).

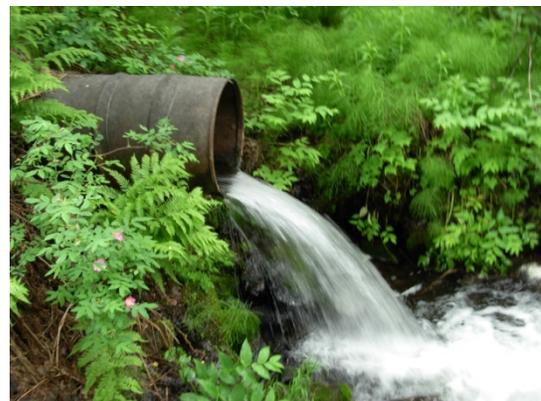
Land use is 100% residential. Stream crosses under road through culvert. Good riparian vegetation. A “no dogs” sign was present at stream edge. A pipe entered stream upstream of road crossing which drained a small impoundment, or duck pond (Photographs C31 and C32). Possible

Photograph 31. Pipe entering South Fork Little Campbell Creek at Our Rd. (N 61.12548, W

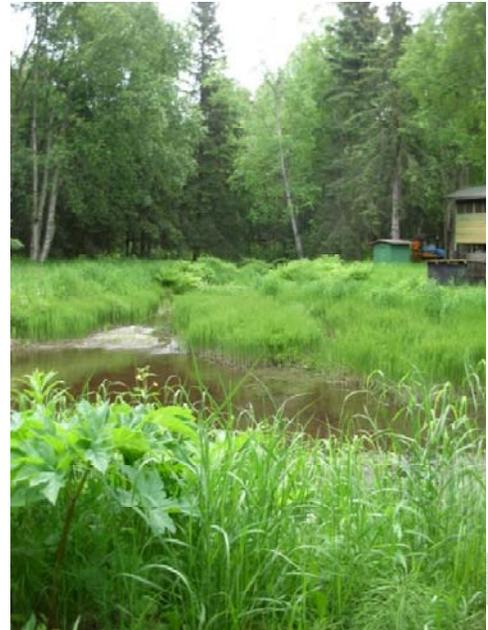
Photograph C32. Impoundment draining into to South Fork Little Campbell Creek at Our Rd. (N 61.12548, W 149.78923).

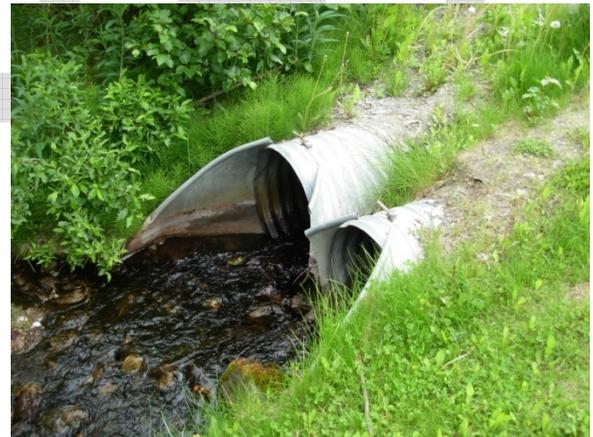
This is a very small creek that goes under the road through a double small culvert (Photograph C33). Land use is 100% residential. The riparian vegetation is mowed to the stream edge at the road crossing. There was evidence of bird waste at the stream edge. Microbial contamination possible from avian sources.

Photograph C33. Double culvert South Fork Little Campbell Creek at 104th Ave. (N 61.12643, W 149.79506).

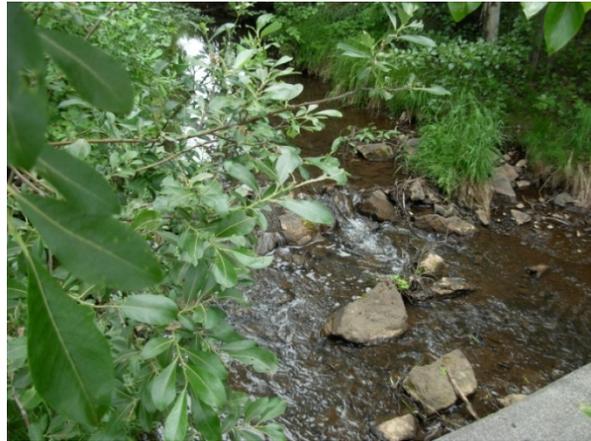
Photograph C36. North Fork Little Campbell Creek at Spring St off 74th Ave. (N 61.15411, W 149.86259).

Land use is 100% industrial. The creek goes under Spring St. through culverts and is fenced off completely up-and downstream of the road (Photograph C36). No obvious sources of microbial input.

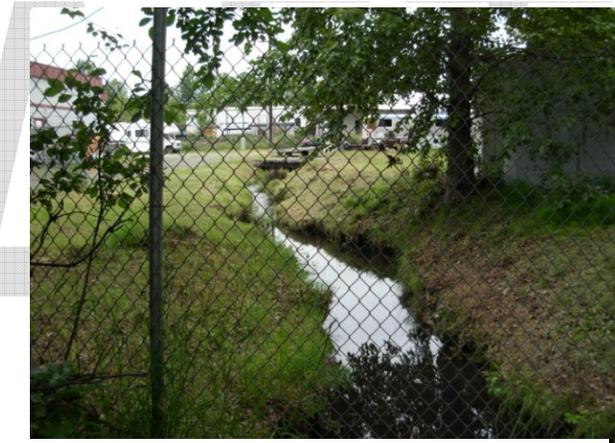
Photograph C37. North Fork Little Campbell Creek upstream from Briarwood and 72nd Ave. (N 61.15482, W 149.86055).

Land use is 50% industrial and 50% residential. Upstream of the road crossing the riparian vegetation is mowed to bank and the stream is slightly impounded (Photograph C37). A small bridge also crosses the stream upstream. Downstream of the road crossing (Photograph 38) the land is cleared adjacent to the stream used by domestic fowl (ducks and chickens). Ducks were observed in the stream. Possible sources of microbial input are avian.

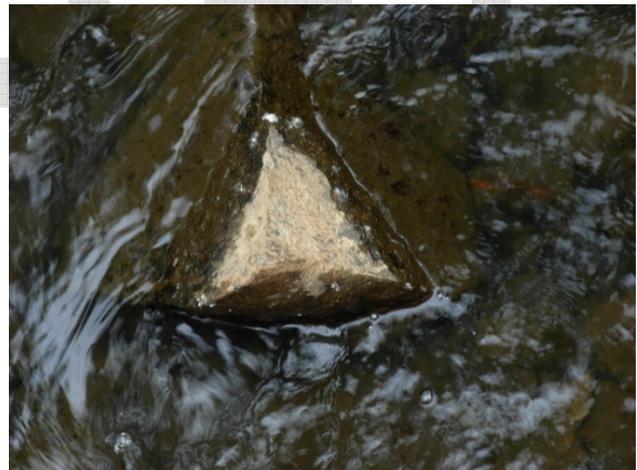
Land use is 50% industrial and 50% residential. Upstream of the road crossing bird waste was observed in and around the stream (Photograph C39) and riparian

Photograph C39. Bird waste in North Fork Little Campbell Creek at Briarwood between 71st and 72nd Aves. (N 61.15553, W 149.86017).

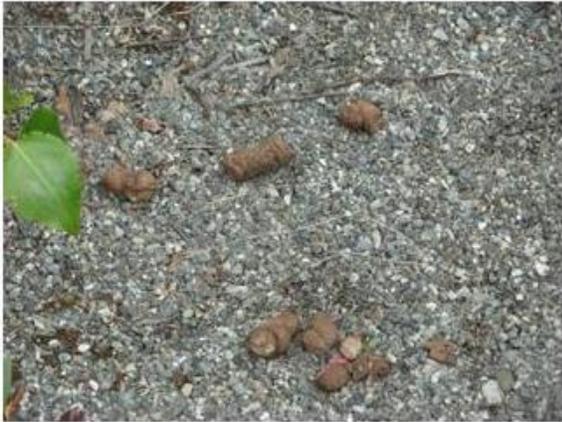
Land use is 100% industrial. Riparian vegetation extends to 2-3 m from stream. Dog waste (Photograph C40) observed at stream crossing contributing to microbial input.

Photograph C40 Dog waste in North Fork Little Campbell Creek at Driftwood (N 61.15643, W 149.85742).

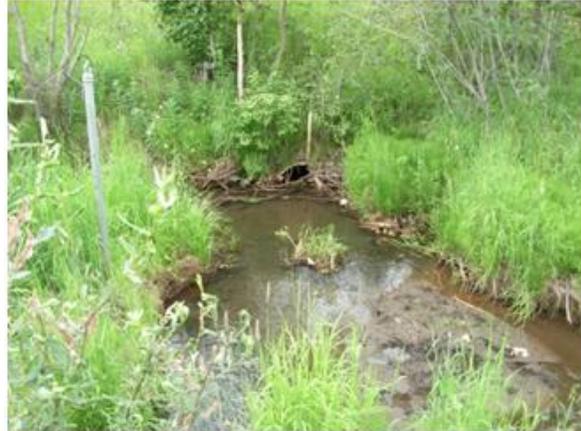
Photograph C41. North Fork Little Campbell Creek at Brayton Dr. (N 61.15849, W 149.85468)

Land use is 100% commercial. The riparian vegetation is intact (Photograph C41). Downstream of the road crossing there are burms/abutments to stop parking lot run off from entering the stream. No apparent fecal sources.

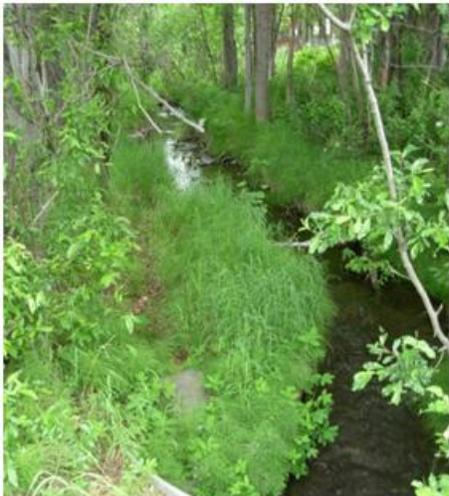
Photograph C42. North Fork Little Campbell Creek at 68th and Brayton Dr. (N 61.15911, W 149.85474).

Land use is 100% industrial. The riparian vegetation is intact (Photograph C42). No apparent fecal sources.

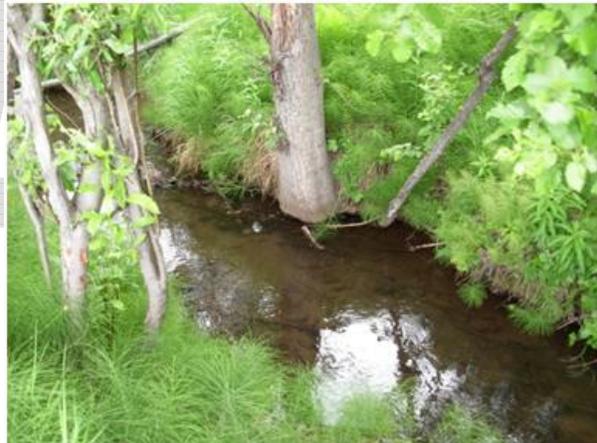
Photograph C43. North Fork Little Campbell Creek at 66th Ave. (N 61.16113, W 149.83652)

Land use is 90% residential and 10% industrial. The riparian vegetation is intact along road (Photograph C43). No apparent fecal sources found.

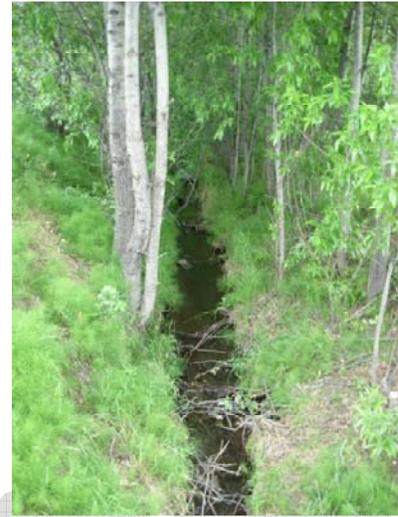
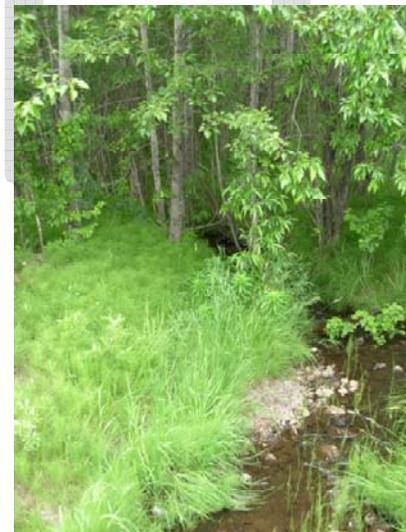
Photograph C44. North Branch North Fork Little Campbell Creek upstream from Lake Otis Parkway (N 61.16116, W 149.83459)

Land use is 70% commercial and 30% forested. Up- and downstream the riparian vegetation is intact (Photographs C44 and C45). Some trash was seen in the stream downstream of road crossing. No apparent fecal sources found.

Photograph C45. North Branch North Fork Little Campbell Creek downstream from Lake Otis Parkway (N 61.16116, W 149.83459)

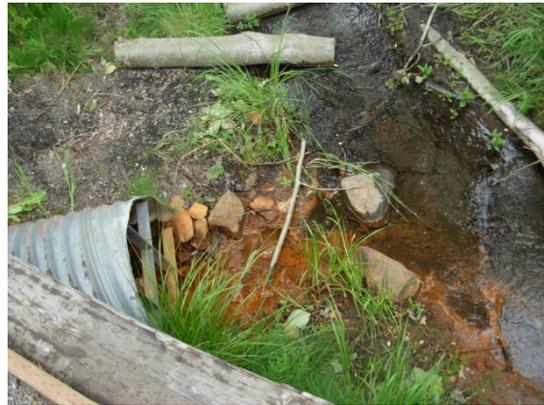
Land use is 100% residential. Riparian vegetation is good from 0-2 m along stream. Downstream, a pipe enters the stream with a heavy iron load (Photograph C46). A storm water pipe also enters the stream. A large pond with geese and ducks empties into creek (Photographs C47 and C48). Heavy human recreational use is in the area. An unknown animal fecal source was found. Possible fecal sources are canine and avian.

Photograph C46. Pipe entering the North Branch North Fork at Tiffany Terrace (N 61.16126, W 149.82513)

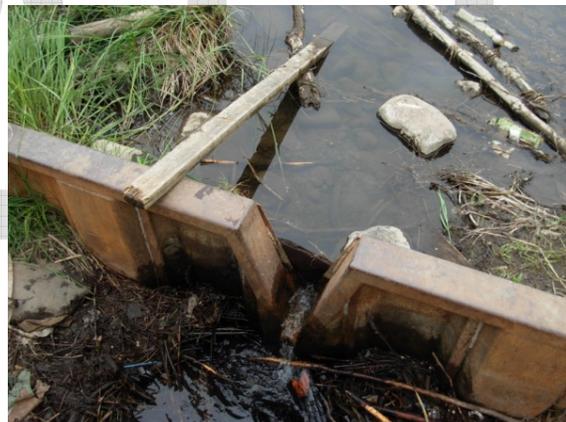
Photograph C47. Impoundment outflow into the North Branch North Fork at Tiffany Terrace (N 61.16126, W 149.82513).

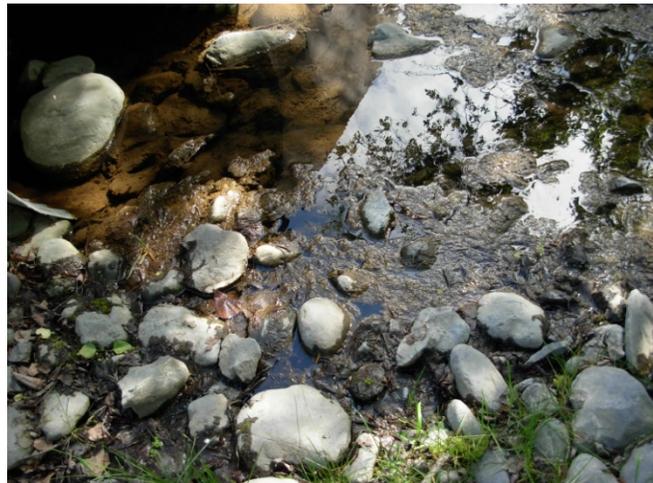
Photograph C49. North Branch North Fork Little Campbell Creek downstream of Elmore between 68th and 72nd Ave. (N 61.15741, W 149.80455).

Downstream of the road crossing land use is 50% residential and 50% undeveloped (forested). Riparian cover good with lots of macrophytes in stream channel. Algal growth is apparent at mouth of culvert. Upstream of road crossing the land use is 100% undeveloped (forested). The stream opens upstream of Elmore Road, expanding into open wetland area forested with spruce. Waterfowl waste was found near creek (Figure C49). Storm drain empties into creek.

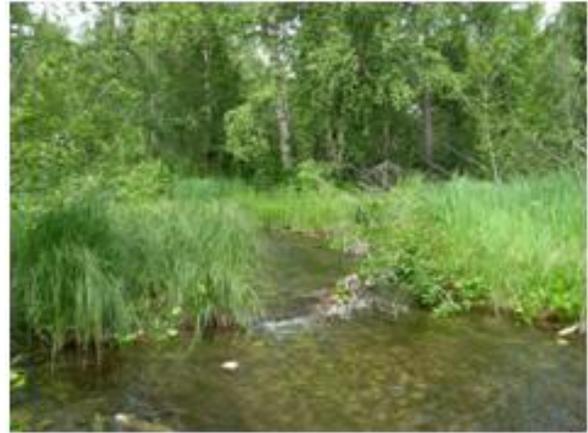
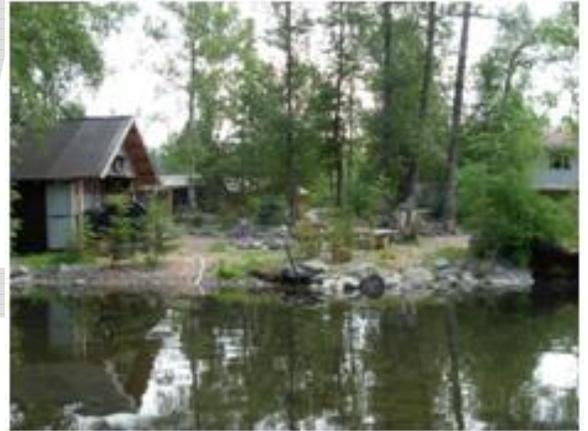
Photograph C51. Cottonwood Creek between Wasilla Lake and Parks Highway (between N 61.58025, W 149.39657 and N 61.57790, W 149.40009).

The land use is 50% residential and 50% commercial (Photographs C51 and C52). The stream is impounded at the Parks Highway bridge crossing (Photograph C53). The riparian vegetation is altered to the streambank in some areas. Avian waste was observed (Photograph C54).

Photograph C52. Cottonwood Creek between Wasilla Lake and Parks Highway (N 61.58025, W 149.39657).

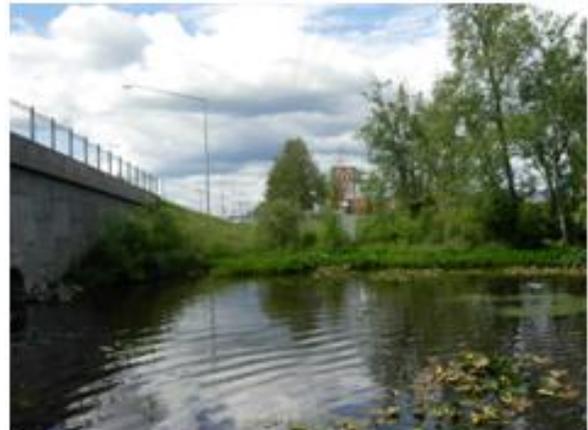
Photograph C53. Cottonwood Creek at the Parks highway (N 61. 57556, W 149. 40347).

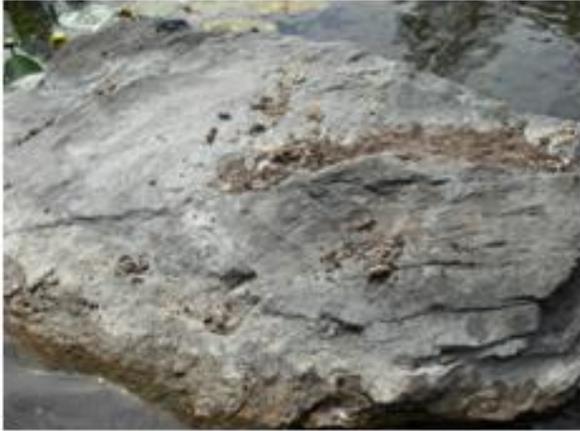
Photograph C54. Avian waste on a rock in Cottonwood Creek (N 61.57613, W 149.40260).

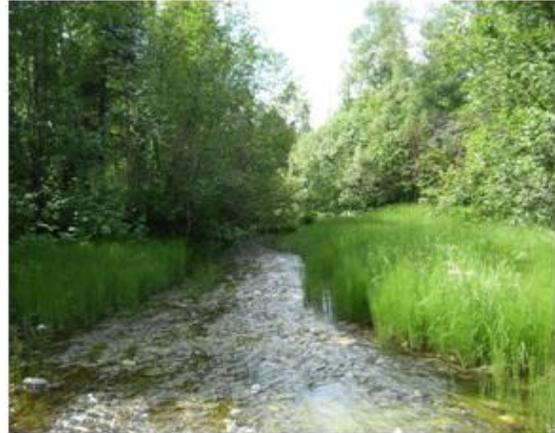
Photograph C55. Cottonwood Creek upstream from Old Matanuska Rd

The land use is 100% commercial. The riparian vegetation is intact along most of the streambank and macrophytes are abundant in the stream channel (Photographs C55).

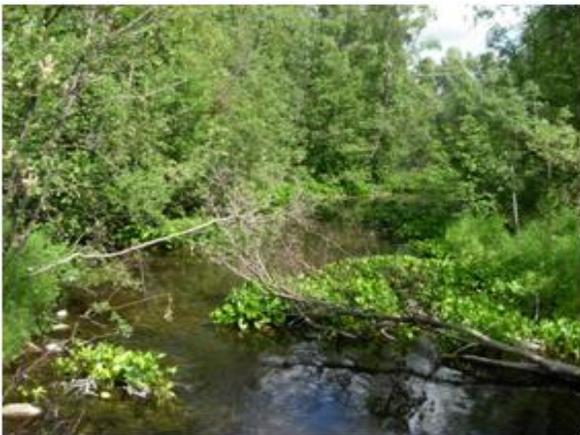
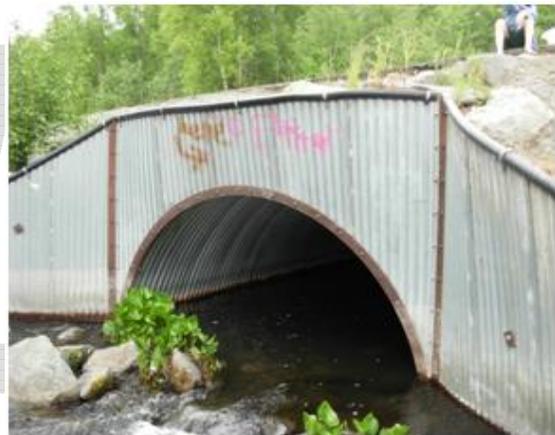
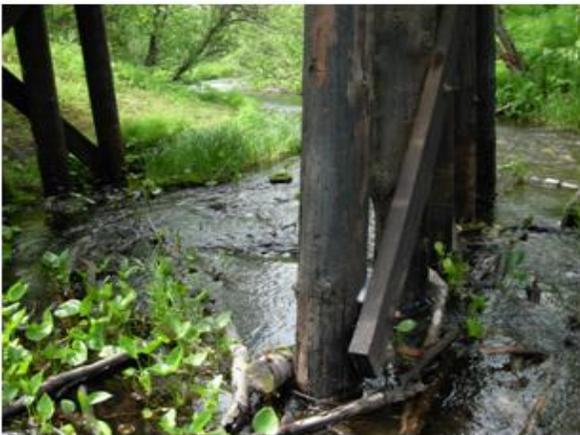
Photograph C56. Cottonwood Creek downstream from Old Matanuska Rd.

Photograph C57. Cottonwood Creek at Glenwood.

Photograph C58. ARR crossing of Cottonwood Creek upstream of Glenwood.

The land use is 100% residential. The riparian vegetation is altered to the streambank in several places. Macrophytes are abundant in the stream channel (Photograph C56, C57 and C58). Algae cover many rocks in the stream as well. There is a vehicle stream crossing upstream of Glenwood. Foam is present (Photograph C59). Fresh dead mussel shells were observed. Some trash was in the stream. Possible sources of microbial input are canine, avian and human.

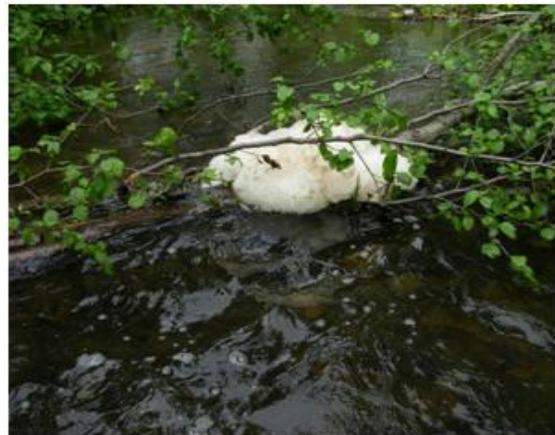
Photograph C59. Foam in Cottonwood Creek between Old Matanuska Rd and Glenwood.

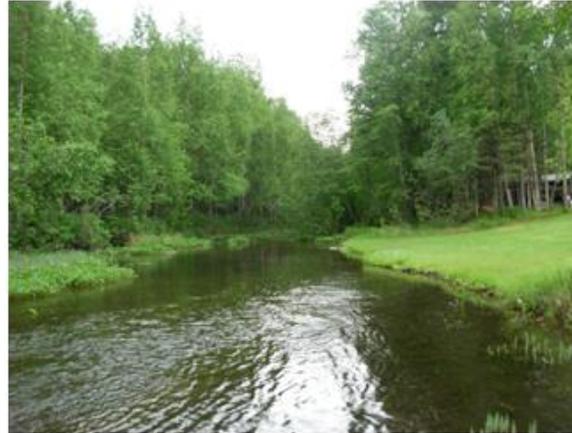
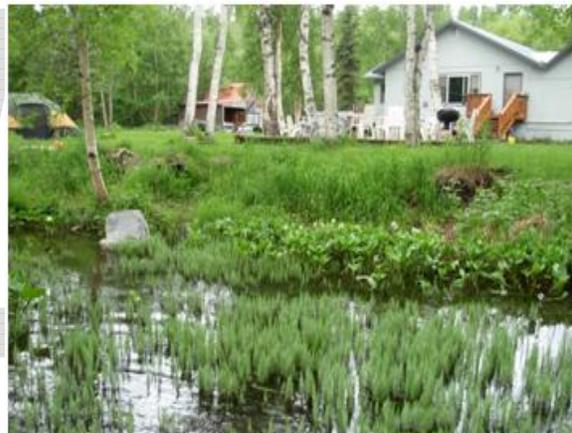
Photograph C60. Cottonwood Creek between Glenwood Ave and Fern St.

The land use is 100% residential. The riparian vegetation is altered to the stream bank in several places (Photograph C60 and C61). Macrophytes are abundant in the stream channel (Photograph C62).

Photograph C61. Cottonwood Creek between Glenwood Ave. and Fern St.

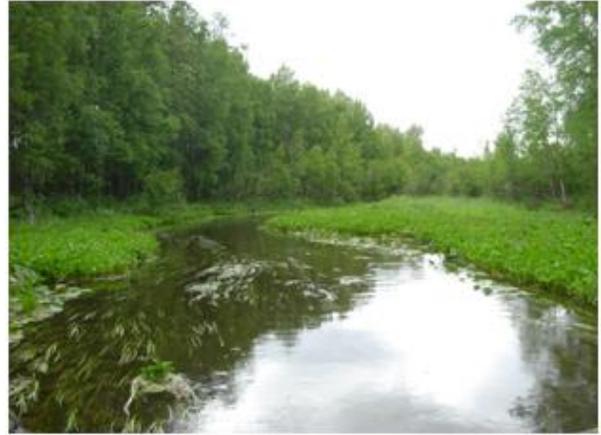
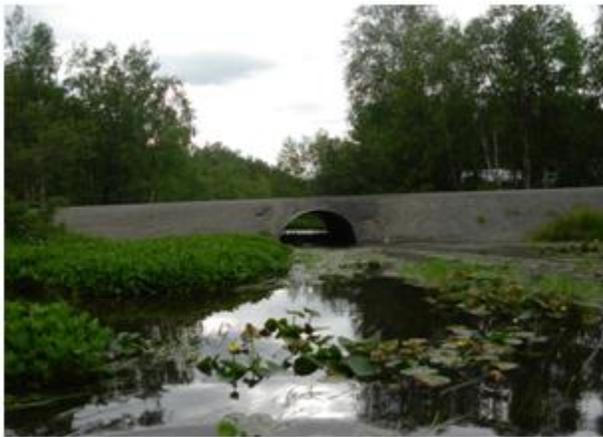
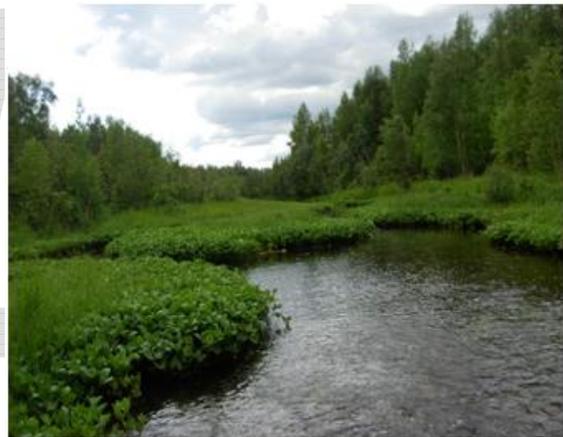
The land use is 90% undeveloped and 10% residential. Macrophytes are abundant in the stream channel (Photographs C63 to C65). The riparian vegetation is altered to the streambank in several places including a full sized vehicle stream crossing (Photograph C66).

Photograph C63. Macrophytes in Cottonwood Creek upstream from Fern St.

Photograph C64. Macrophytes in Cottonwood Creek at Fern St (N 61.55440 W 149.48815).

Photograph C65. Cottonwood Creek between Fern St. and Edlund Rd.

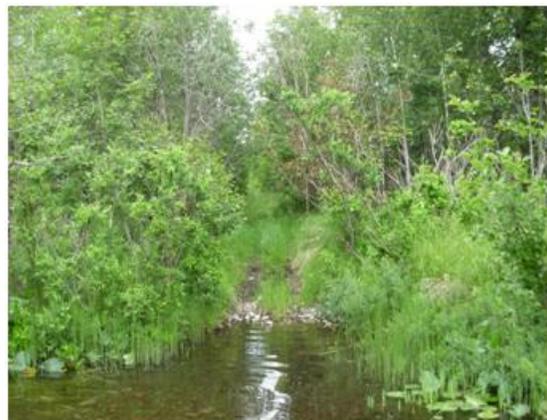
Photograph C66. Full sized vehicle crossing on Cottonwood Creek between Fern St and Edlund (N 61.55885, W 149. 46029).

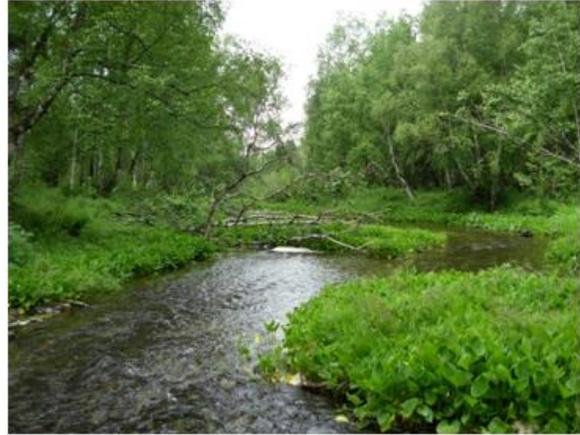
Photograph C67. Cottonwood Creek between Edlund Road and Marble Way.

The land use is 70% undeveloped and 30% residential. The riparian vegetation is altered to the streambank in several places. Macrophytes are abundant in the stream channel (Photographs C67 and C68). Some trash and foam were observed. No apparent sources of microbial input observed.

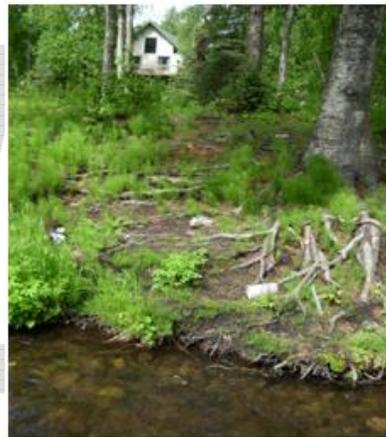
Photograph C69. Cottonwood Creek between Marble Way and Riverdell Drive.

The land use is 100% residential. The riparian vegetation is altered to the stream bank in several places (Photograph C69). Macrophytes and some trash are abundant in the stream channel. A moose carcass was in the stream channel (Photograph C70). Sources of microbial input are from birds or moose.

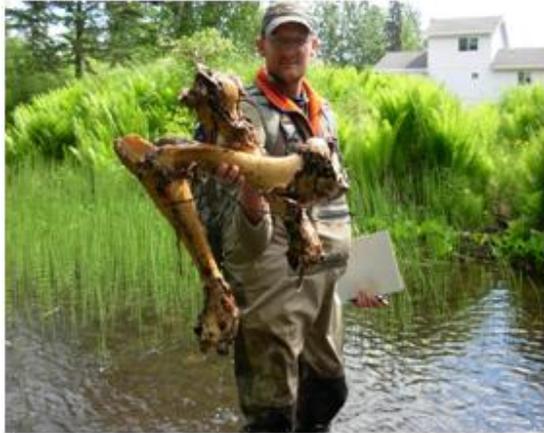
Photograph C70. Moose carcass in Cottonwood Creek between Marble Way and Riverdell (N 61.53271, W 149. 52631).

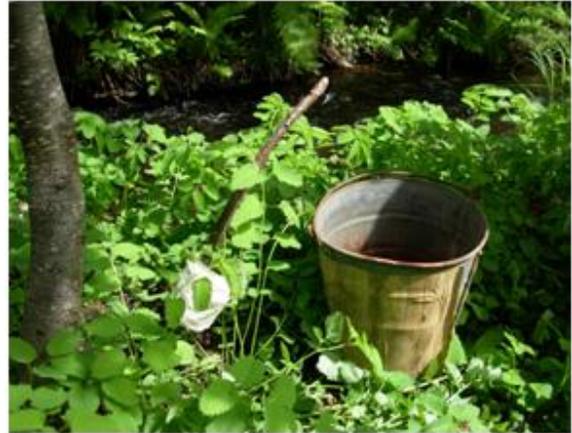
The land use is 100% residential. Macrophytes and foam are abundant in the stream channel. A bucket with toilet paper was found near the stream channel possibly contributing to microbial contamination (Photograph C71).

Photograph C71. Latrine at Cottonwood Creek between Riverdell and Fairview Loop (N 61.53028 W 149.52746).

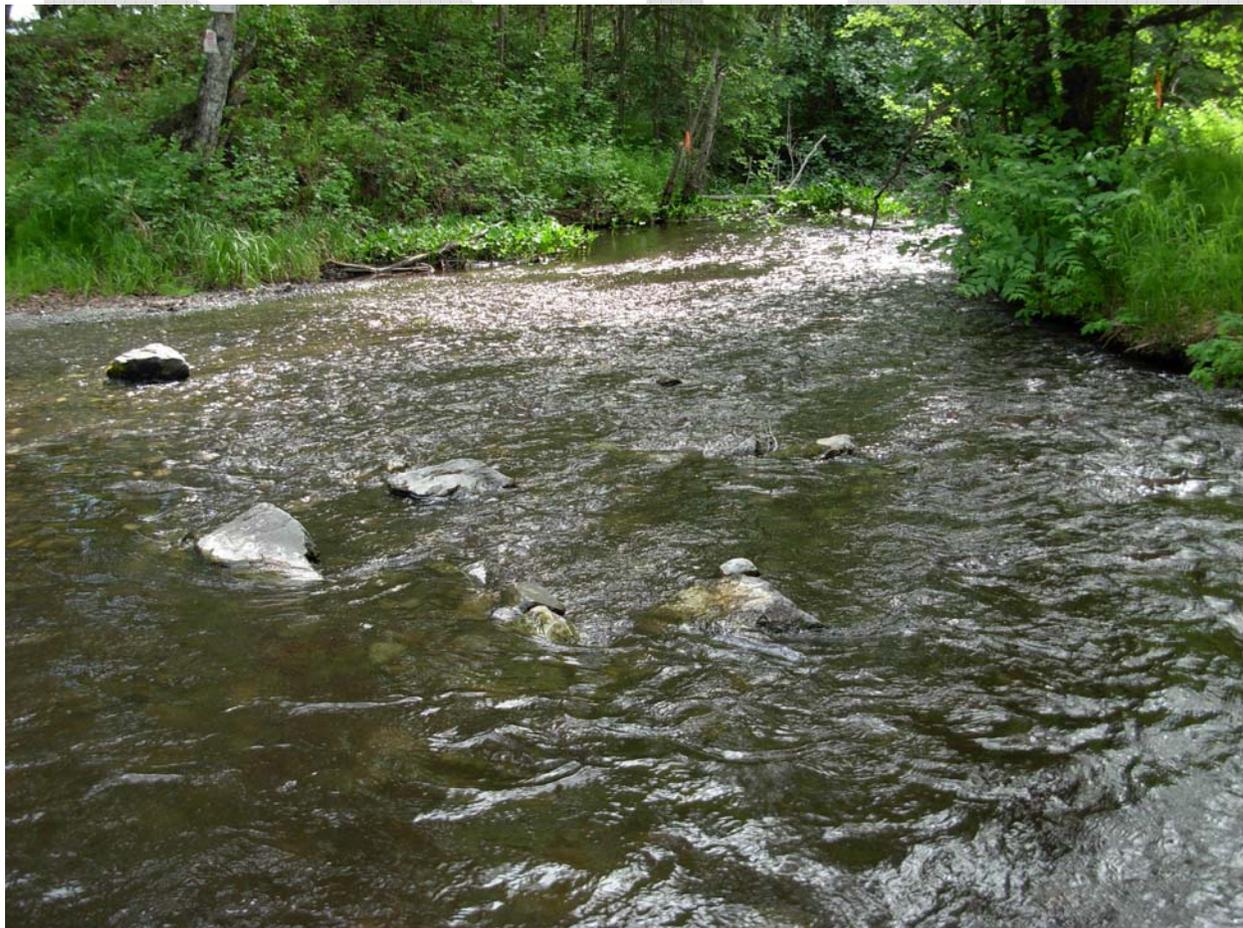
Photograph C72. Cottonwood Creek downstream from Fairview Loop showing intact riparian and lack of development.

The land use is primarily undeveloped with some residential development (Photograph C72). No apparent microbial sources observed.
