**VOLUME 1**  
**REVISED FINAL CLEAN-UP REPORT**  
**ICY BAY WEST CAMP #1**

**DMC Technologies  
3528 West Hwy. 33  
Rexburg, ID 83440**

*May 24, 2004*

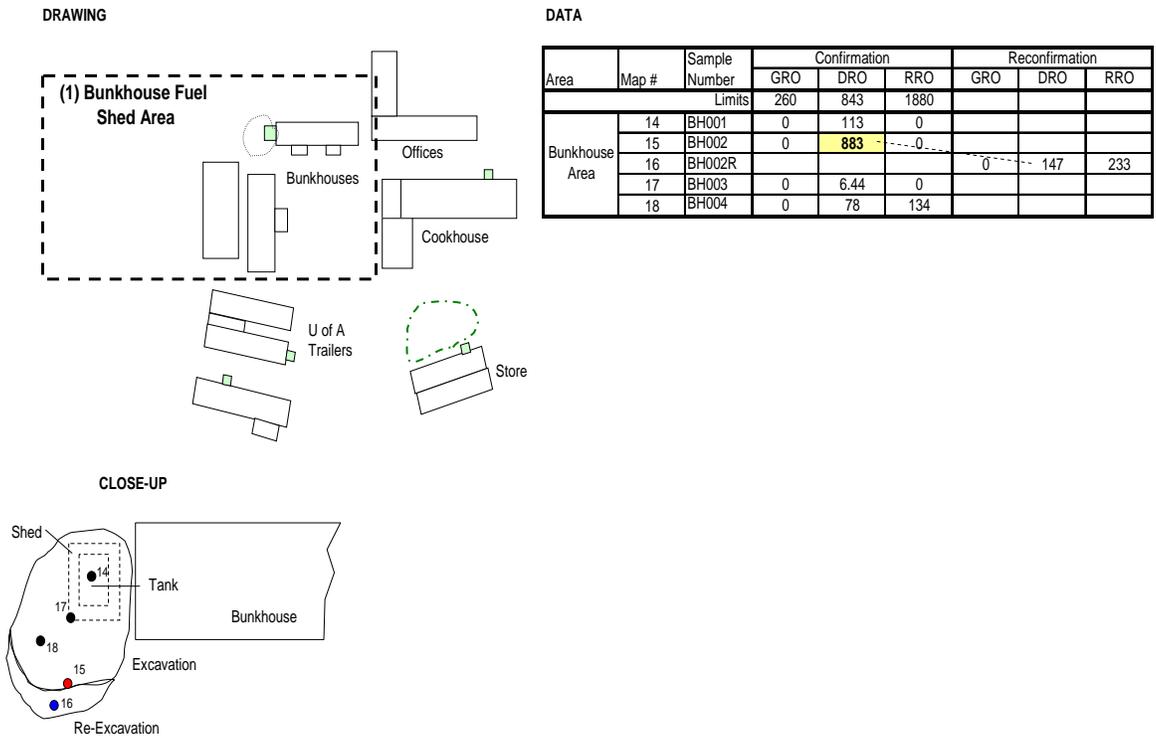
Figure 14. Bunkhouse Fuel Tank Area Excavation and Sampling

The bunkhouse fuel tank shed was characterized in June 2002. At initial inspection both filter and connection lines were noted to be unprotected (no underlying liner). Two samples indicated the presence of DRO at a concentration of 8,600 ppm. An area 15 ft. x 20 ft. to a depth of 4 ft. was estimated for clean-up.

The fuel shed and tank were removed in May allowing complete access for excavation. Excavation was performed on 8/23/03 and resulted in the removal of 122 CY of contaminated soil. Excavation completed at the water table at a depth of 6 ft. BGS. Five confirmation samples and one reconfirmation sample were collected. Figure 10 illustrates the excavation area.

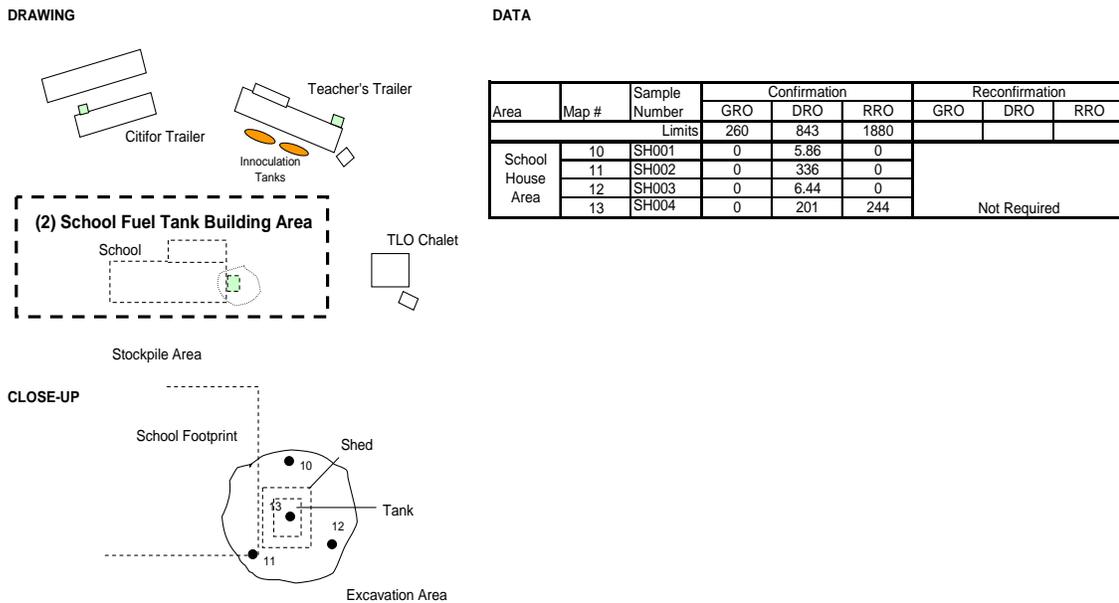
Figure 15. School Fuel Tank Building Area

The school fuel tank shed was inspected June 2002. Staining and a removal of the liner underlying the tank in the shed created suspicion of contamination. A sample collected near the tank under the liner indicated DRO concentrations of 9,300 ppm. It was estimated that an area 10 ft. x 20 ft. would need to be excavated to a depth of 6 feet to remove the contamination.

The fuel shed and tank were removed in May and the school was burned to the ground on August 5, 2003 allowing complete access for excavation. Excavation was performed on 8/23/03 and resulted in the removal of 95 CY of contaminated soil. Excavation completed at the water table at a depth of 6 ft. BGS. Four confirmation samples were collected. Figure 11 illustrates the excavation area.

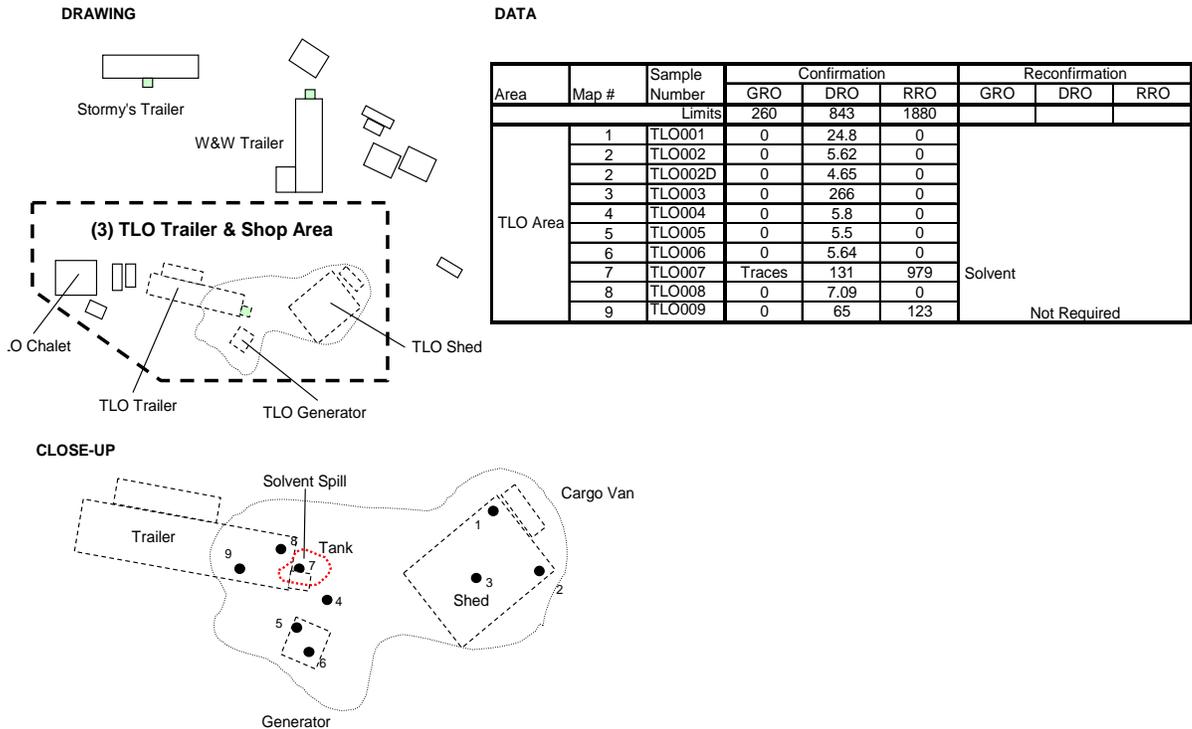
Figure 16. TLO Trailer and Shop Area

The TLO area was inspected June 2002. The Chalet was found to be clean. The trailer was found to be contaminated at the fuel tank shed on the end of trailer. A fuel shed sample noted a DRO contamination of 18,000 and 6,800 ppm. The contaminated area was estimated to be 30 feet square and 10 feet deep. The TLO shop was investigated and a sample collected from under the trap door through the wooden floor on the west half indicated both DRO and RRO contamination (5,500 ppm and 23,000 ppm respectively). It was estimated that an approximate 10 foot square area to a depth of 6 foot would need to be removed.

The Trailer, Shed and Generator Shack were removed and demolished in August 2003 allowing complete access for excavation. Excavation was performed on 8/23/03 and resulted in the removal of 326 CY of contaminated soil and 22 CY of solvent contaminated soil (from the west end of the trailer – likely dumped on the ground from the shop during maintenance). The excavation appears large in size the figure since much surface soil was removed. The deepest portion of the excavation was under the garage and at the trailer corner (6 ft.) where excavation completed at the water table to a depth of 6 ft. BGS. Nine confirmation samples were collected including two samples from the area contaminated with solvents. Figure 11 illustrates the excavation area.

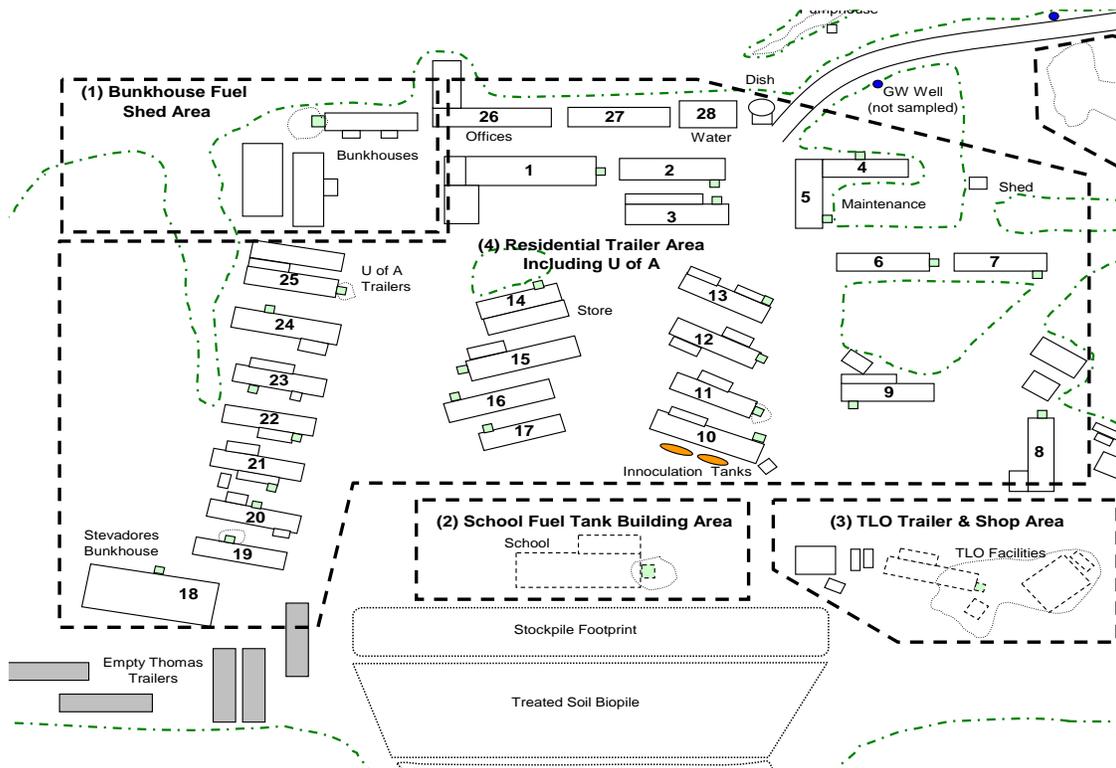
Figure 17. Residential Area Buildings and Trailers of Concern

In June, 2002 the residential area of Camp #1 was evaluated. 12 of the 20 buildings/trailers area in the area were inspected. The fuel oils systems servicing the facilities were found to be in relatively good condition with little visual contamination present in lined traps under the elevated tanks. Soil samples were collected from 6 trailers and no contamination was detected. A recommendation for future investigation was made prior to final camp closure to ensure that all trailer environments were free of contaminants. It is important that this action be taken since noted contamination was not removed.

Additional investigation was performed in July, 2003 as remediation efforts were underway with results reported in the table following the figure. Figure 13 illustrates the buildings/trailers of interest:

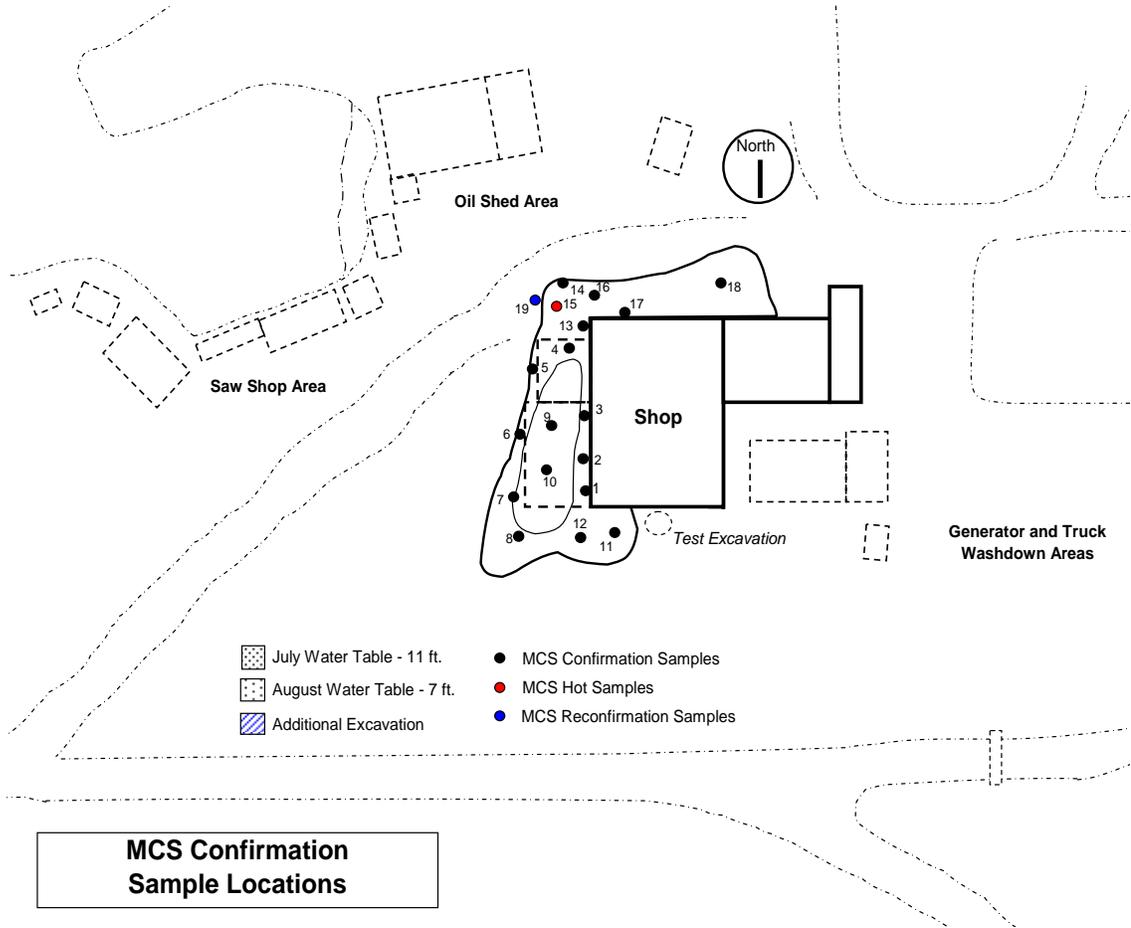
Figure 21. Shop (MCS) Excavation and Confirmation Sampling

Excavations in and around the shop were performed on 8/16, 8/18-8/21 and on 8/23 resulting in the removal of 1,240 CY. The more extensive excavations followed the building footprint pattern shown. The following figure illustrates excavations in and around the shop

As excavations proceeded on the north end of the shop it was apparent that soil contamination was wrapping around the northwest corner and along the west side of the shop. Although not previously characterized as an excavation area, the west side of the shop exhibited contamination and excavation proceeded along the west of the shop to the excavations at the front of the shop. Excavations reached 9 feet in depth and extended 2 feet below the water table. 1 characterization sample (west side), 18 confirmation samples and 1 reconfirmation sample were collected supporting remediation.

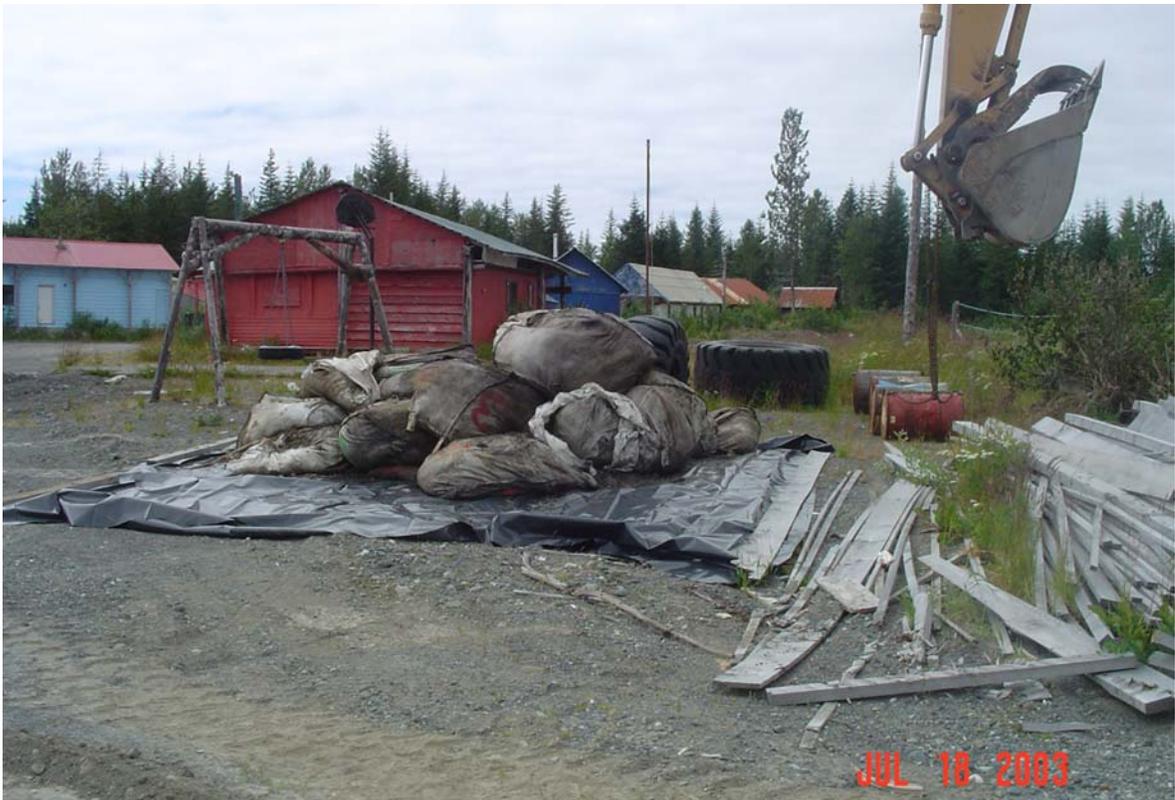
Figure 22. Contaminated Soil in Supersacks Staged for Bioremediation

Each sack and drum was inspected to ensure that the sack only contained petroleum contaminated soil. The Camp Manager was helpful in identifying the various types of materials in numbered sacks and drums. The sacks contained approximately 14 CY of contaminated soil.

The soils and liquid were evenly spread across the top of the stockpile prior to bionutrient and inoculants addition. After dosing the materials were tilled into the lift and effectively treated. Empty drums were returned to the shop and empty toe sacks were burned with the Icy Bay School. The following figures show the staged location of the bags and drums prior to placement on the stockpile.

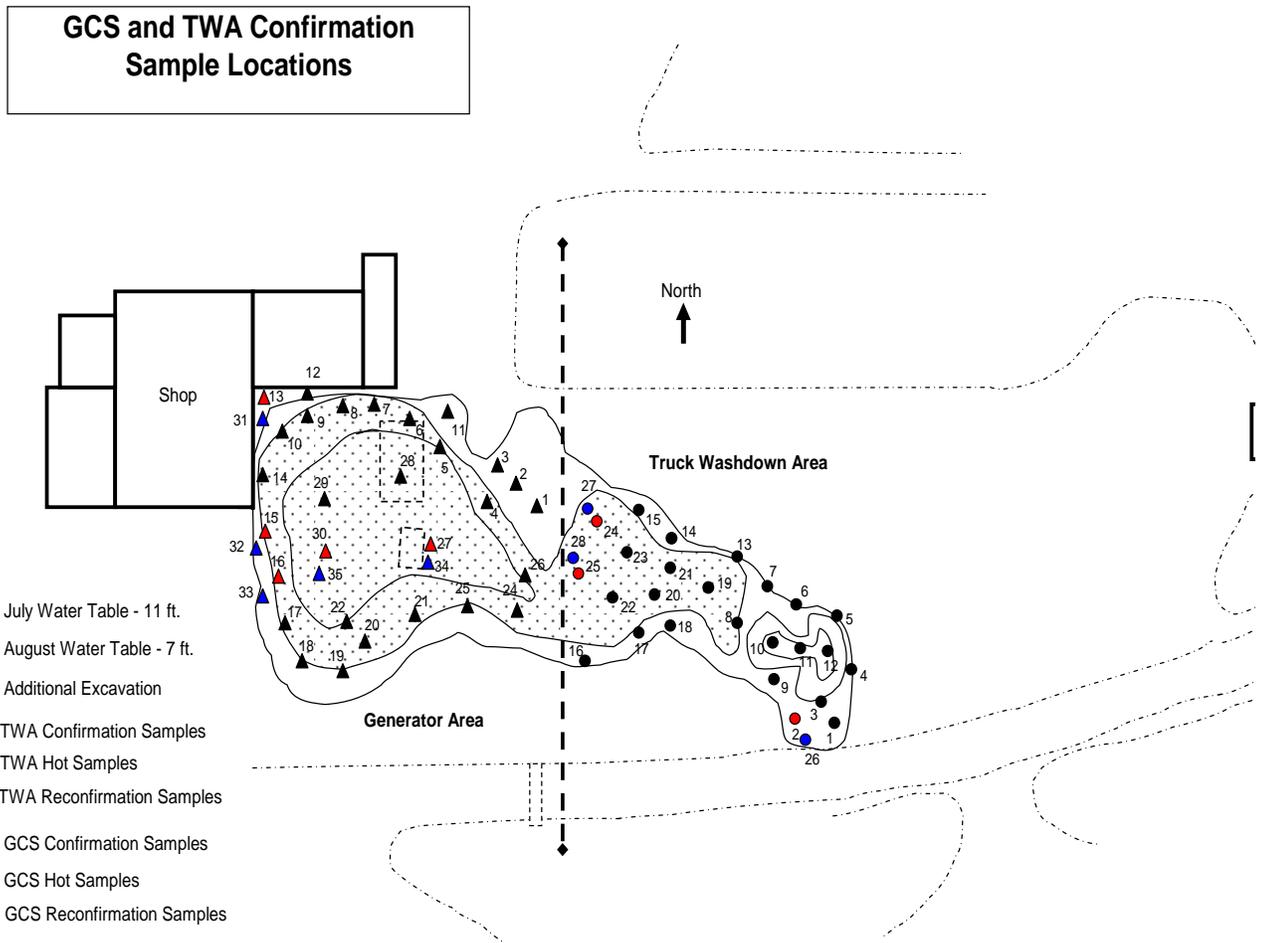
Figure 24. Generator Area (GCS) and Truck Washdown Area (TWA) Excavation and Confirmation Sampling Data

Traces of residual oil were detected on the water surface of the excavation after excavations were completed and considered clean. The surface of the water exhibited a bright sheen. Within 24 hours the sheen and any traces of residual oil were no longer visible. 39 confirmation samples were then collected.

The west bank of the excavation along and including the southeast corner of the shop, bottom of the excavation and a small corner of the shop were not found to be clean and new excavations were performed. The remaining smear band in the area was removed and the bottom of the pond deepened. Samples of the smear band were collected for characterization. The excavation proceeded as far under the building as prudent without risking damage the structure. 6 reconfirmation samples were collected. Results of excavation and sampling are noted the following figure and table.

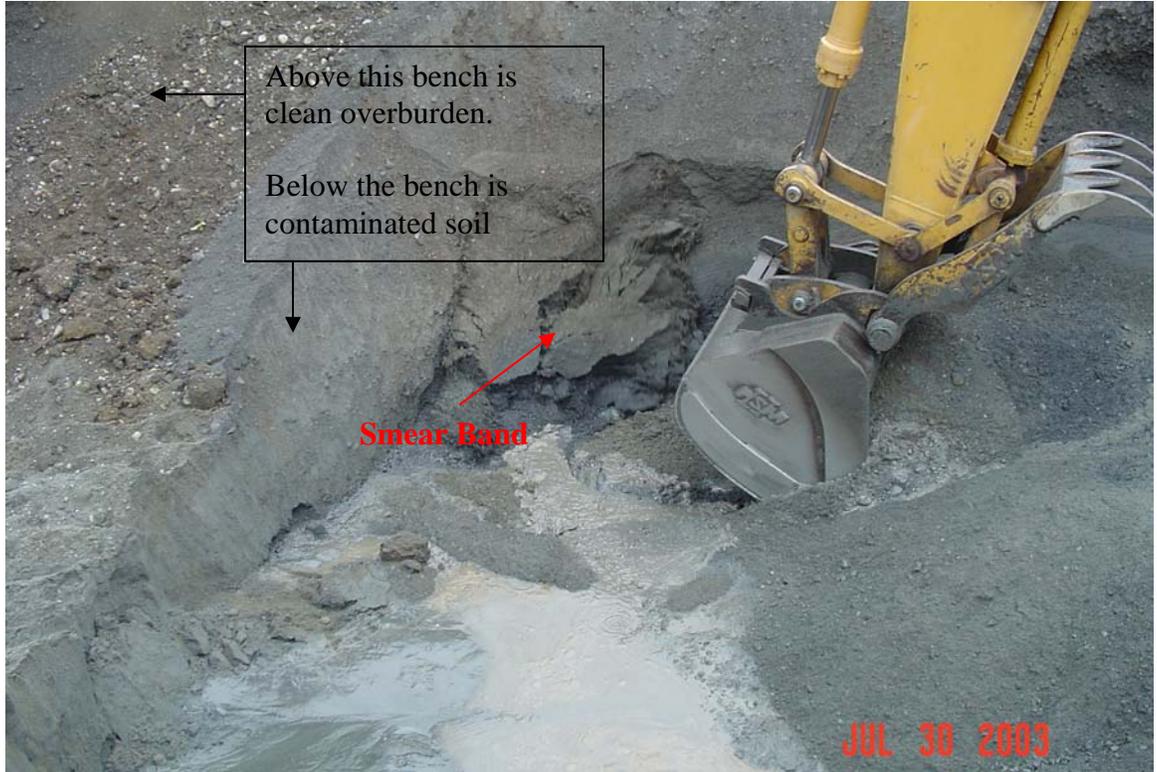
Excavations surrounding the water table identified a 6"-12" thick black band of sand & gravel saturated in motor oil. Contaminated and discolored soil also extended above and below the smear band for several feet. Free oil was visible in the interstitial spaces of the sample media and was easily released to the water creating a black slick. The following photos illustrate field observations:

Figure 25. Smear Band Excavation at the Oil Shed

Because of the presence of the smear band at the Generator Shed excavation and again at the Oil Shed, it was determined that complete smear band removal would be necessary in order to eliminate the need for future groundwater monitoring. Accordingly, large volumes of clean overburden were removed from the area to allow access and removal of the smear band with associated underlying and overlying layers of contamination. This effort is discussed further in the groundwater section of this report.

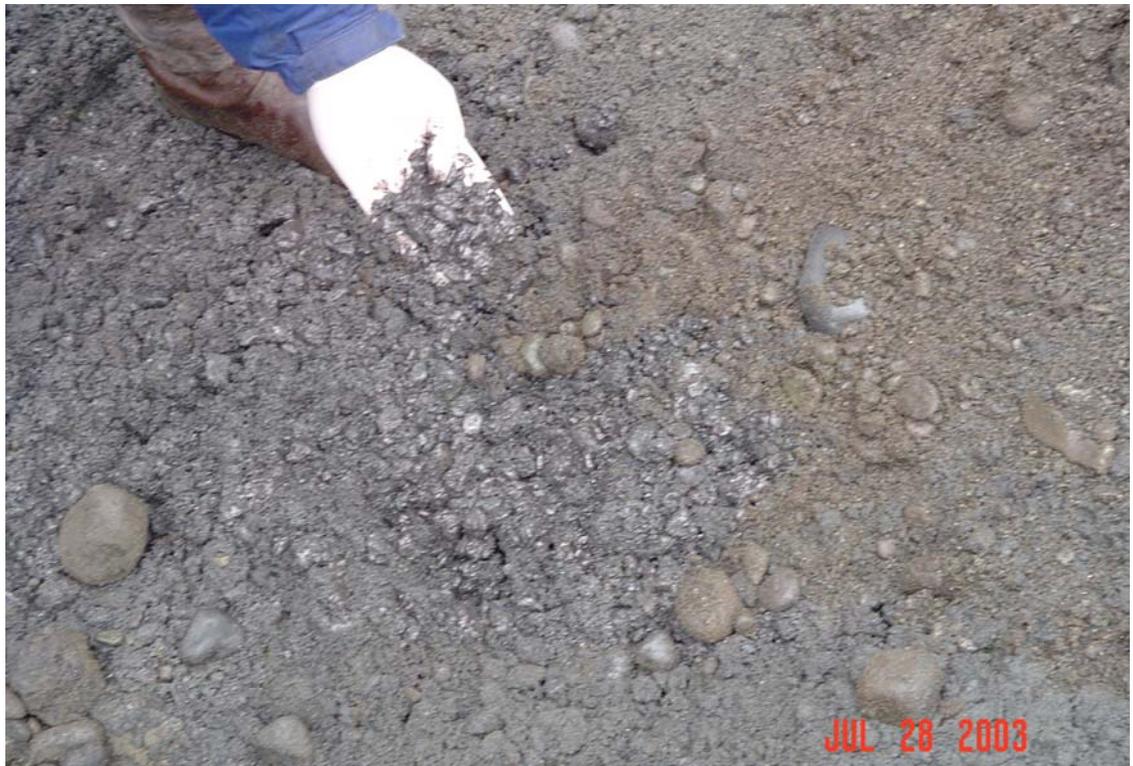
Figure 26. Excavated Smear Band Material at the Oil Shed Containing Motor Oil

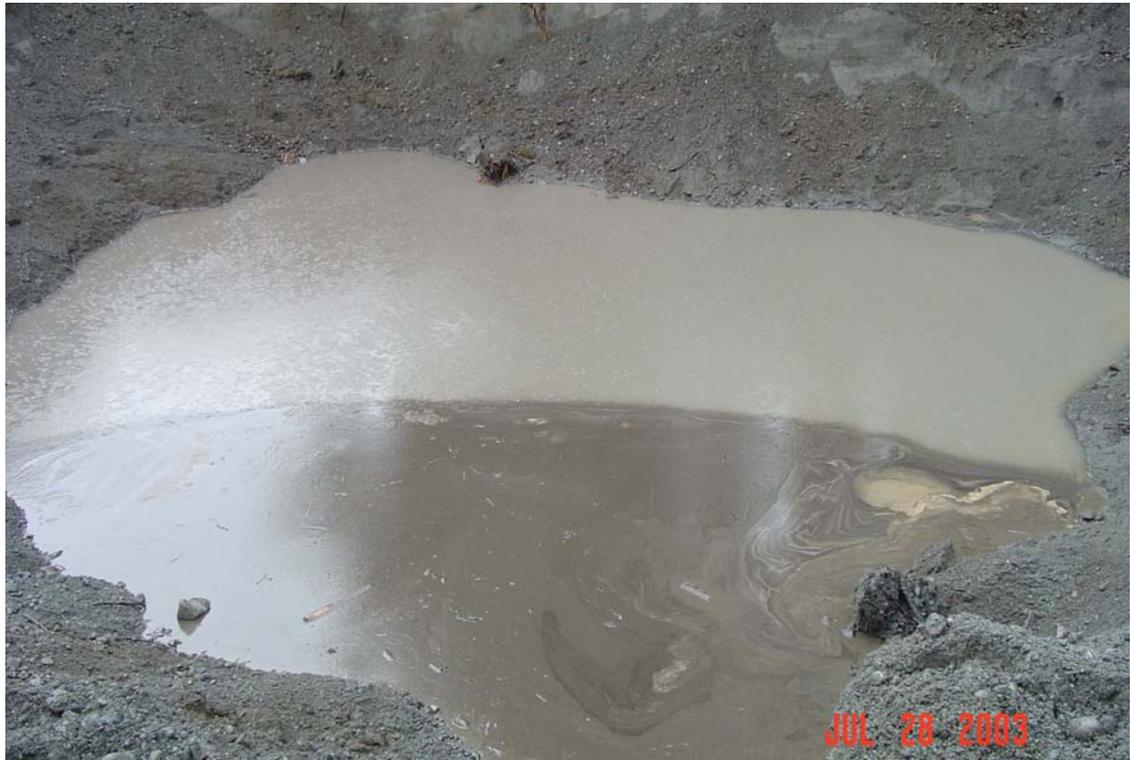
Figure 27. Motor Oil Released on Water Table From Smear Band Excavation

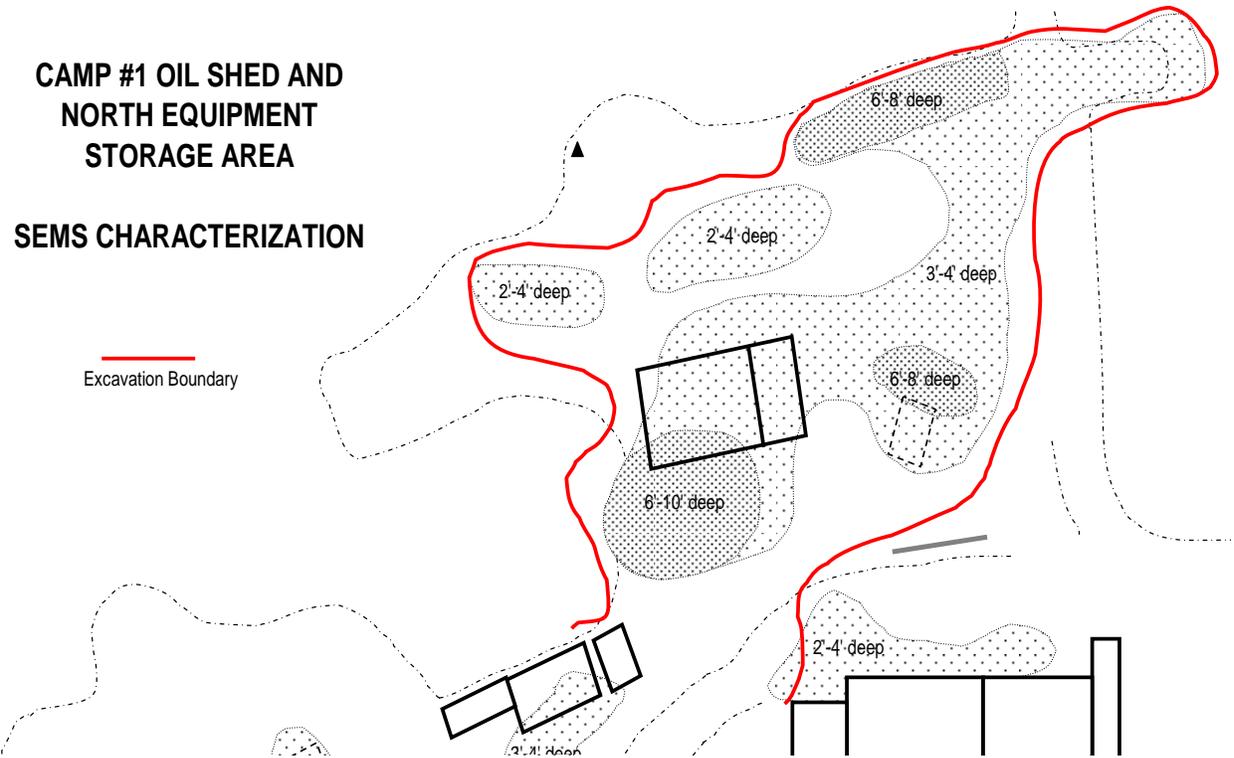
Figure 31. Excavation Boundary Associated With Oil Shed and North Equipment Parking Area Relative to Characterization

Adequate excavation coverage was provided to ensure that all the areas identified in the characterization report were addressed as noted below. General excavation and two sessions of re-excavation were performed to ensure all contaminated soils were removed.

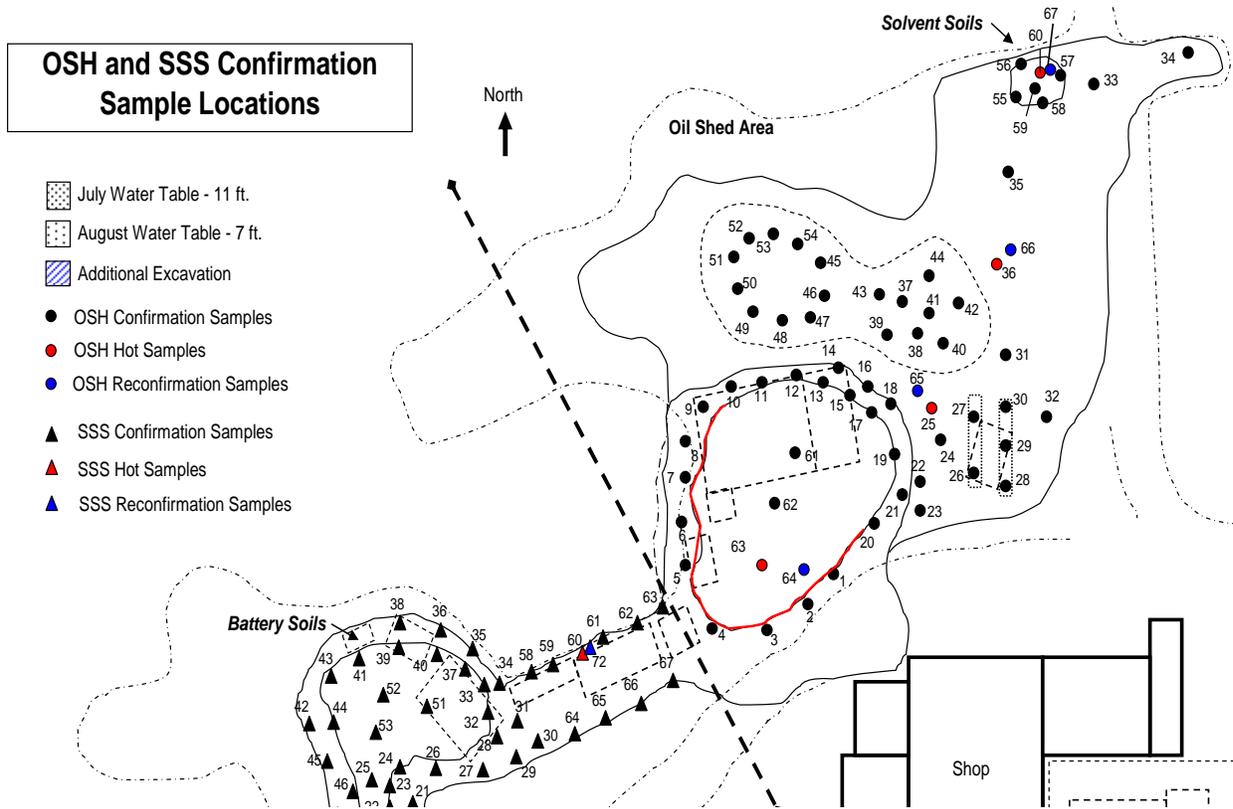
Figure 32. Oil Shed and North Equipment Storage Area Confirmation Sampling

As noted from the sample data illustrated, the bottom of the south end of the excavation and the associated eastern sidewall failed to initially remove contaminants. The north sidewall of the narrow excavation neck connecting to the oil shed excavation also required additional excavation. Following repeated excavation, reconfirmation samples were collected with results indicating that contamination had been successfully removed. Analytical results of confirmation and reconfirmation sampling are presented below.

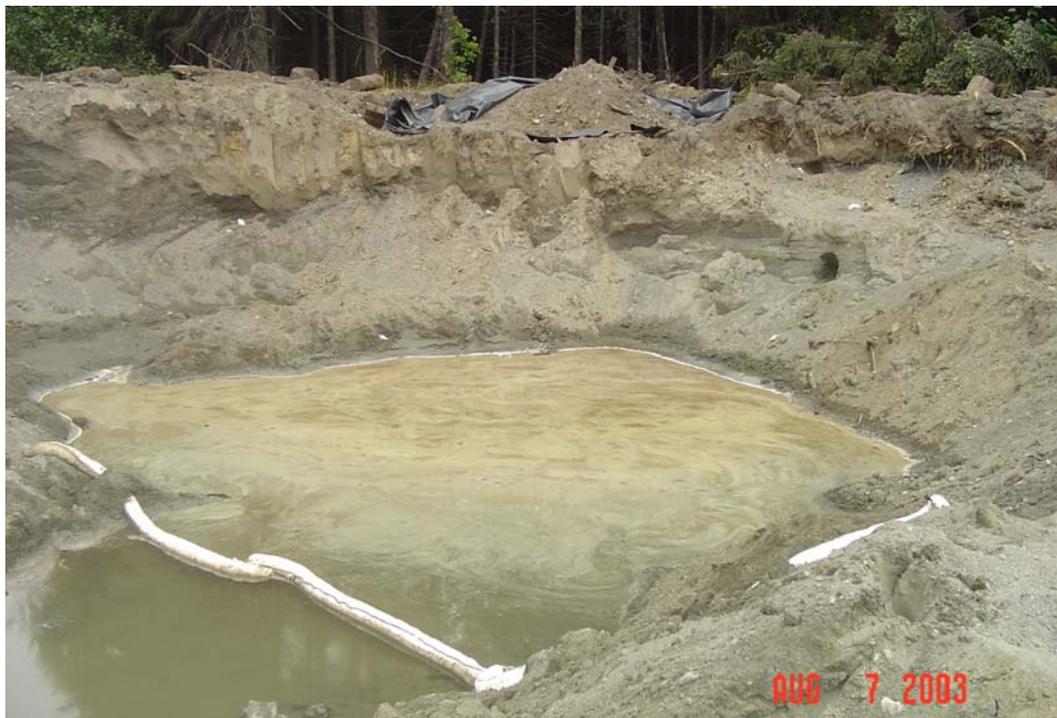
Figure 34. Saw Shop Excavation with Lighter Oil on Water Table

As with the Oil Shed Area, excavations surrounding the water table identified a 6"-12" thick black band of sand & gravel saturated in oil. The oil was much lighter than oil under the oil shed and appeared to contain some amount of pre-1972 hydraulic oil with zinc. The smear band diminished in color and intensity under the Saw Shack and the volume of oil released to the water was also **observed** to lesser quantities than what had been previously observed. As with the Oil Shed, contaminated and discolored soil also extended above and below the smear band for several feet. However free oil was no longer visible in the interstitial spaces of the sample media. Large volumes of overburden were removed from the area to access and remove the smear band. The shape of the plume as noted by the shape of the excavation suggested a groundwater path moving from the northeast to the southwest. The following figures illustrate information noted:

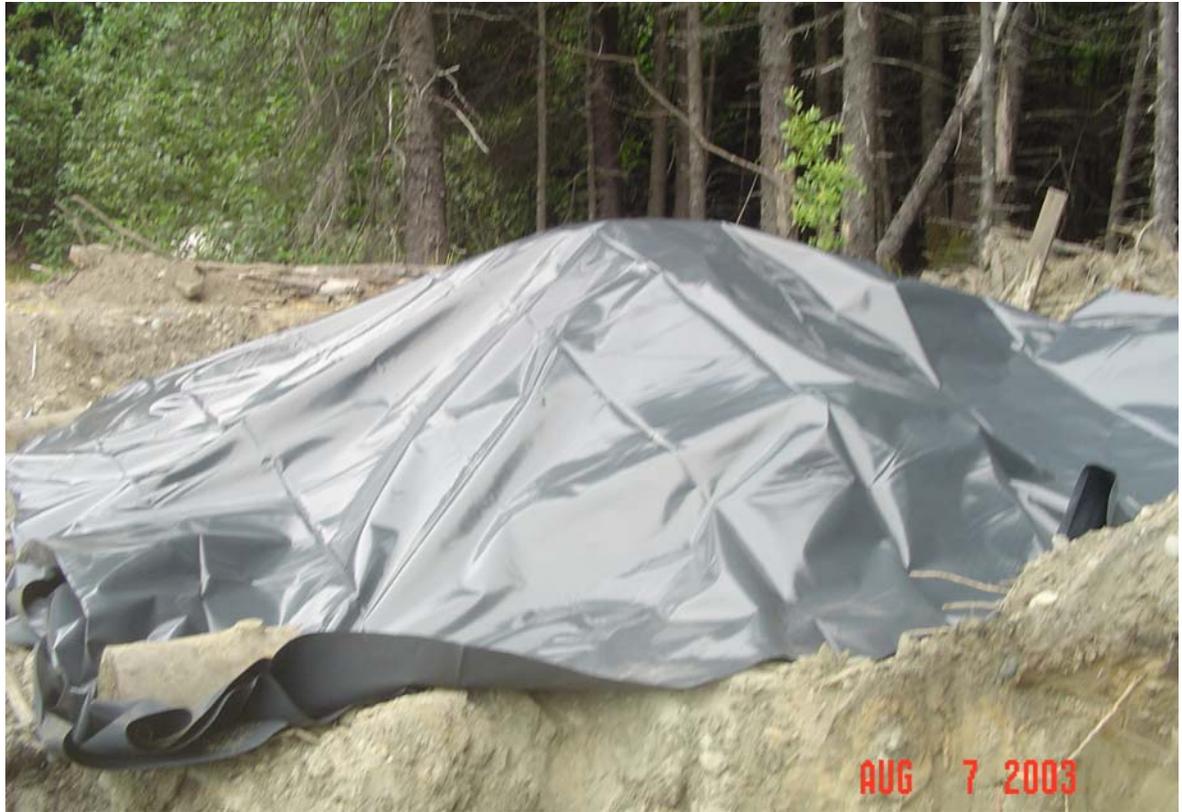
Figure 39. Acid Stained Soil Stockpile Adjacent to Saw Shop Excavation

Soils with bright orange discoloration were detected at the north end of the main saw shop excavation near an area where an historic battery shop had been located. Gray/blue discoloration typical of petroleum contamination was also noted. In these circumstances the possible presence of lead from lead/acid batteries is a concern. 1-2 CY was collected and placed on a lined and covered stockpile away from other petroleum contaminated soils pending characterization analyses for lead. No evidence of batteries was found in any excavation.

The acid stained soils contained no lead and were therefore likely the result of acid spills during the filling of new batteries with no lead present. The small amount of soils collected (1-2 CY) and sequestered from the main petroleum contaminated stockpile for testing were then added back to the pile for treatment.

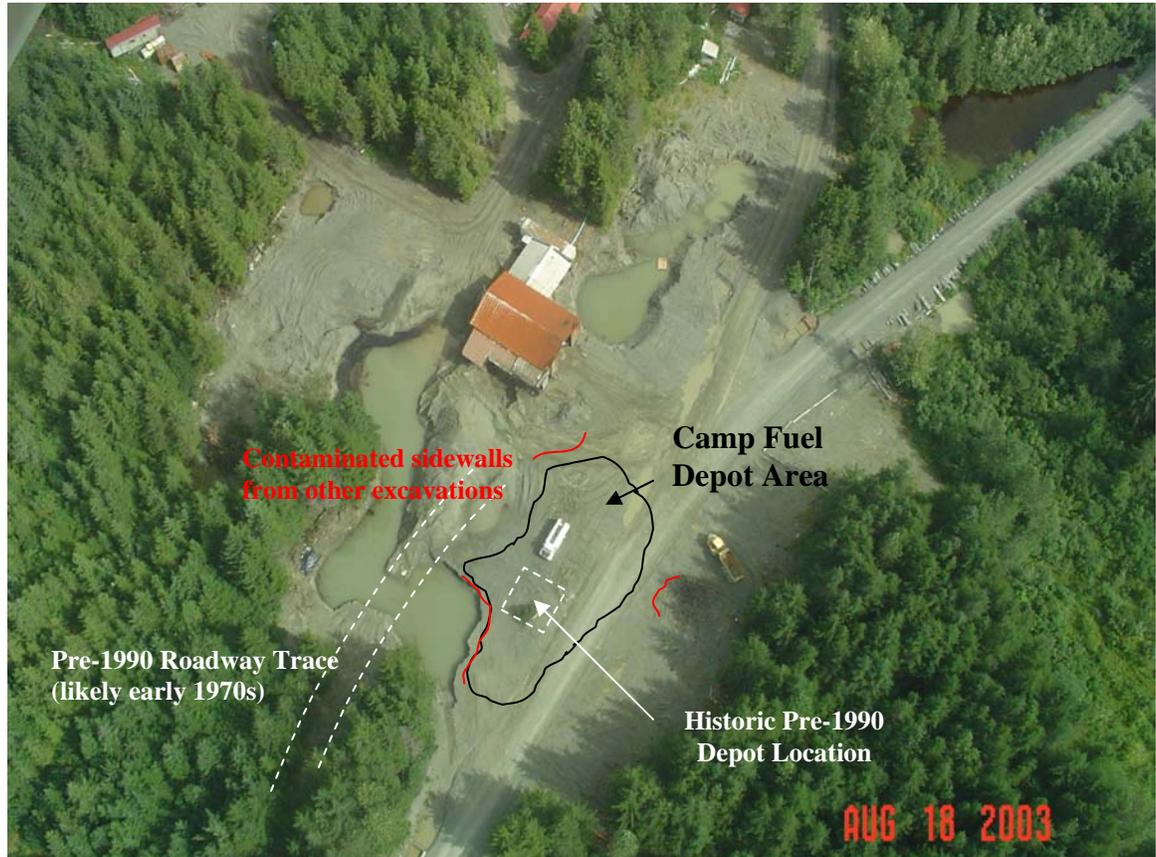
Figure 40. Camp Fuel Depot Excavation Area Location

This area was not identified during site characterization work in June 2002 and was discovered on August 14, 2003 at the conclusion of excavations at the Maintenance Shop, Saw Shop and South Equipment Parking Area. [Following discussions with landowners and ADEC, a determination was made to proceed with remediation.](#) Sidewalls in each of these excavations bordering the undiscovered depot were difficult to clean and exhibited DRO concentrations below but near the clean-up limits. Historic mapping indicated that a camp fuel depot had been used prior to 1990. Based on the map and the presence of DRO contaminants in adjoining excavation sites, exploratory excavations were performed and resulted in the identification of the depot site at the location noted in the figure below. Characterization samples were collected and analyzed from

five (5) samples all indicating the presence of DRO exceeding clean-up limits (3,000 ppm to 6,000 ppm DRO). Exploratory excavations successfully identified the location of the depot. Following discussions with land owners a decision was made to excavate the depot.

Excavation of the camp depot was performed September 8,9,10 and 11, 2003. Excavation resulted in the removal of 3,767 CY of contaminated soil. The soil was placed in the previously approved runway stockpile for treatment. Excavation depths exceeded 12 feet. All traces of smear band at the water table were excavated and removed. Only traces of oil were noted accumulating at the water surface during excavation. Following the excavation, the water surface was observed to be clean. Prior approval was granted by ADEC to limit confirmation sampling numbers to minimum acceptable in order to preserve remediation funding. Sample results are noted following photographs of the excavation.

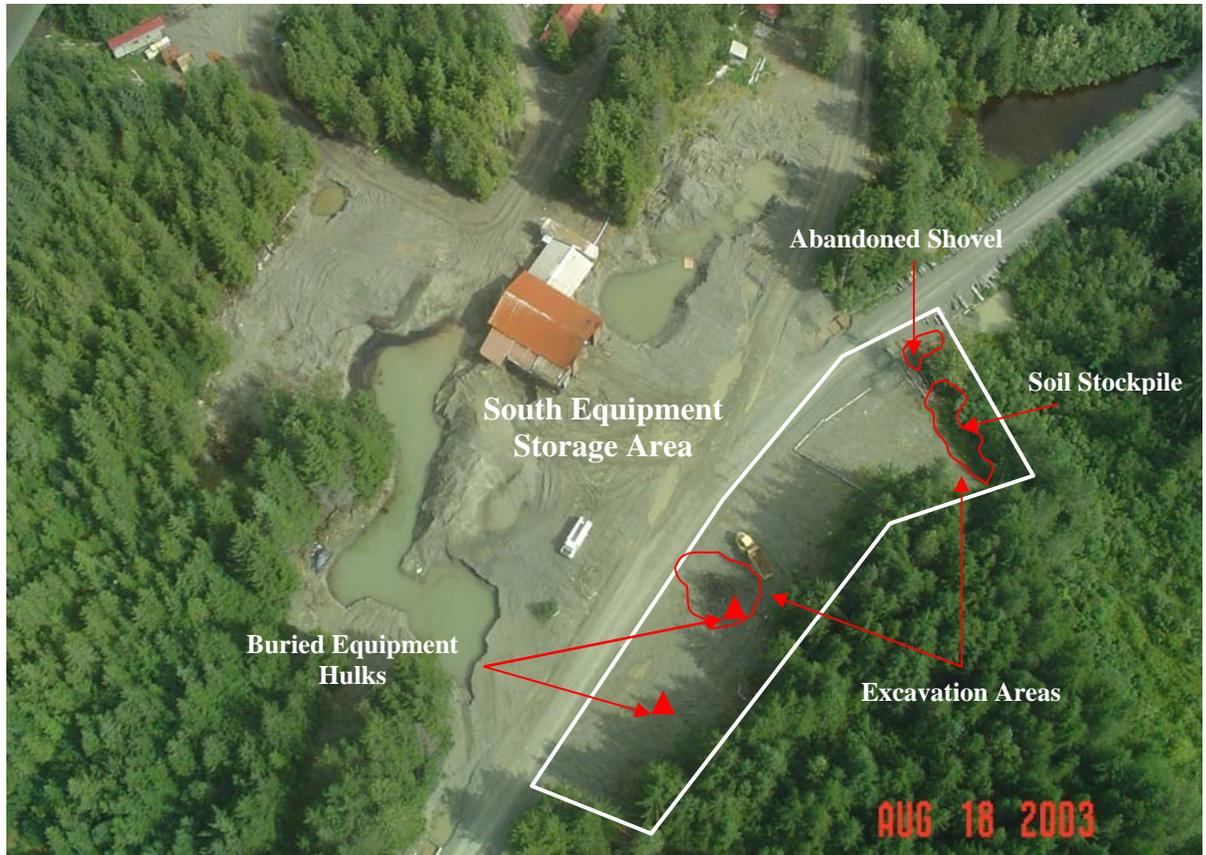
Figure 44. South Equipment Storage Area Location

Characterization efforts in June 2002 resulted in the collection of 15 samples from the South Equipment Storage Area. 6 of 15 samples failed for DRO contamination with a high reading of 7,500 ppm. 2 of 15 samples failed for RRO contamination with a high reading of 21,000 ppm. 30 to 100 CY of contamination was estimated for excavation to a maximum depth of 4 feet. The following figure illustrates the extent of the area in question:

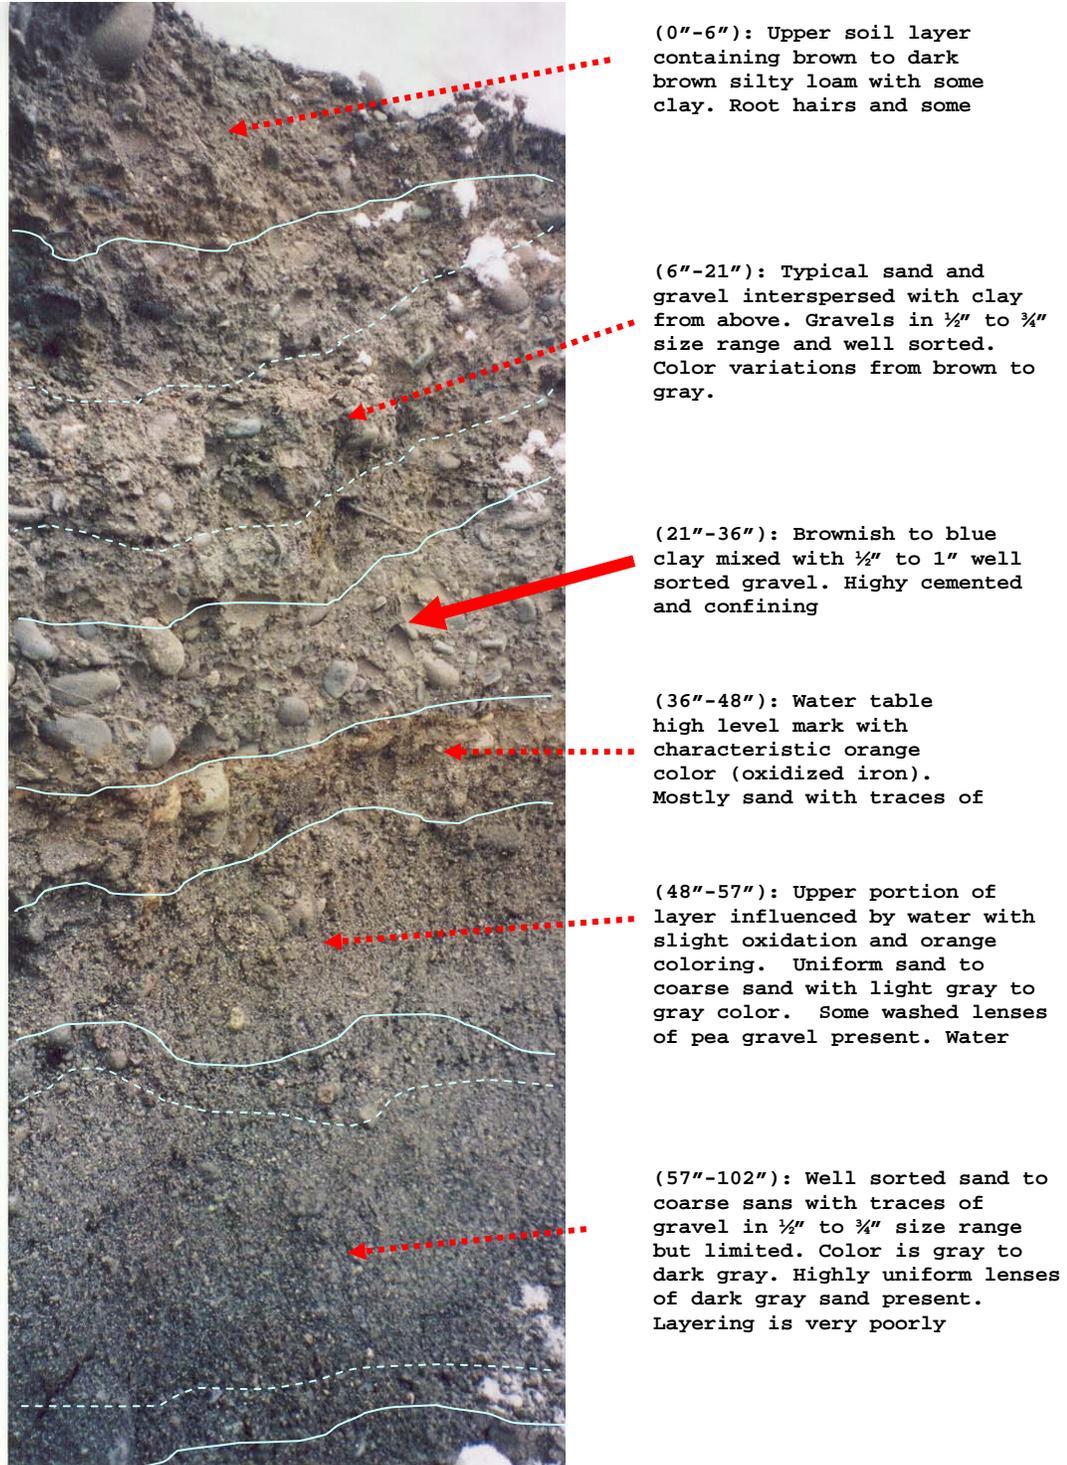
Figure 48. Typical Soil Profile Fuel Depots

After removal of snow, the surface area immediately under the depot was inspected and PID surface measurements collected. From a surface perspective, there was no visual or PID evidence that a significant release at the surface had occurred. The only positive readings obtained, and far below response limits, were in the center of the depot between containment cells #2 and #1. Large excavations holes were opened through the center of each containment cell and the refuel bay to provide further observations. The soil profile in each excavation pit was inspected and sampled. Approximately 500 feet of lateral trench was opened for observation. Consistently, three (3) layers of interest were identified across the depot area including surface soils containing clay from 3”-6”; a cemented layer of clay and gravel from 27” to 30”; and an orange tinted water table layer composed of sand, clay and gravel from 36” to 39”. The water table layer was clearly distinguishable by its color. Uniform coarse sand and fine gravels were detected to depth under the water table. Identification of layering provides the ability to model transport and fate mechanisms associated with diesel spills under the depot. The typical profile is noted and described below:

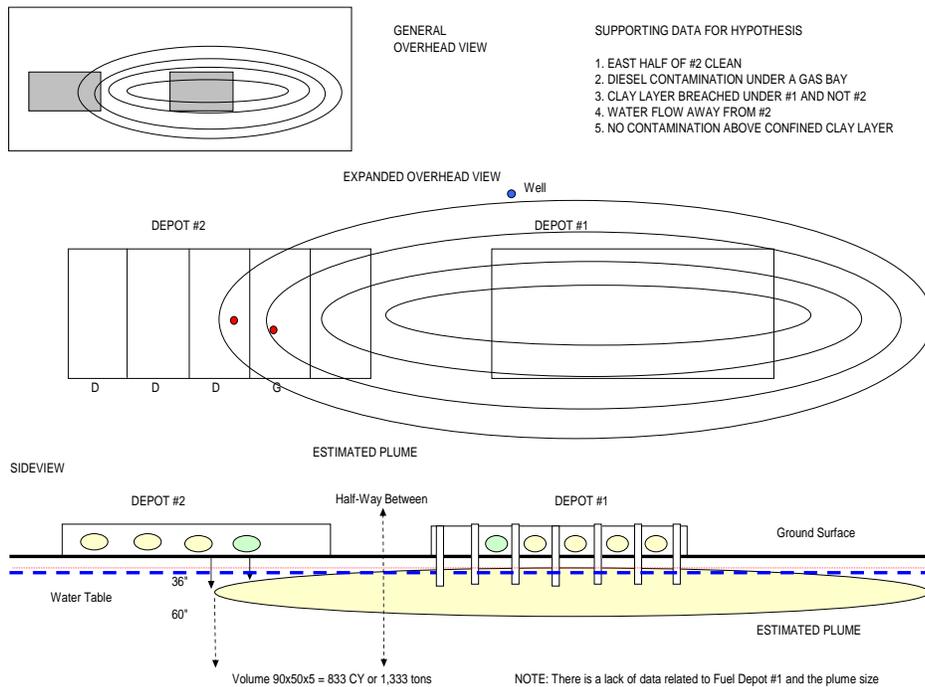
Figure 50. Revised Plume Hypothesis Fuel Depots

Based on the March investigations, Diesel contaminated soils present under depot #2 likely originate under depot #1 and follow the movement of the water table both up and down and from west to east.

The appropriate boundary between depot #1 and depot #2 is not the halfway point between the depots. Rather, the delineation should be the most probable location where contamination from depot #2 could no longer be present. Based on data collected to date, this location is a line between depot #2 containment cells #1 and #2 as noted below:

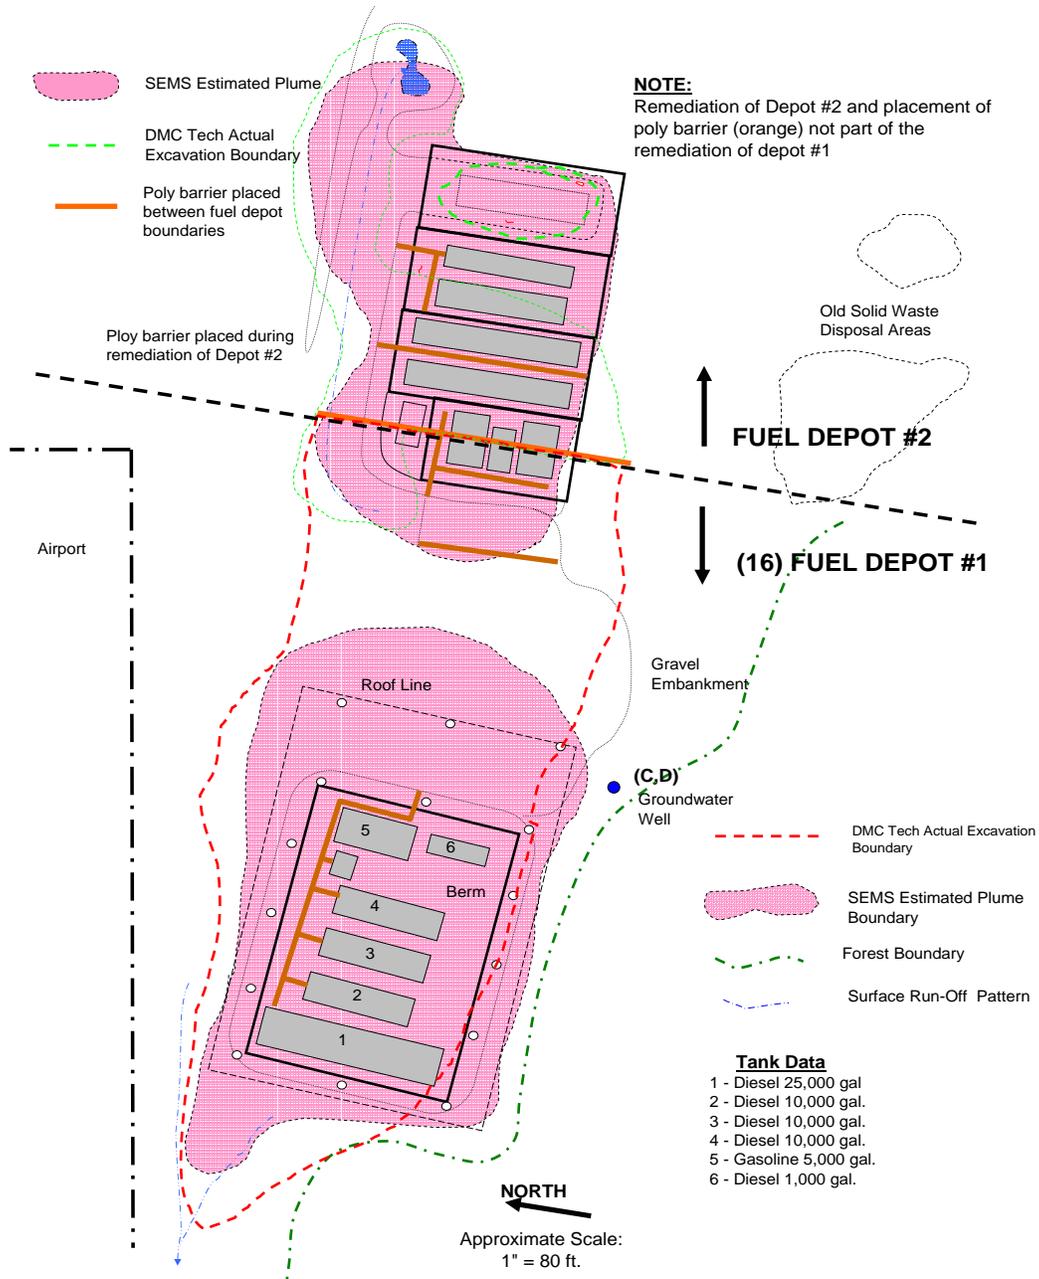
Figure 54. Fuel Depot #1 Prior to Remediation.

The following figure illustrates the layouts of Fuel Depots #1 and #2 and defines the characterization effort plume estimate and actual excavation performed. As illustrated, the bounds of actual excavation cover the plume estimates from the characterization work and clearly indicate that the plume extends between the depots as suggested in DMC Tech hypothesis.

The original June 2002 characterization of the depot resulted in the collection of 21 soil samples to depths of 4 feet. 13 of the 21 samples breached the clean-up limit for DRO. The maximum DRO contamination observed was 7,500 ppm. Based on the data collected it was estimated that 1,500 to 2,500 CY of soil would need to be excavated.
