**VOLUME 1**  
**REVISED FINAL CLEAN-UP REPORT**  
**ICY BAY WEST CAMP #1**

**DMC Technologies  
3528 West Hwy. 33  
Rexburg, ID 83440**

*May 24, 2004*

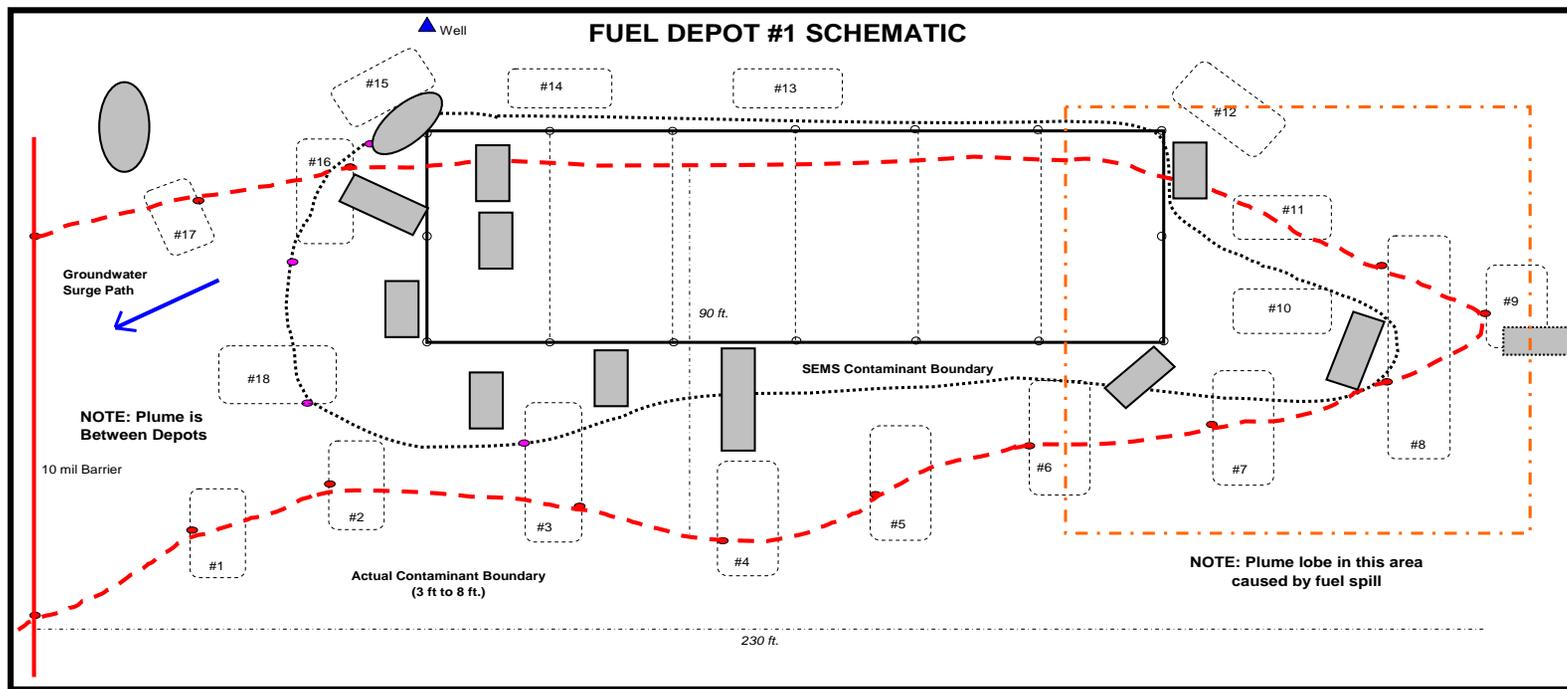
Figure 55. Fuel Depot #1 Additional Excavations

In addition to the 13 - 2002 excavations 18 new exploratory excavations were developed in mid-July 2003 as shown in the following figure. Each excavation was developed to define the contaminant plume boundary or leading edge (x-y coordinate) and contaminant plume depth through the water table (z coordinate). Excavations were mapped beginning at the 10 mil plastic barrier placed in the ground at Fuel Depot #2. Clear points where contamination ended were identified during the placement of the barrier. Conclusions drawn from the additional excavation are noted below:

1. The plume extends from the 10 mil plastic barrier westward under Depot #1. There is no separation of plumes between depots.
2. Excavations were successful in identifying a plume boundary both laterally and with depth. The plume is expected to contain 3,833 CY of soil including soils under the structure.
3. A determination must be reached to demolish and remove the structure in order to remove contaminated soils.
4. The west end of the plume can be tied to an historical diesel spill and is clearly shown to migrate along the upper drainage channel.

Exploratory results are the subject of a special report included in Appendix C. Based on the position of the contaminate plume a determination was made to demolish the depot structure and move all tanks to a new depot location approximately 500 Yards west of the former location. Demolition was accomplished in early September making room for complete remediation including soils under the depot footprint.

The noted figure guided remedial excavations of the depot which were performed from September 2<sup>nd</sup> to the 4<sup>th</sup>, 2003 and resulted in the removal of 2,557 CY placed in the runway stockpile near the depot. Excavations proceeded to the barrier placed during remediation of Depot #2. Due to cost constraints and upon approval from ADEC confirmation sampling was limited to 20 samples illustrated in the following figure:

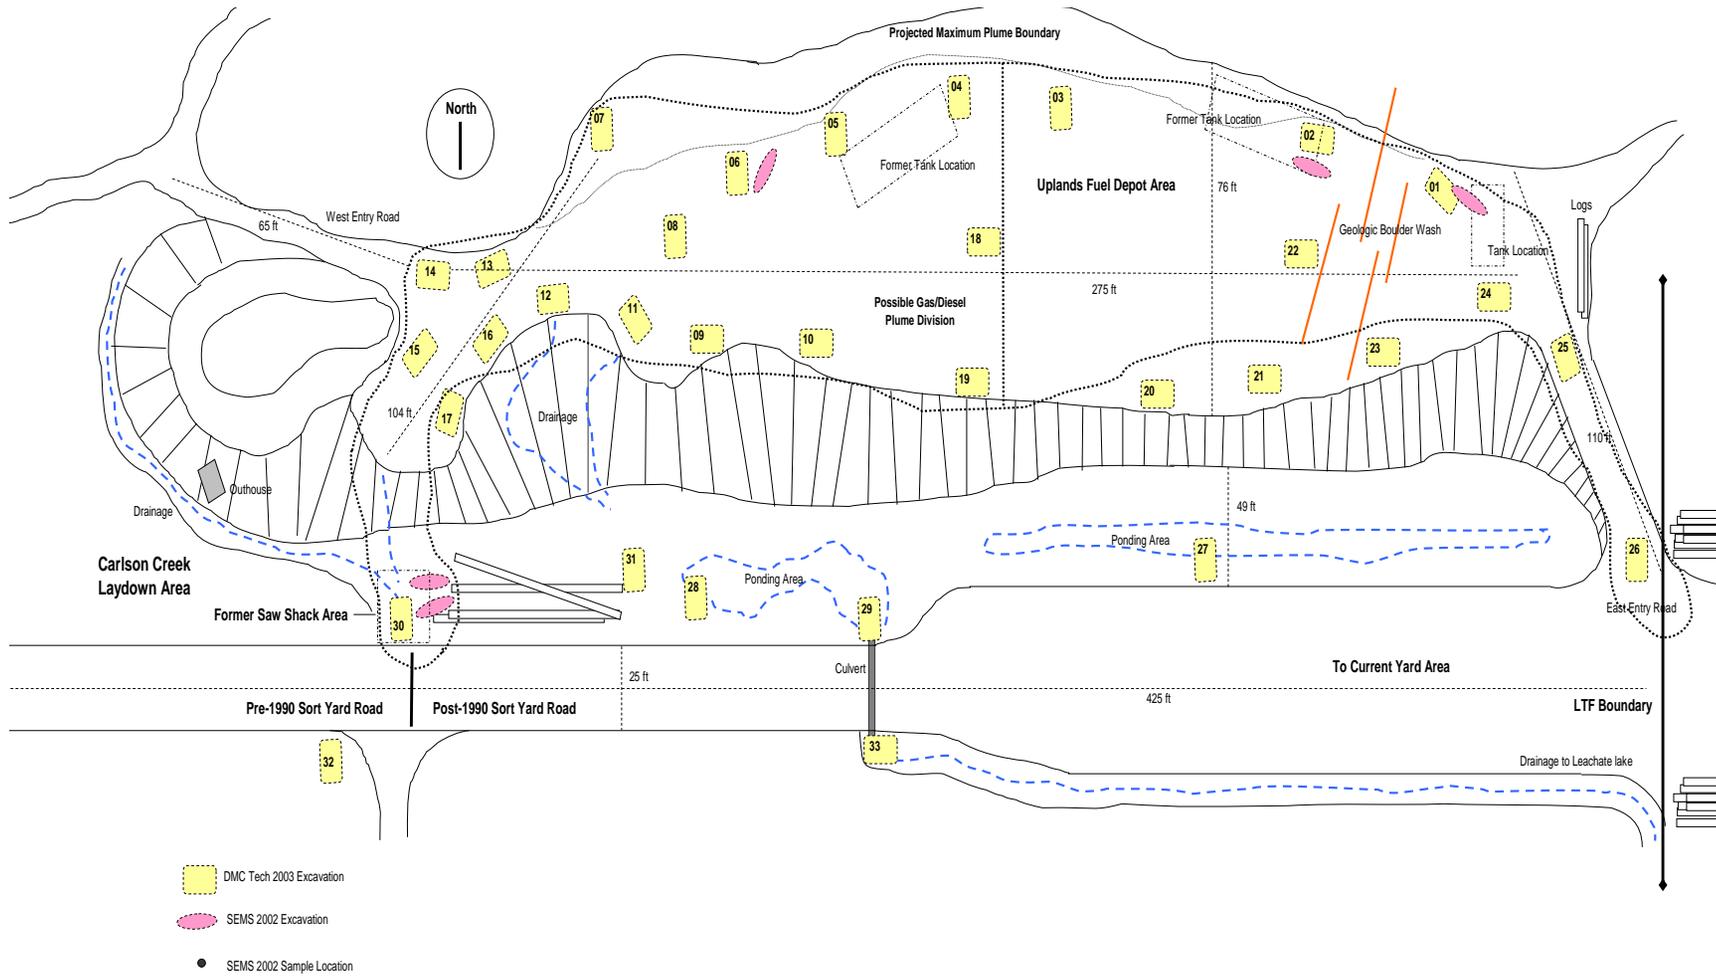
Figure 59. Uplands Fuel Depot Exploratory Excavations - 2003

During the investigation, 42 field samples were collected from 33 different excavations. Excavations varied in depth from 6 ft. to 17 ft. The majority of samples collected from the fuel depot exhibit stained soils suggesting historical contamination. These samples also exhibit high PID readings.

- The depth of contamination in several holes is characteristic of a long term leak or spill history.
- Contamination in holes at the toe of the bench may be extensions from the upper bench either by migration or by drainage from the upper bench.
- Shallow groundwater along the toe of the bench is **likely** from surface water run-off. Deeper groundwater is detected at apx. 12 ft. BGS.
- Contamination is present in sufficient concentrations to warrant concern.
- Historic contamination has a **perceived** pathway from the upper bench to the lower bench and then to leachate lake and Icy Bay. **It is unknown if this occurred and not easily supported from available data. Alternatively, the soils are contaminated, but contaminants are stable and have not moved into Leachate Lake.**

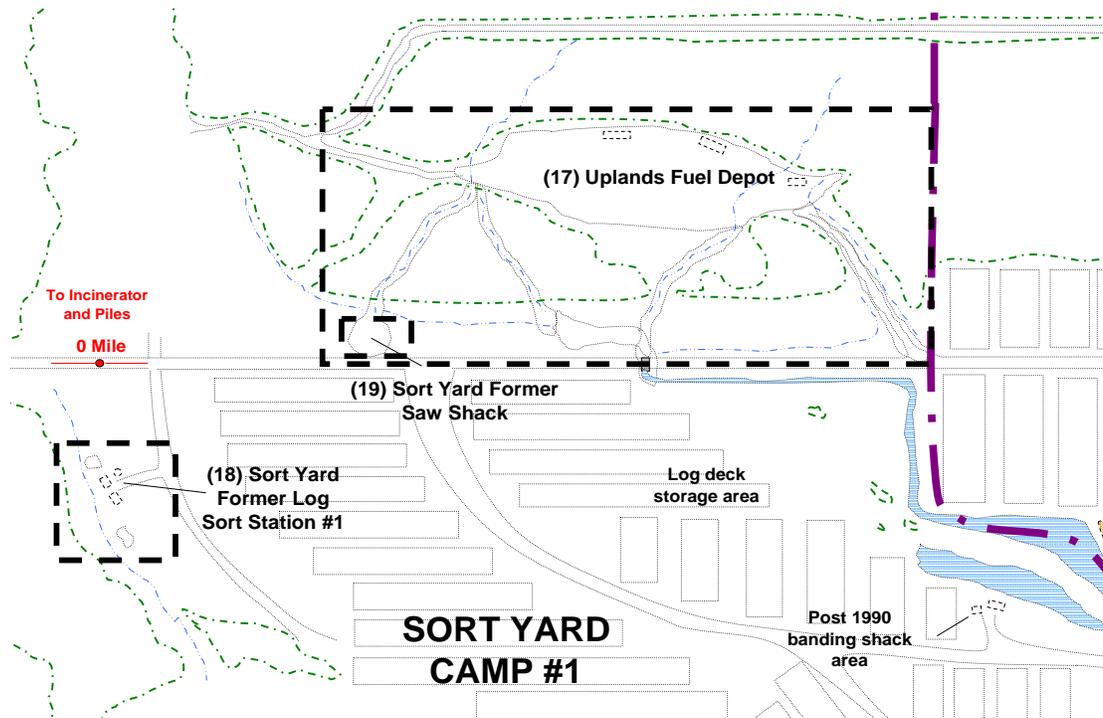
Figure 61. Locations of Sort Yard Former Log Sort Station #1 and Sort Yard Former Saw Shack

It should be noted that the Sort Yard Former Saw Shack appears to be within the boundary of the Uplands Fuel Depot. A small ephemeral run-off channel exits the upper bench of the Uplands Fuel Depot and flows into the Saw Shack area. Historic contamination from the Uplands Depot could easily have migrated to this area.

Two deep excavations have occurred in the saw shack area to the water table – one in June 2002 and one in August 2003. The June excavation proceeded to 9 feet. The August excavation was 16 feet deep. The water table was detected and 9 feet and 12 feet deep respectively. Contamination was visible throughout the depth of both excavations. It is uncertain that the operation of a saw shack could cause contamination to depths of 12 feet or more. More than likely contamination in the Saw Shack Area was influenced by both the Uplands Depot and on-site saw shack activities in the yard. Contamination in and around the shack is estimated at a volume of 300-400 CY. **This contamination will be addressed with the Uplands Fuel Depot.**

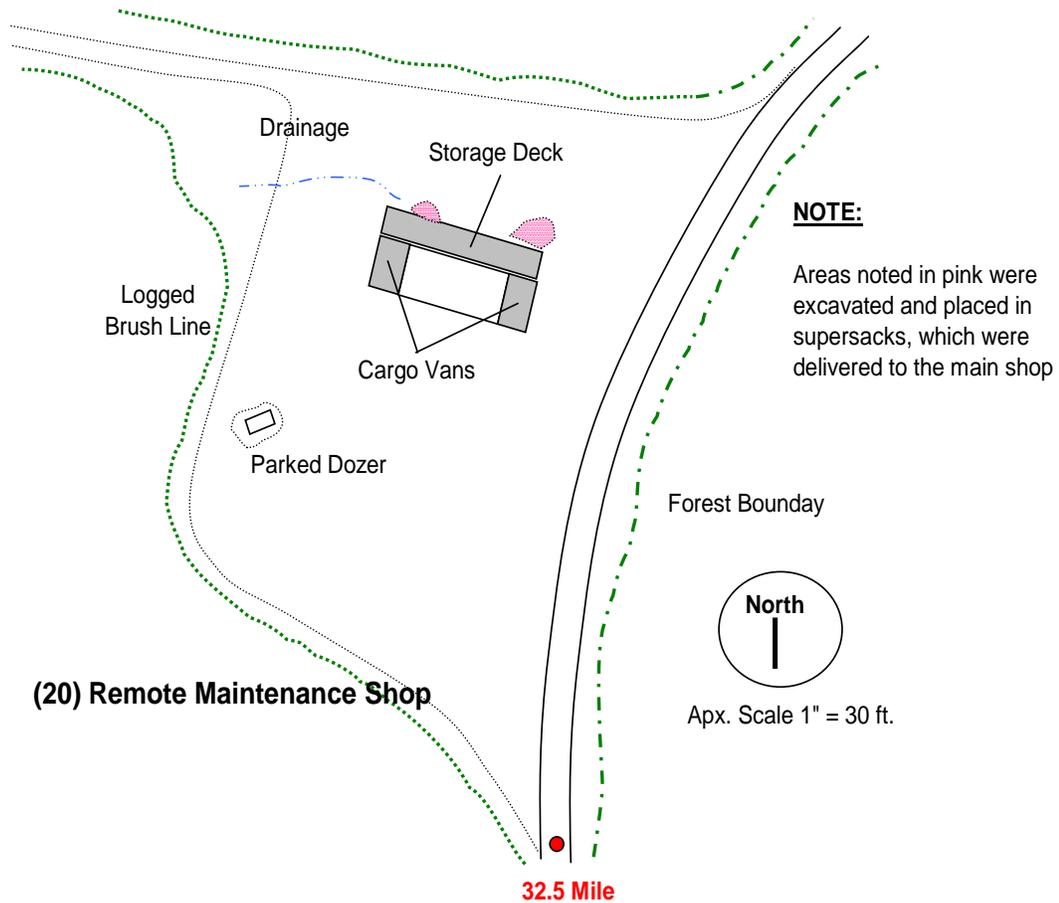
Figure 63. Remote Maintenance Shop Excavation Areas

In September, the Remote Maintenance Shop was reinspected. No soil stains were observed in and around the Shop. The excavation of the soils in August was

considered sufficient remediation of the site. The site will be re-inspected during future final camp closure as required.

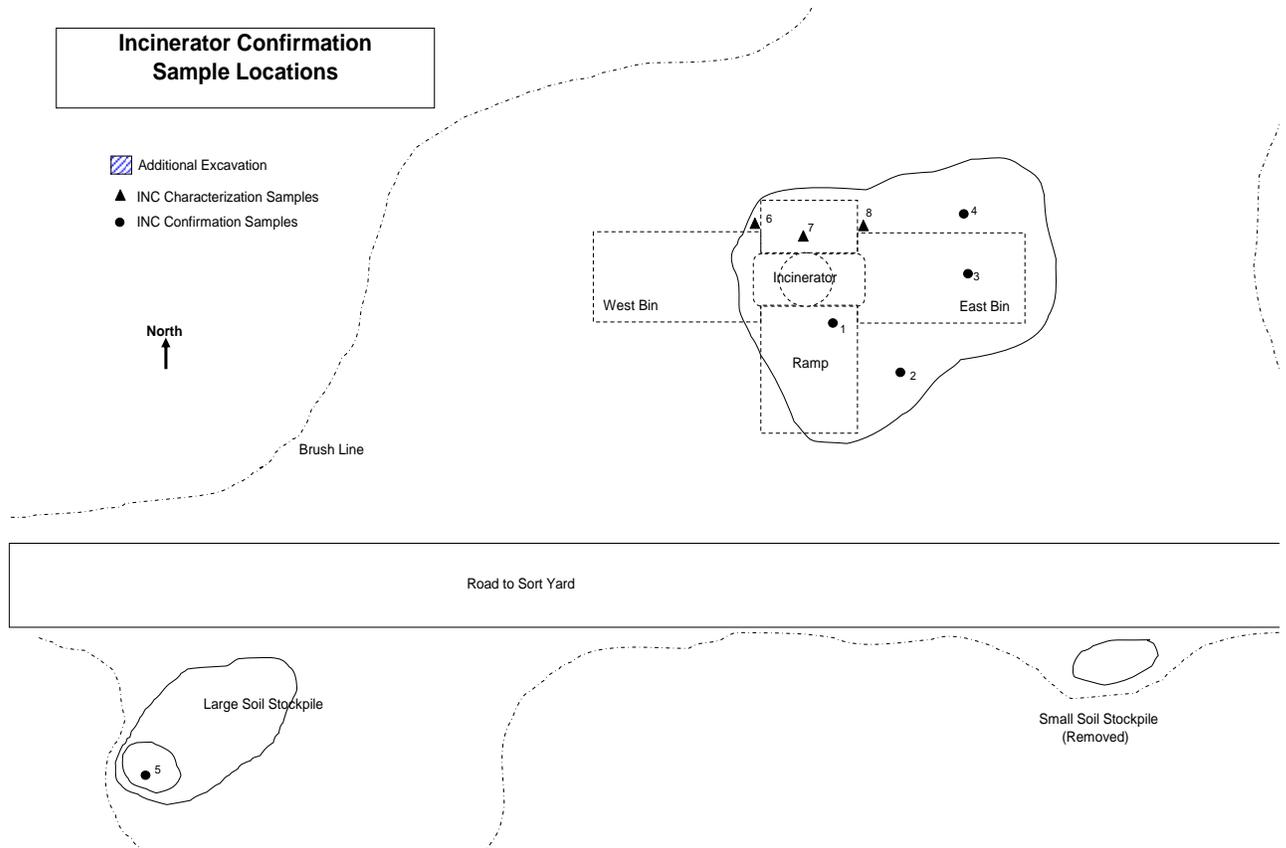
**CONFIRMATION SAMPLES**

In June 2002, 11 samples were collected from the incinerator environment for analyses. 5 of the 11 samples failed the analyses for DRO. A single sample failed the analyses for RRO, but represented ash in the truck bed bin. It is not uncommon to find diesel or oil in the ash since the liquid is used to light the incinerator. Based on the data collected, it was estimated that 170 to 250 CY would need to be excavated from the site to complete remediation. At the time of characterization, several stockpiles across the road from the incinerator were observed. It was recommended that these piles be tested and removed. In August, 2002; the smaller of the stockpiles was bagged into a supersack and delivered to the shop. This sack was later dumped on the contaminated stockpile for treatment as previously discussed.

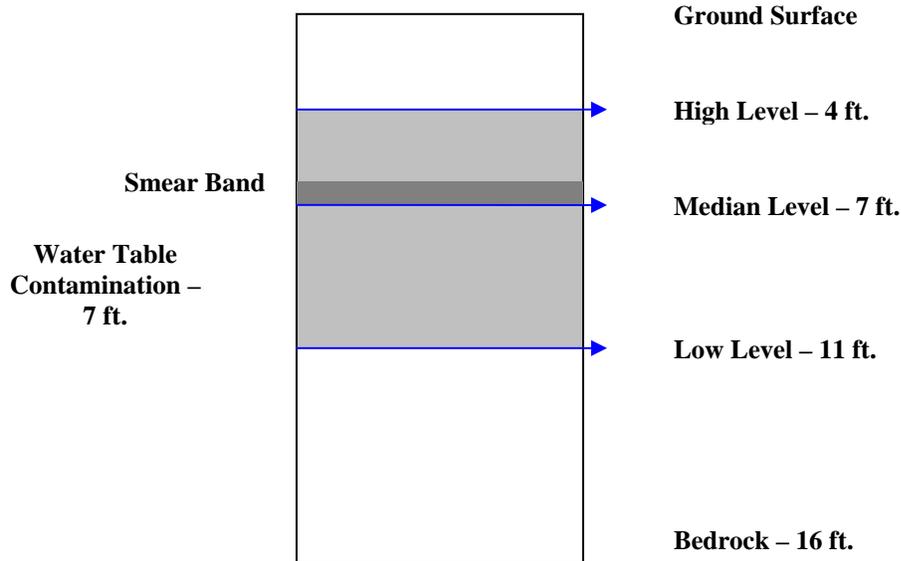
Figure 65. Water Table Vertical Profile and Fluctuation

Based on several months of observations a general model regarding vertical and horizontal movement of the water table can be provided. The following figure illustrates vertical movement of the water table at Icy Bay:

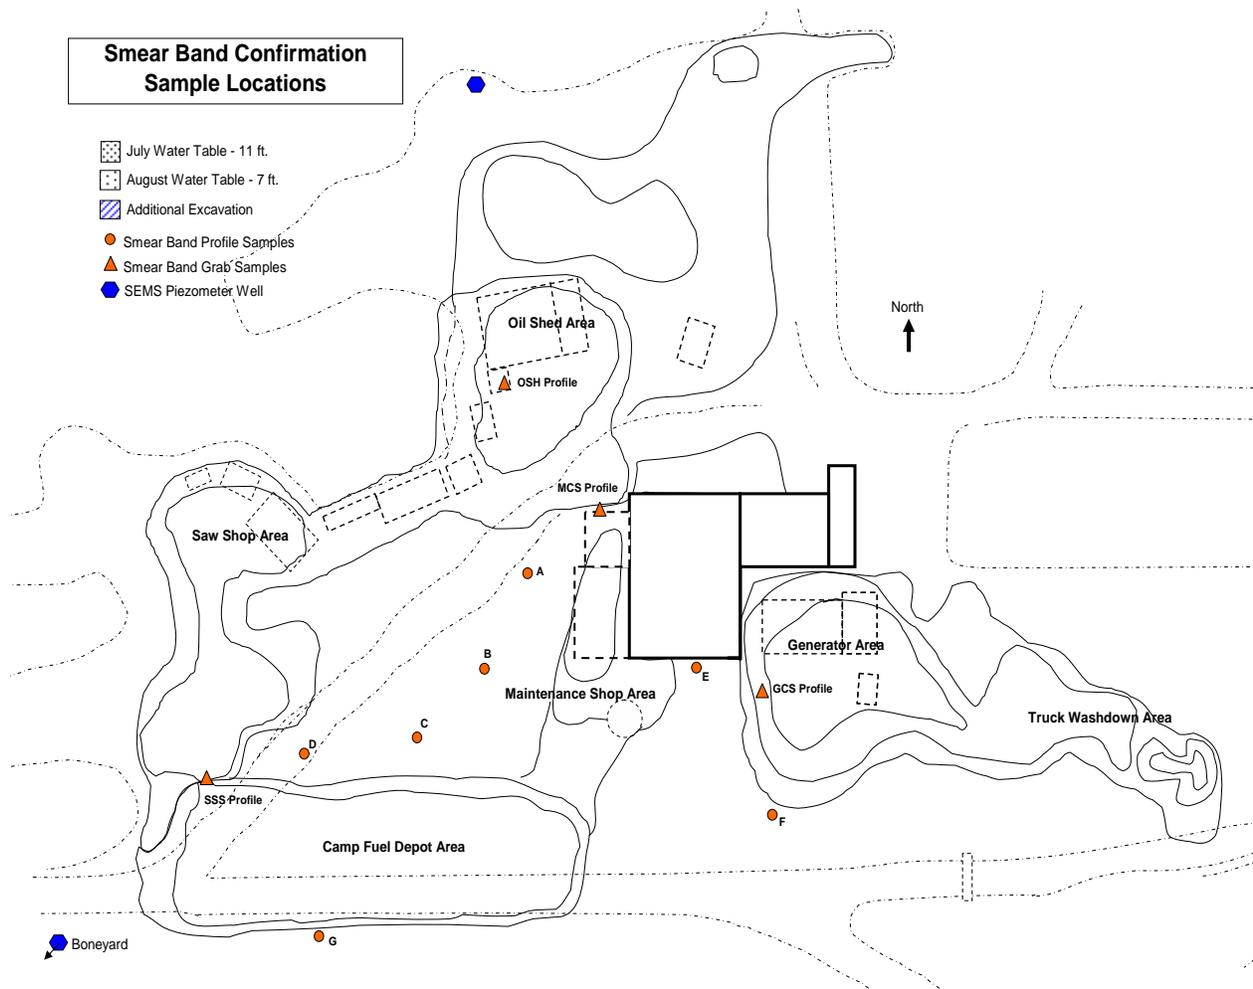
Figure 70. Smear Band Samples and Exploratory Excavations Supporting a Petition for No Groundwater Monitoring

As excavations preceded additional smear band was detected around the maintenance shop and at the newly discovered Camp Depot. Concern mounted that perhaps the smear band covered a very large area. Accordingly, exploratory excavations were made in and around the shop and around the edges of the major excavations. It was learned that the smear band was actually limited to the excavation areas. In fact, confidence was building that perhaps the smear band could be removed. To limit contaminated material, the smear band was sampled with depth in several locations and a contamination band was consistently observed at a thickness of 7 feet. The contamination zone commenced at the high water table at 4 feet and extended to the lower water table line at 11 ft. It was agreed that by removing the overburden of 4 feet and excavating contamination zone, any source of contamination that could potentially creat a risk would be removed. Thus, the need for groundwater monitoring would be eliminated. A determination was reached to remove the smear band in it's entirely.

4 smear band samples and 7 exploratory excavations are noted. Date follows. As mentioned, groundwater samples collected upgradient and downgradient of the smear band mass - still present in 2002; indicated no contamination.

From July to September, excavations focused on complete removal of the smear band and exploratory holes to ensure that no smear band remained. After collecting data, a petition for no groundwater monitoring was made and then approved by ADEC. Data presented to ADEC follows for review:

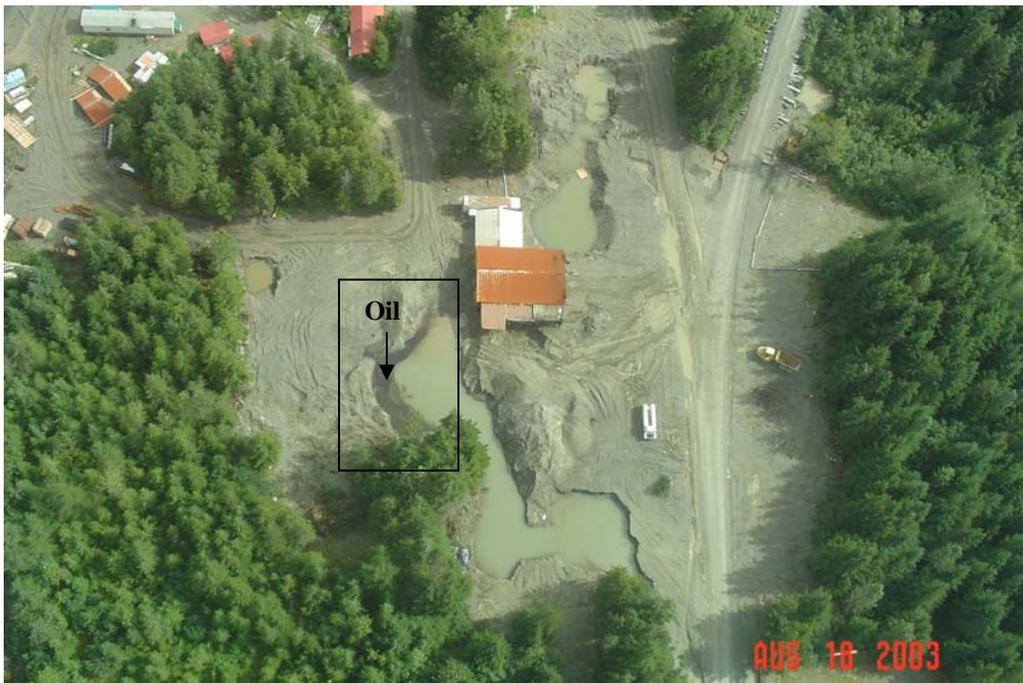
Figure 80. Blackish Oil on Surface of Water in Oil Shed Excavation

Free product was observed on the water surface of excavations in the form of motor oil, hydraulic oil and traces of diesel during the excavation of contaminated soil in Camp #1 in and around the shop. No free release of petroleum product was observed from Camp #1 excavations outside of the shop area. At these locations soil contamination was present as noted by field observations and measurements indicating discoloration, sheening and odor. However, the volume and form of contamination was not of sufficient quantity to create observable releases. The following photos depict free product from the excavations.

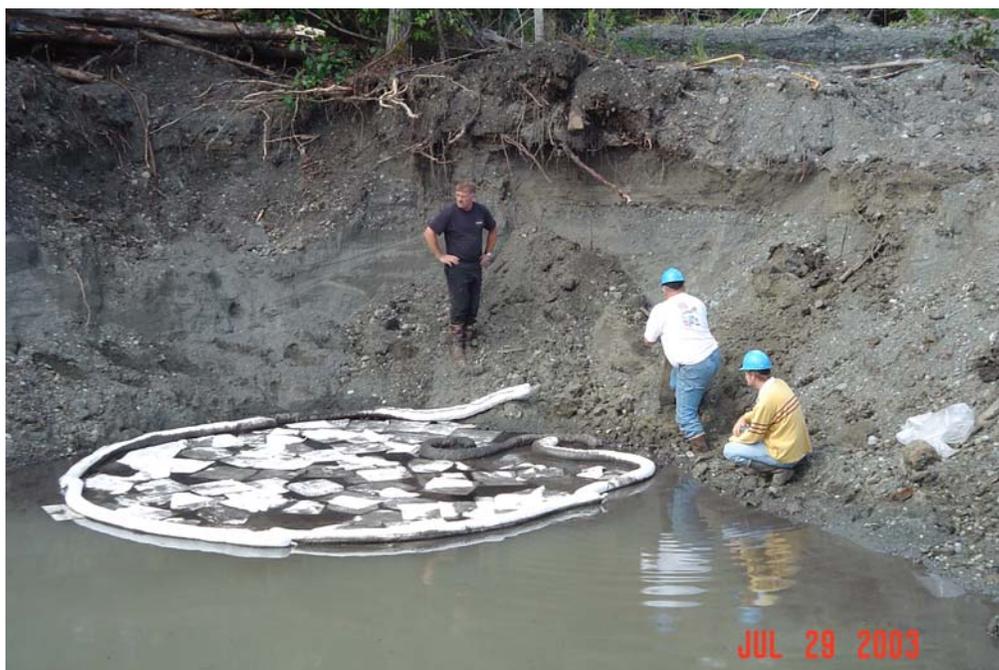
Figure 84. Booms and Pad Clean-Up at Oil Shed Area

Clean-up of free product was very effective. Excavations were not backfilled until water was clean and petroleum-free.

The following photographs illustrate the free-product clean-up process:

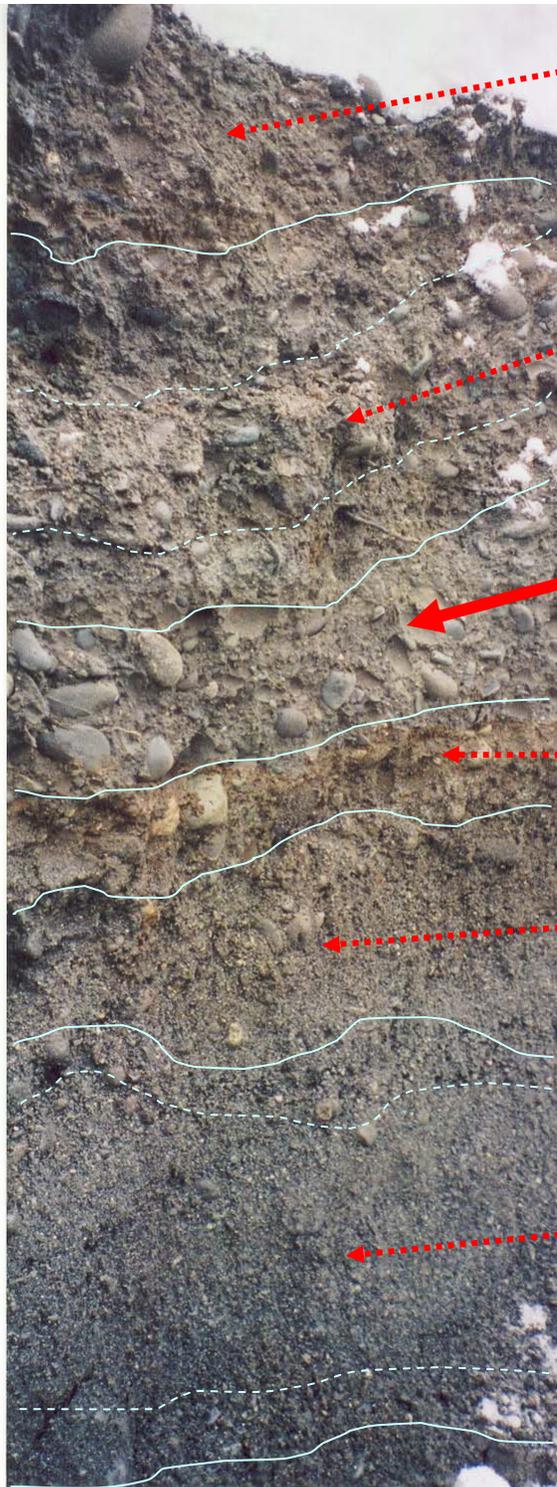
After removal of snow, the surface area immediately under the depot was inspected and PID surface measurements collected. From a surface perspective, there was no visual or PID evidence that a significant release at the surface had occurred. Large excavations holes were opened in each containment cell to provide further observations. The soil profile in each excavation pit was inspected and sampled. Three (3) layers of interest were identified across the depot area including surface soils containing clay from 3”-6” ; a cemented layer of clay and gravel from 27” to 30” ; and an orange tinted water table layer composed of sand, clay and gravel from 36” to 39” . Approximately 500 feet of lateral trench was opened for observation. The water table layer was clearly distinguishable by its color. Uniform coarse sand and fine gravels were detected to depth under the water table. Identification of layering provides the ability to model transport and fate mechanisms associated with diesel spills under the depot. The typical profile is noted and described below:

(0"-6") : Upper soil layer containing brown to dark brown silty loam with some clay. Root hairs and some

(6"-21") : Typical sand and gravel interspersed with clay from above. Gravels in 1/2" to 3/4" size range and well sorted. Color variations from brown to gray.

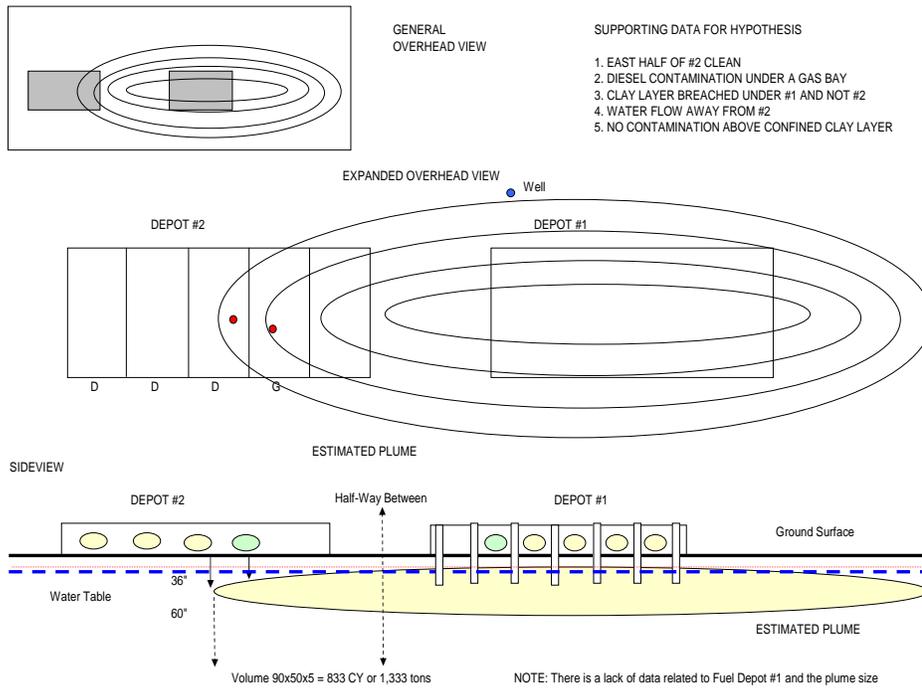
Diesel contaminated soils present under depot #2 likely originate under depot #1 and follow the movement of the water table both up and down and from west to east.

The appropriate boundary between depot #1 and depot #2 is not the halfway point between the depots. Rather, the delineation should be the most probable location where contamination from depot #2 could no longer be present. Based on data collected to date, this location is a line between depot #2 containment cells #1 and #2 as noted below:

1. Accept the proposed location of the boundary between depots #1 and #2 as illustrated.
2. Accept recommendations noted below.

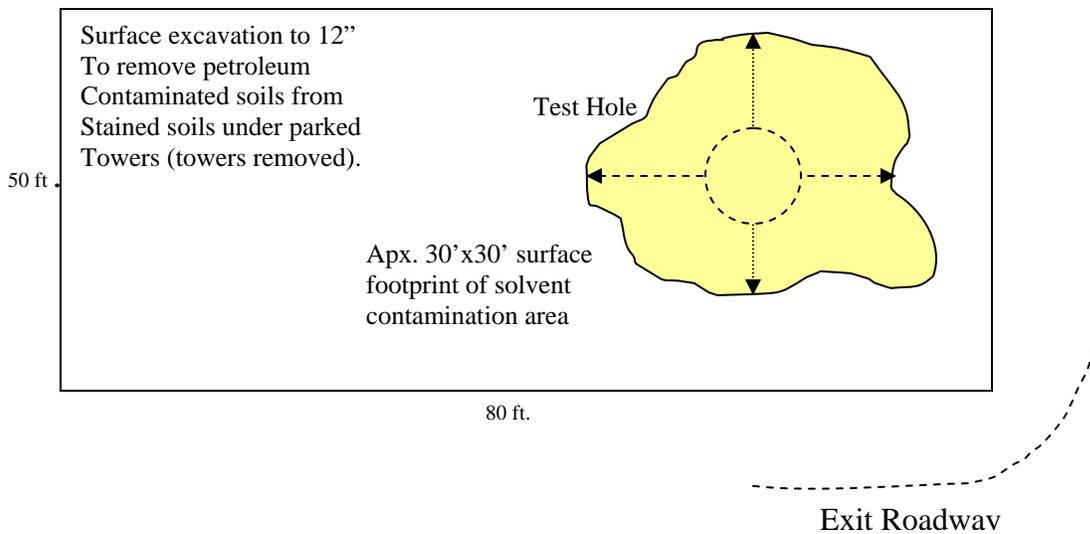
#### SE Corner of East Parking Area

During the routine excavation of diesel-contaminated soils in the East Parking Area, the track hoe operator detected solvent odor. Surface soils were analyzed utilizing the PID (photoionization detector) and levels were noted between 10-20 ppm. The surface area was gridded and a carefully surveyed to map a surface plume shown as follows:

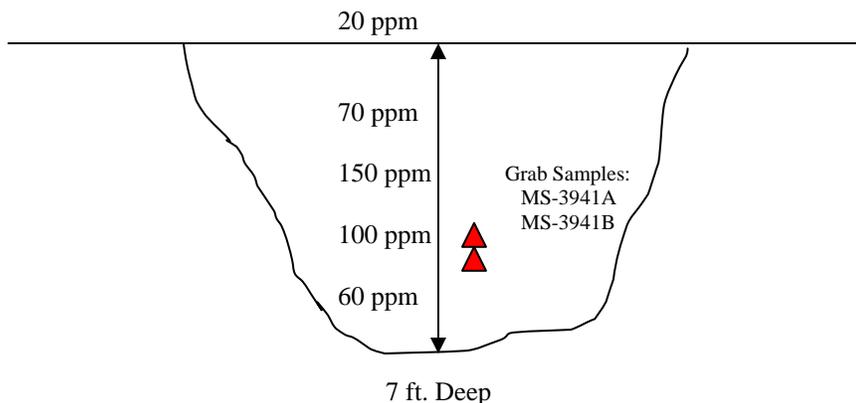
A test hole was excavated in the center of the spill footprint to evaluate the depth of contamination with PID results as follows. A grab sample was collected at 60".

The volume of material is estimated at 233 CY or 373 tons.

The recommendation is that the solvent contaminated soil be treated on-site by bioaugmentation. ADEC (B. Janes) concurs with this recommendation.

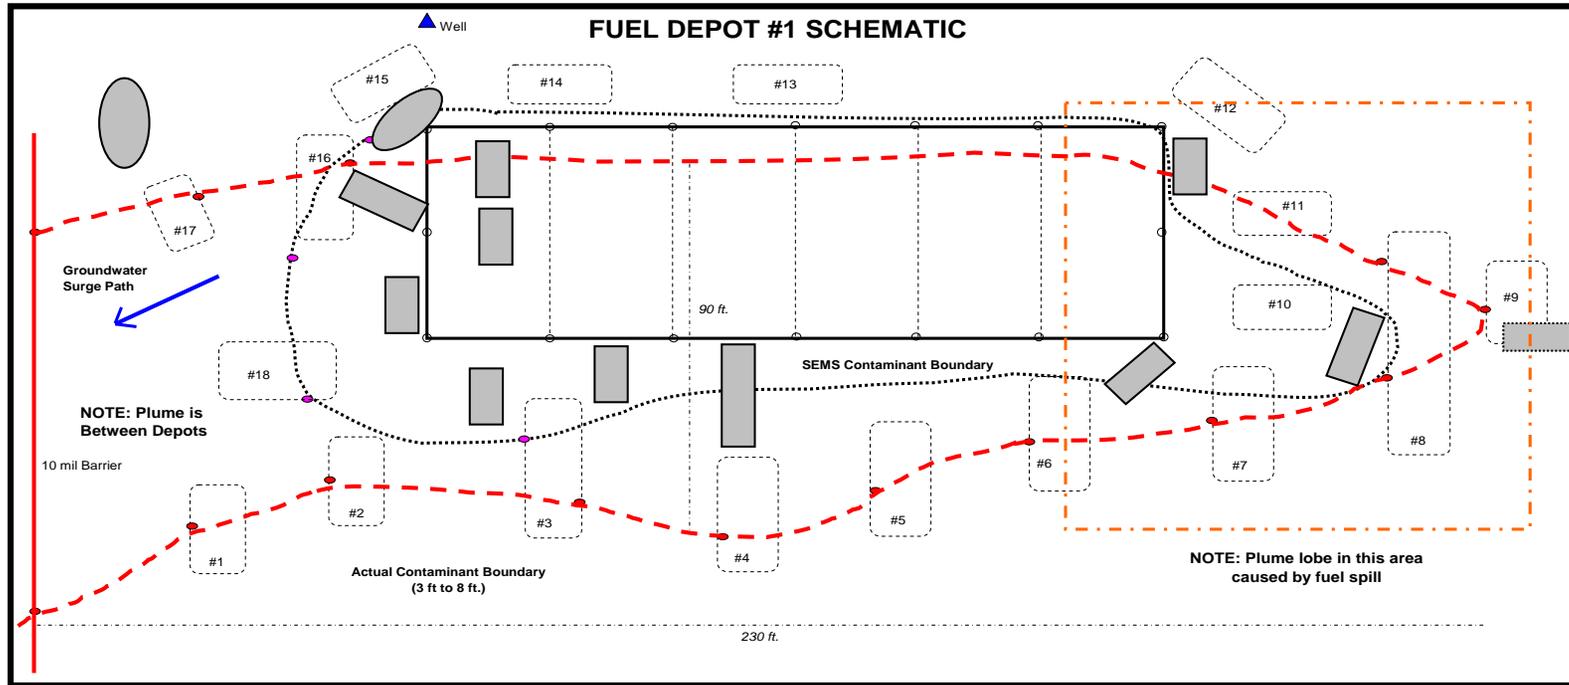
5. The plume extends from the 10 mil plastic barrier westward under Depot #1. There is no separation of plumes between depots.
6. Excavations were successful in identifying a plume boundary both laterally and with depth. The plume is expected to contain 3,833 CY of soil including soils under the structure.
7. A determination must be reached to demolish and remove the structure in order to remove contaminated soils.
8. The west end of the plume can be tied to an historical diesel spill and is clearly shown to migrate along the upper drainage channel.

230 ft long x 90 ft wide x 5 ft deep = 3,833 CY  
(Note: assumes contamination from 3 ft to 8 ft deep)
