**VOLUME 1
FINAL CLEAN-UP REPORT
ICY BAY WEST CAMP #2**

Icy Bay

January 5, 2004

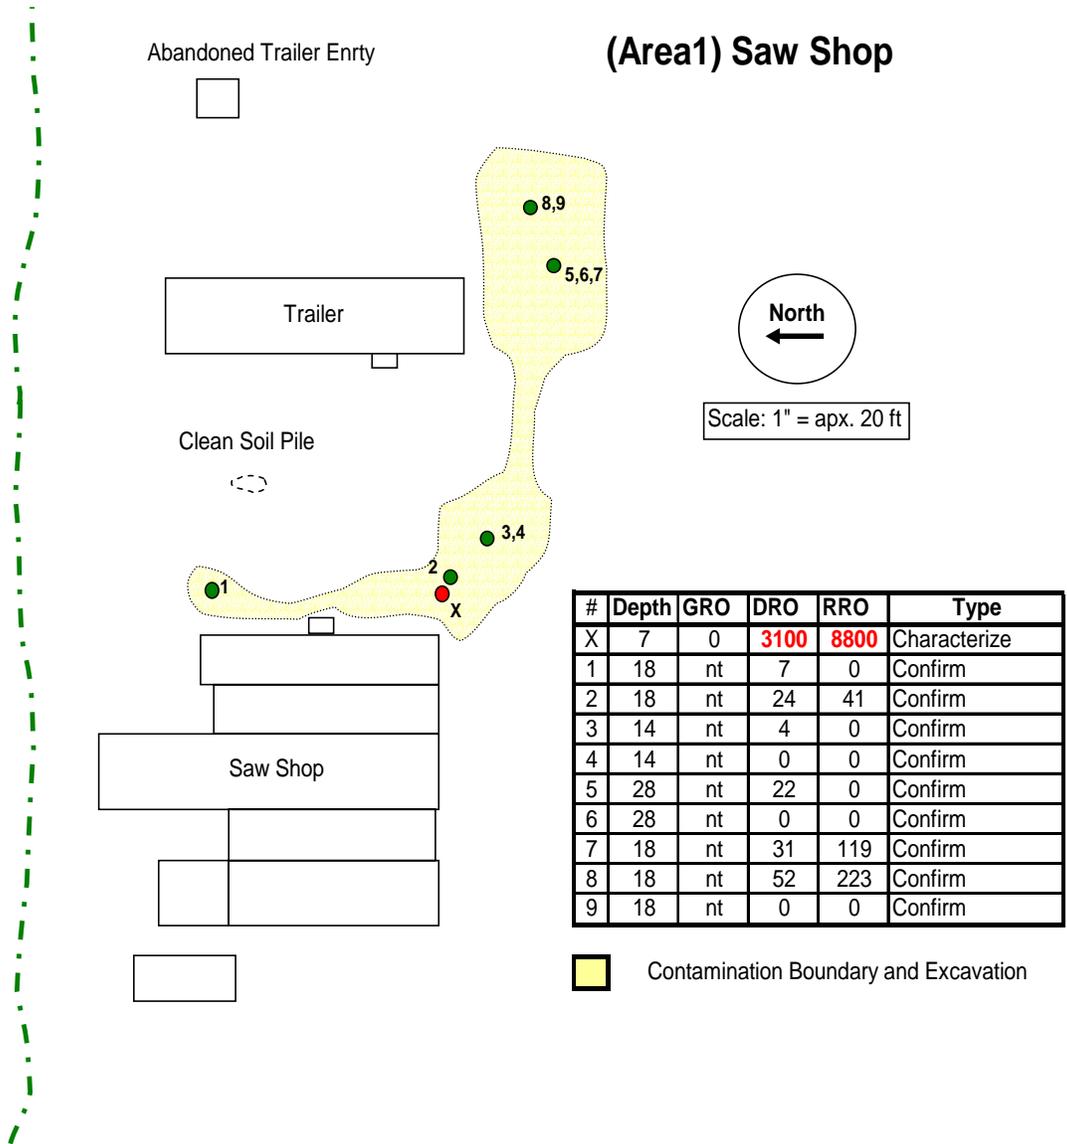
Figure 10. Sawshop Excavation and Sampling

On June 14, 2003; the area was reinvestigated and additional staining was found at both the southeast and southwest corners, under the east entrance steps to the shop, and in the lay down area east of the southeast corner towards the nearby residential trailer. The characterization report previously noted that these areas were potentially contaminated. This remaining staining was excavated resulting in 41 CY of contaminated soil to a depth of 3 feet. Another seven confirmation samples were collected all indicating that excavation was complete. The site was backfilled in late June, 2003. Figure 10 illustrates work completed in this area.

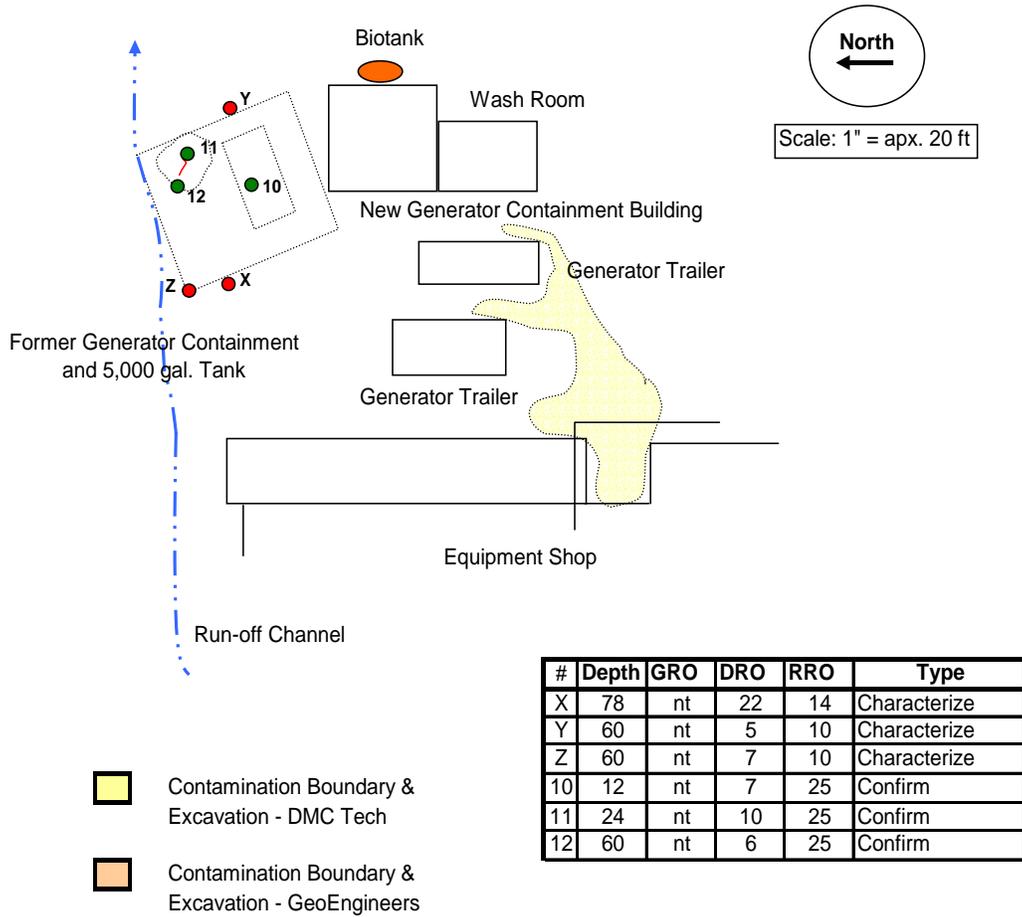
Figure 11. Generator Tank Containment Excavation and Sampling

Browning Timber dismantled and removed the 5,000 gal diesel tank and containment structure in early December, 2002 to provide unobstructed access to excavate under the containment. On December 5, 2002; after removal of the tank and liner, the area immediately under the AST was inspected. There was no visual evidence that a release had occurred from under the AST. GeoEngineers optioned to not excavate significantly under the containment based on this observation. Approximately 3 CY of contaminated soils under the area above the liner tear were excavated to a depth of 1 foot and removed to the long term stockpile. Three confirmation samples were collected following the excavation all indicating the absence of contamination. Backfilling was performed immediately and a new containment structure was constructed immediately southwest of the historic location. Figure 11 illustrates work completed in this area.

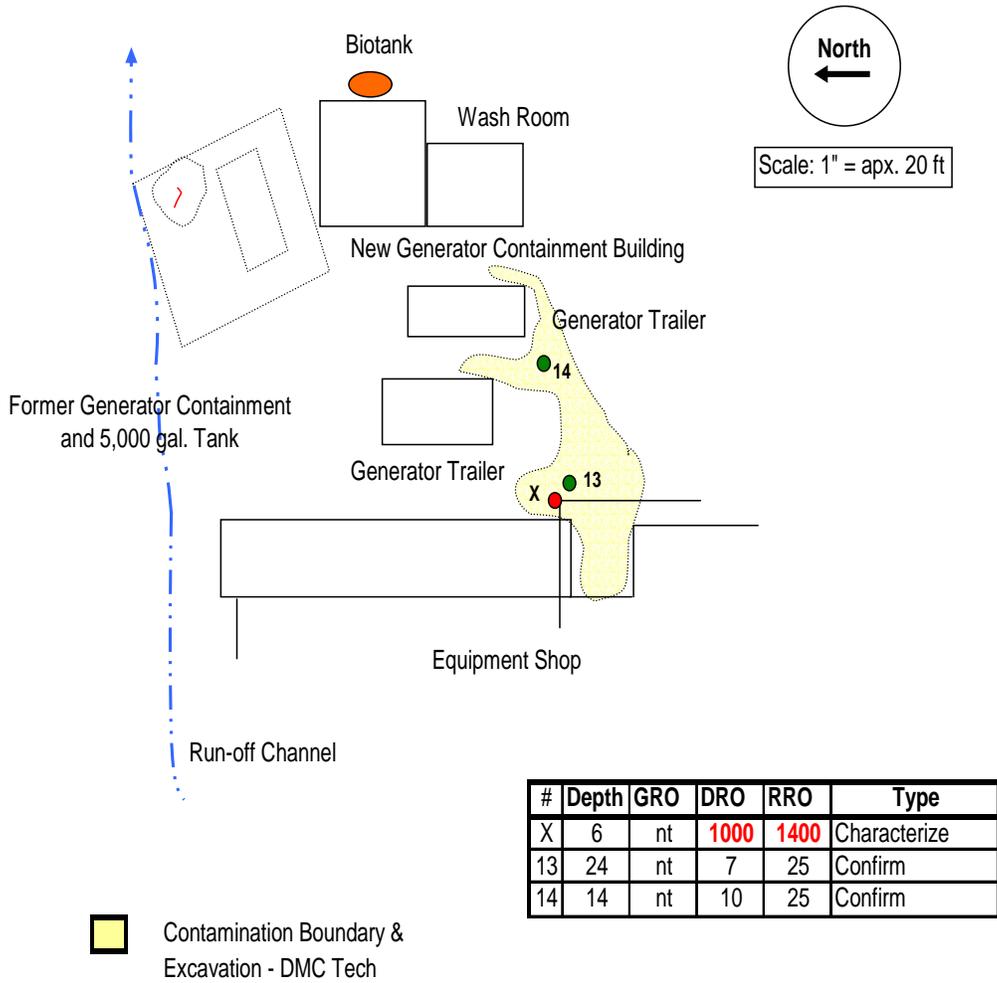
Figure 12. Generator Trailers Excavation and Sampling

On March 23, 2003; the Camp Manger identified the general location where this contamination had previously been observed, but which was no longer visible. Approximately 6 CY from the noted area was excavated to a depth of 2 feet and one confirmation samples collected indicating a clean excavation. On June 14, 2003; the area was re-inspected and new stains were clearly visible near the trailers and outside of the previous excavation pattern. Another 35 CY was removed to a depth of 3 feet and one additional confirmation sample collected indicating that contamination removal was effective. The area was backfilled in late June. Figure 12 identifies the layout of this area and related work as described.

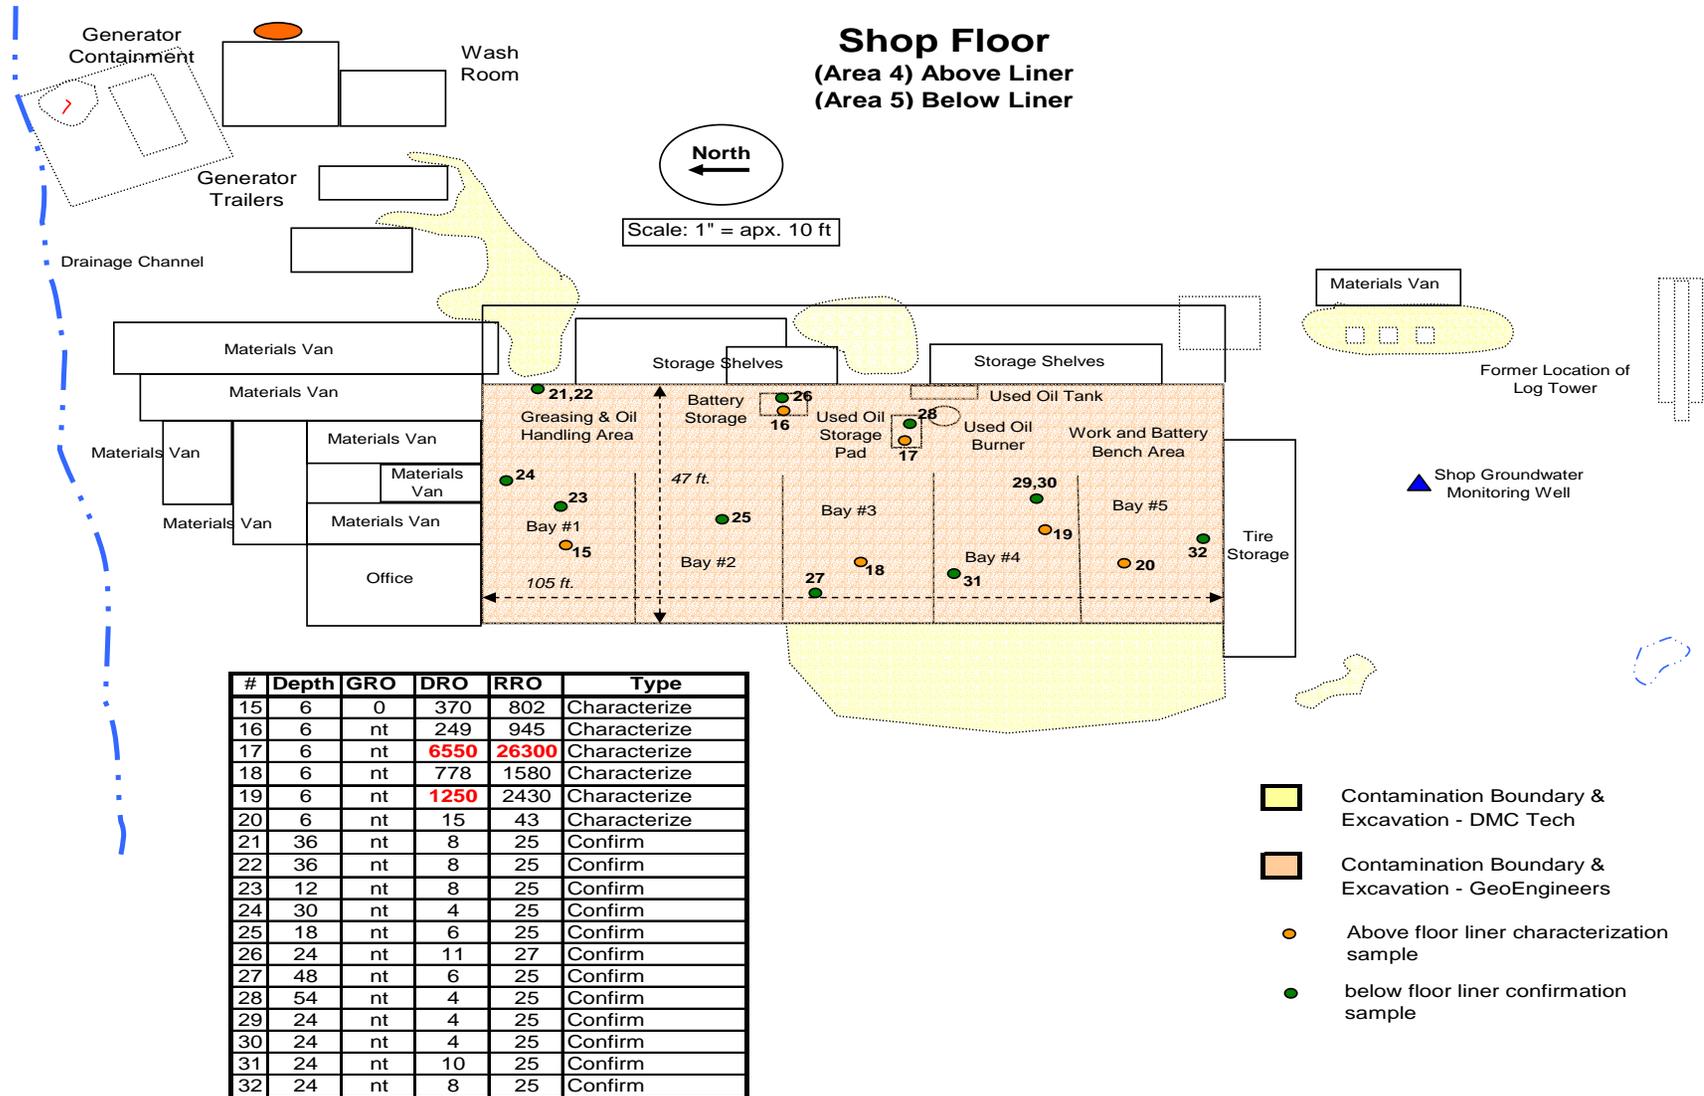
Figure 13. Shop Floor Excavation and Sampling

Field screening was performed on soils under the liner to determine the extent of excavation required to achieve clean closure. SEMS had originally recommended that 150-320 CY of contaminated soil be removed from under the shop liner. Based on field measurements, approximately 145 CY of soil were removed. Twelve confirmation samples were collected from soils left in-place to validate clean up. Excavated soil was then placed in the long-term stockpile. The liner removed from the shop was brushed clean and saved for future camp use. The shop was immediately backfilled with clean soil and a manufactured sub floor with steel plates to reduce shop downtime and return the camp to operation status. Collected confirmation samples under the shop floor liner indicated that all contaminated soils had been removed. Figure 13 illustrates the equipment shop area and work performed.

Groundwater was collected from the shop well (see Figure 13) and subjected to analyses as noted in Table 6 previously presented. Concentrations of several metals including As, Be, Cr, Pb and Ni were found in shop groundwater at levels exceeding ADEC clean-up standards. However, as noted in Table 2, soils at Icy Bay are highly mineralized. This mineralization naturally disperses metals to the surrounding groundwater. More importantly, the camp does not use products containing the metals noted and could create the higher concentrations observed.

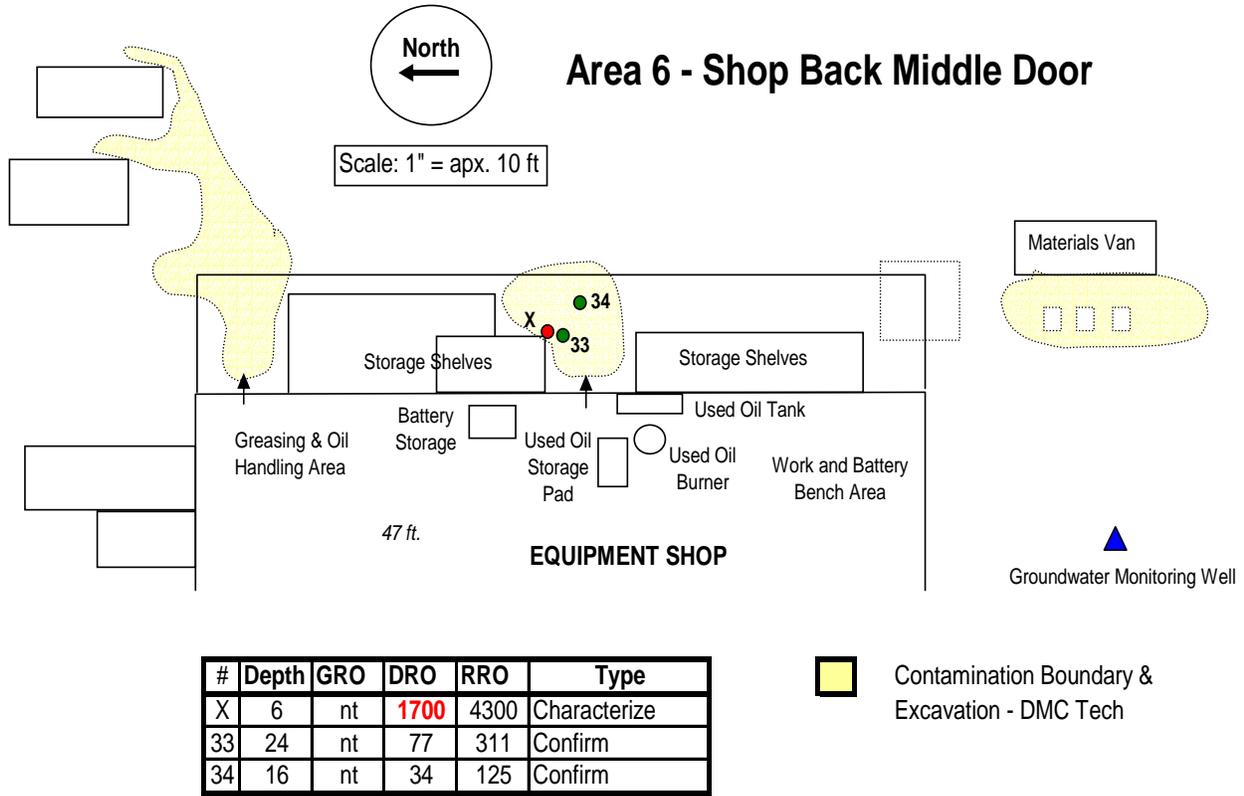
Figure 14. Shop Middle Back Door Excavation and Sampling

As before, on March 23, 2003; the Camp Manger identified the general location where this contamination had previously been observed, but which was no longer visible. Approximately 2 CY from the noted area was excavated to as depth of 1 foot and one confirmation sample collected indicating a clean excavation. On June 14, 2003; the area was re-inspected and other soil staining identified. An additional 4 CY was excavated to a depth of 2 feet and another confirmation sample collected. Confirmation samples indicate that all contaminated soil was removed. Figure 14 illustrates the location in question.

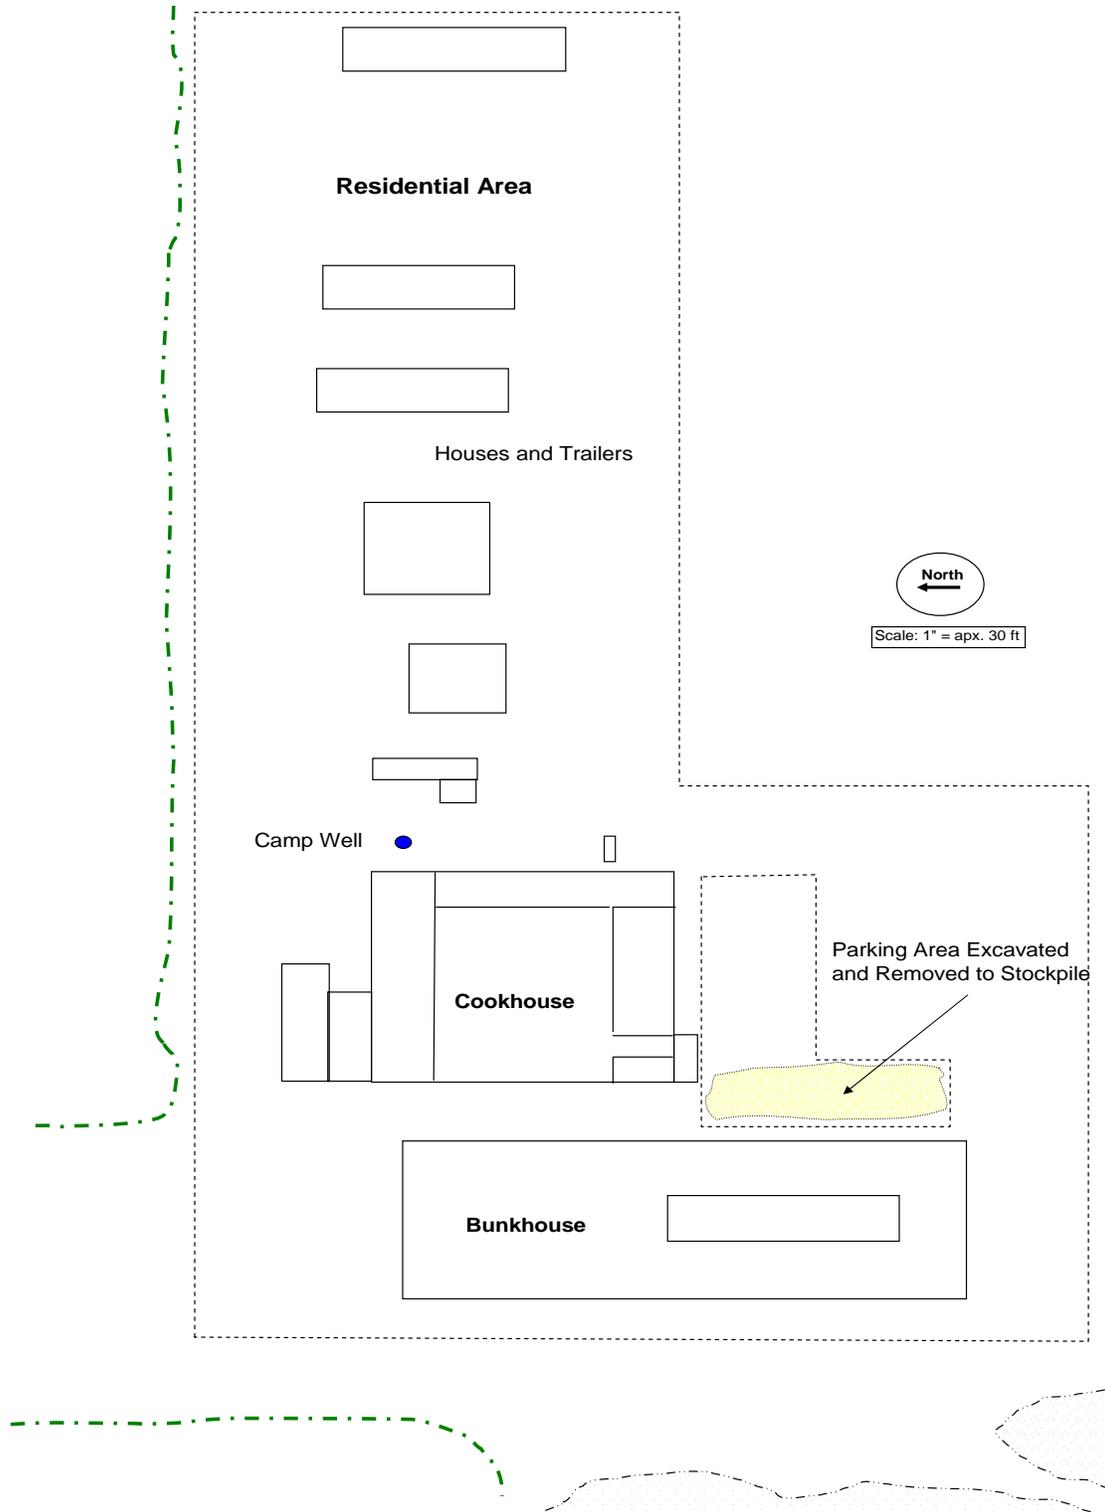
Figure 29. Residential Area Excavation

The parking area in front of the office, bunkhouse, and cookhouse complex was frequently used. A large rectangular area containing soil stains was excavated to a depth of 2 feet resulting in the placement of 27 CY into the contaminated soil stockpile. Filed measurements were used to determine effective removal since the site was not previously characterized and since the work was considered routine camp maintenance. A 10 mil reinforced liner was placed at the base of the excavation prior to backfilling. Figure 29 identifies work performed in the residential area.

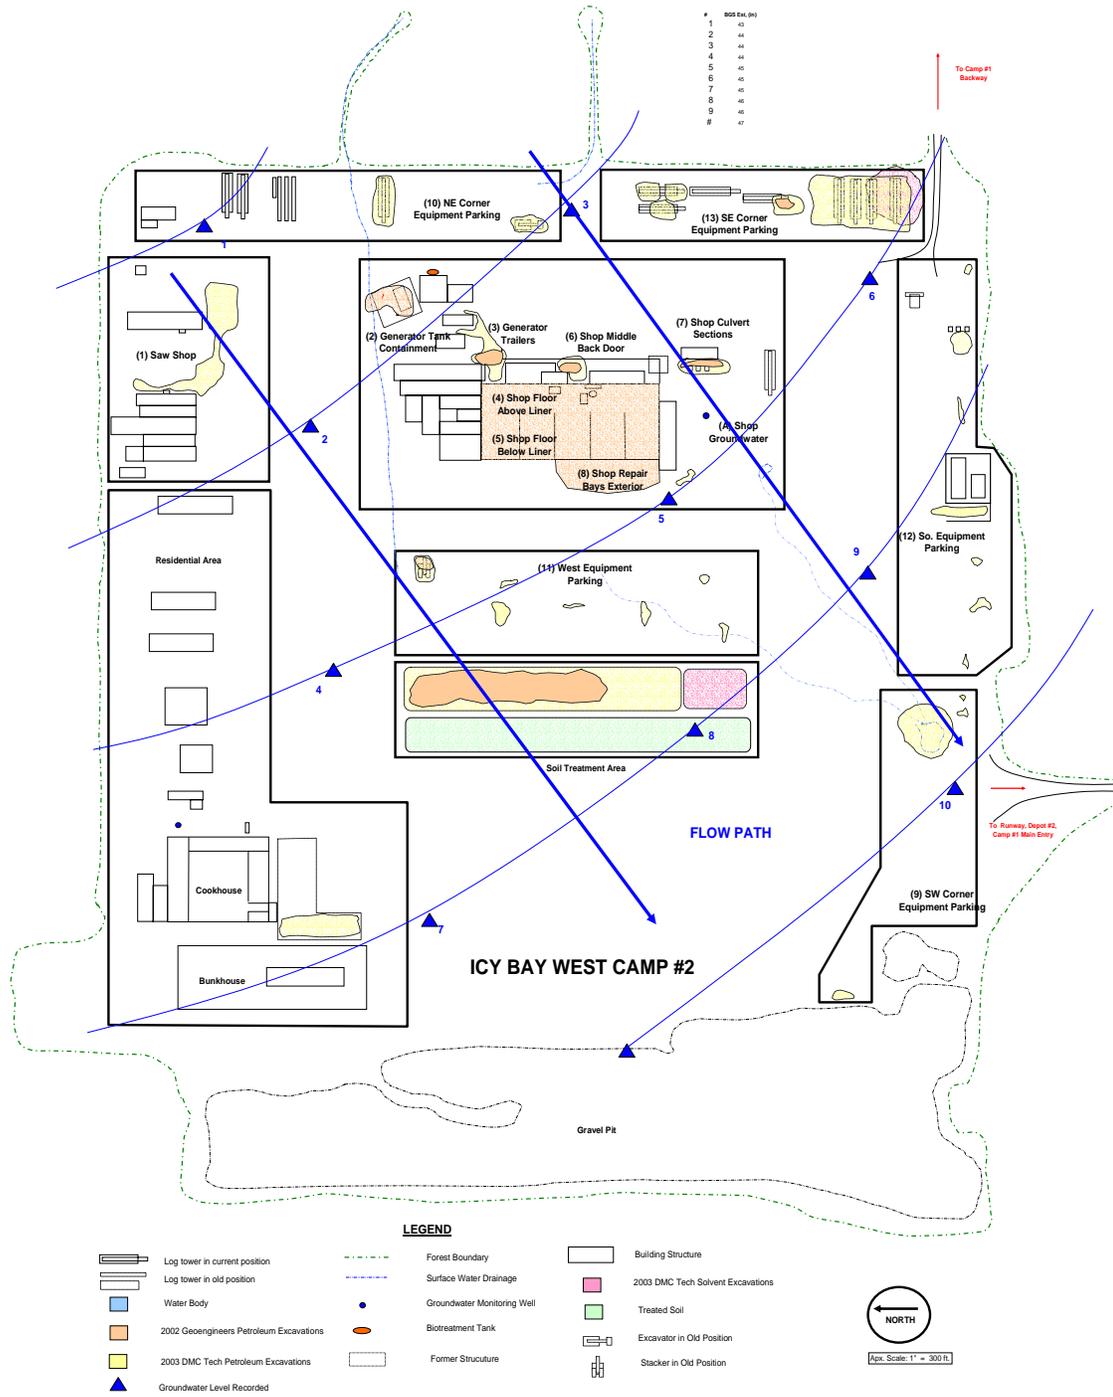
Figure 30. Camp Water Table Measurements

On June 12, 2003; 10 shallow excavations to the water table were created with a track hoe in various locations across the main camp area. Water was allowed to quiescence overnight. The next morning, a GPS unit was used to measure the surface of the water table in each excavation and from the water ponded in the gravel pit. Water levels were used to develop a flow net. Data indicates that groundwater under the camp flows from northeast to southwest towards surface water stream located between camp and the airport. Figure 30 illustrates the data collected.

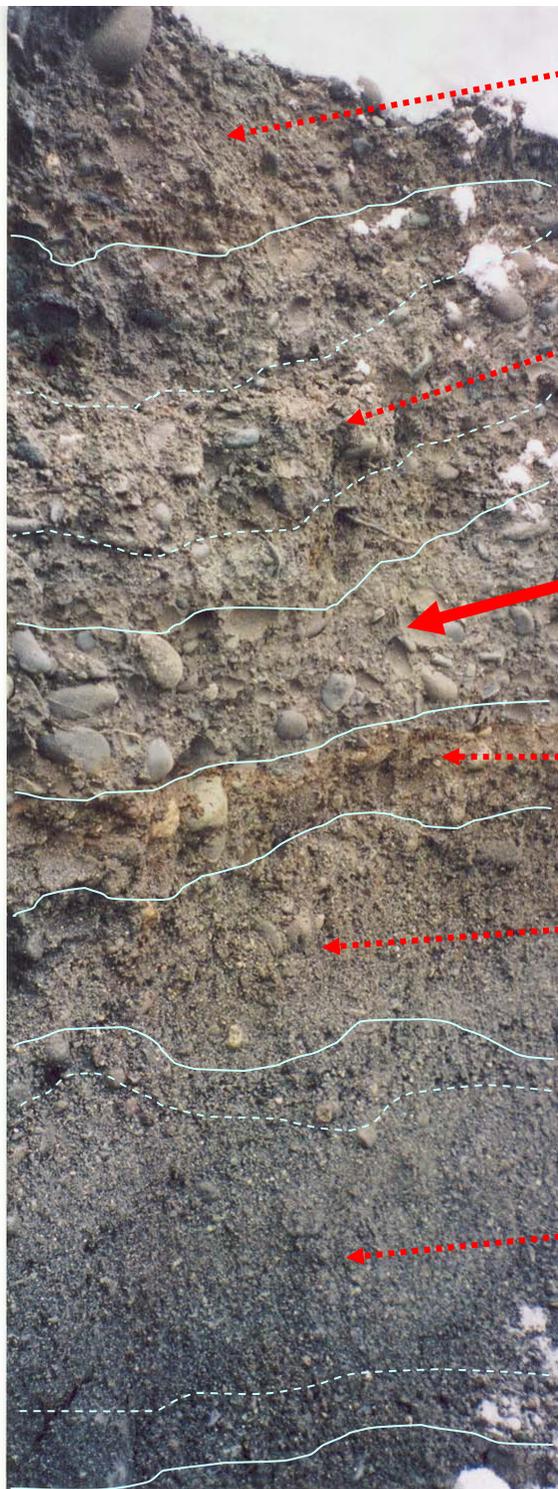
After removal of snow, the surface area immediately under the depot was inspected and PID surface measurements collected. From a surface perspective, there was no visual or PID evidence that a significant release at the surface had occurred. Large excavations holes were opened in each containment cell to provide further observations. The soil profile in each excavation pit was inspected and sampled. Three (3) layers of interest were identified across the depot area including surface soils containing clay from 3”-6” ; a cemented layer of clay and gravel from 27” to 30” ; and an orange tinted water table layer composed of sand, clay and gravel from 36” to 39” . Approximately 500 feet of lateral trench was opened for observation. The water table layer was clearly distinguishable by its color. Uniform coarse sand and fine gravels were detected to depth under the water table. Identification of layering provides the ability to model transport and fate mechanisms associated with diesel spills under the depot. The typical profile is noted and described below:

(0"-6") : Upper soil layer containing brown to dark brown silty loam with some clay. Root hairs and some

(6"-21") : Typical sand and gravel interspersed with clay from above. Gravels in 1/2" to 3/4" size range and well sorted. Color variations from brown to gray.

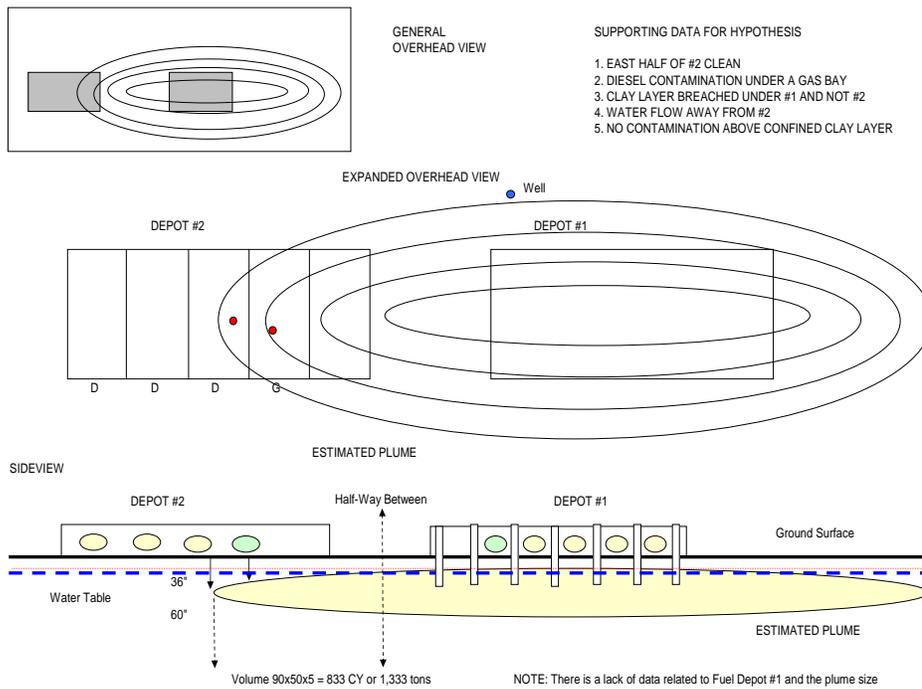
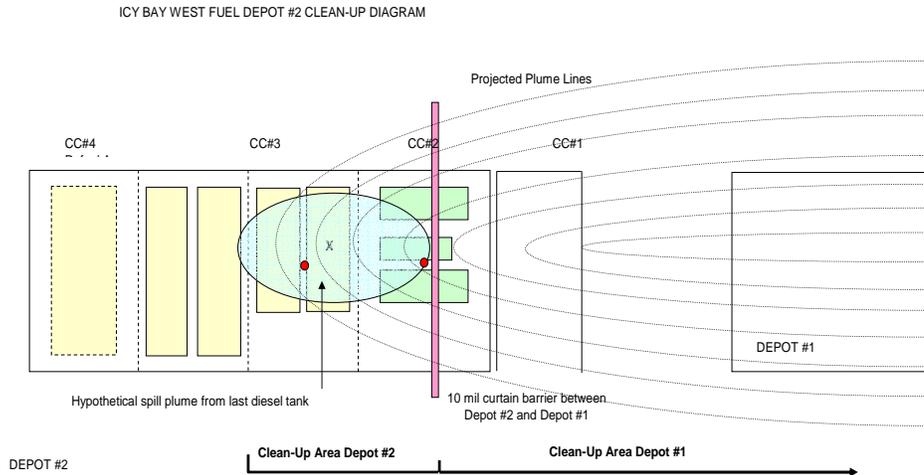
Diesel contaminated soils present under depot #2 likely originate under depot #1 and follow the movement of the water table both up and down and from west to east.

The appropriate boundary between depot #1 and depot #2 is not the halfway point between the depots. Rather, the delineation should be the most probable location where contamination from depot #2 could no longer be present. Based on data collected to date, this location is a line between depot #2 containment cells #1 and #2 as noted below:
