ALASKA DEPARTMENT OF ENVIRONMENTAL CONSERVATION
Division of Spill Prevention and Response
Prevention and Emergency Response Program

SITUATION REPORT

INCIDENT NAME: Gambell Drinking Water Well

SITREP #: 3 and final

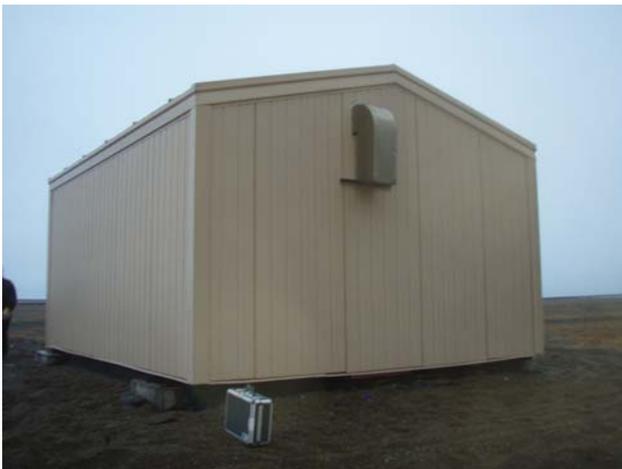
Building surrounding the infiltration gallery. Photo by ADEC.

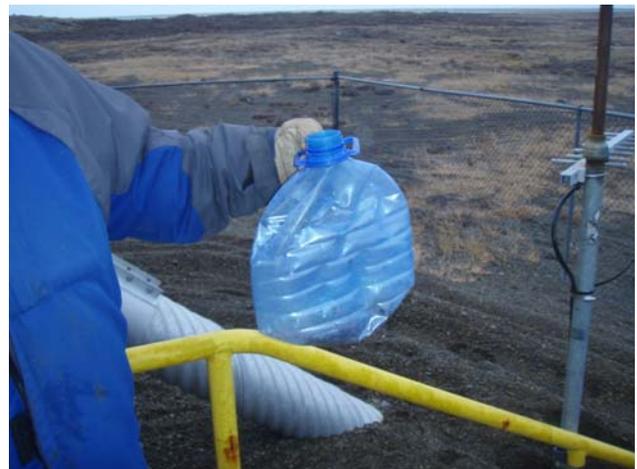
TYPE/AMOUNT OF PRODUCT SPILLED: The ADEC Responder on site visited with some kids that were in the area. They stated that a small amount of gasoline had dribbled out of the fuel tank of a four wheeler when it was turned over. No evidence of a petroleum release could be found.

The gas container initially thought to have been the source. Photo by ADEC.

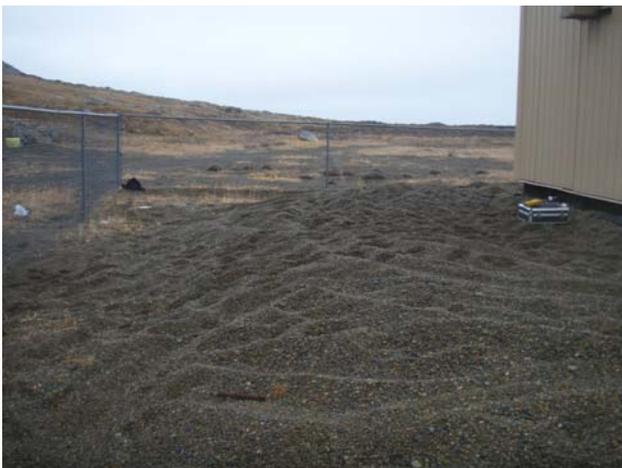
CAUSE OF SPILL: No evidence of a release was discovered.

The reported spill site. Photo by ADEC.

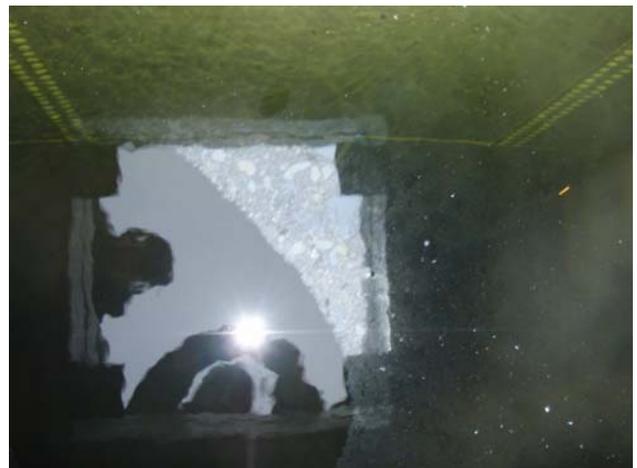
RESPONSE ACTION: The sheen in the city well infiltration gallery and the holding tanks was found to be caused by organic matter. The ADEC Division of Water Quality/Village Safe Water Program and Division of Environmental Health/Drinking Water Program worked with the City Water Plant operator to collect appropriate waters samples for analysis. An ADEC spill responder was dispatched to Gambell to assess the site for any fuel spills. No evidence of spilled fuel was found. While on site, the ADEC spill responder interviewed the local law enforcement personnel and one of the Gambell residents who was allegedly involved in the spill. The interview did not reveal any potential sources.

Two water samples were collected from the Gambell Water Plant: one from the infiltration gallery (well) and one from the newest water holding tank. Both samples were analyzed for volatile organic compounds (VOC), a class of chemicals that reflect petroleum contamination. The sample collected from the infiltration gallery showed no signs of VOC. The sample collected from the holding tank showed trace amounts of VOC, which were well below the drinking water standards.

Organic sheen in one of the holding tanks. Photo by ADEC.

FUTURE PLANS AND RECOMMENDATIONS: No further action will be taken.
